**Level 3, Premium Reserve Analysis**  
**Report Period – 01/01/19 – 12/31/19**

**Client Reference Number - \$\$\$\$**  
**Property Type – Commercial**

**Fiscal Year End –** December 31  
**Number of units-** 14  
**Date of Property Observation -** January 18, 2018

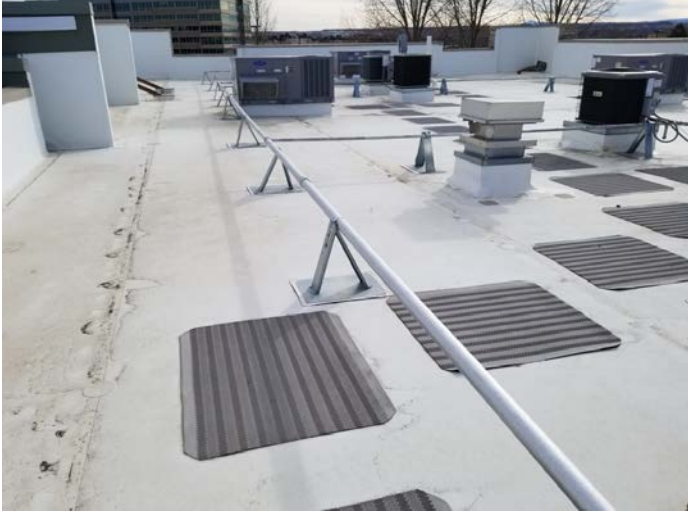
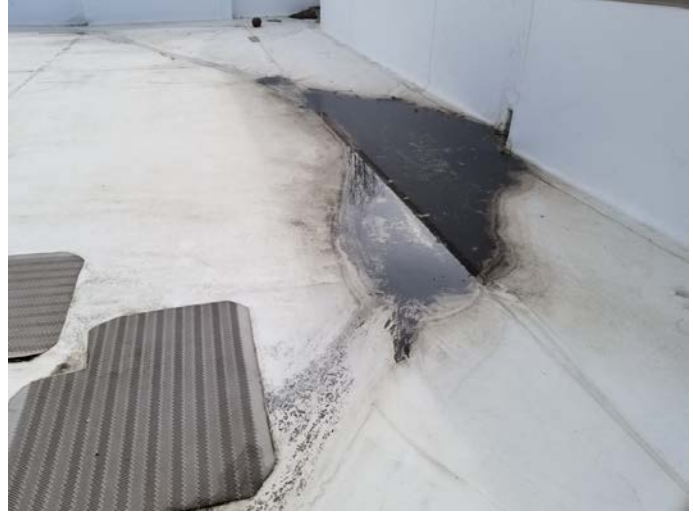
Comp #: 104 TPO Flat Roof - Replace

- This type of roof has a 17 - 20 year life expectancy as long as proper maintenance and limited foot traffic is achieved over the duration of the life of the roof
- Reported recent work and continued annual maintenance will ensure a full life expectancy
- The remaining life is based on the age of the property.

Best Cost: **\$231,000**  
\$1100/square; Estimate to replace

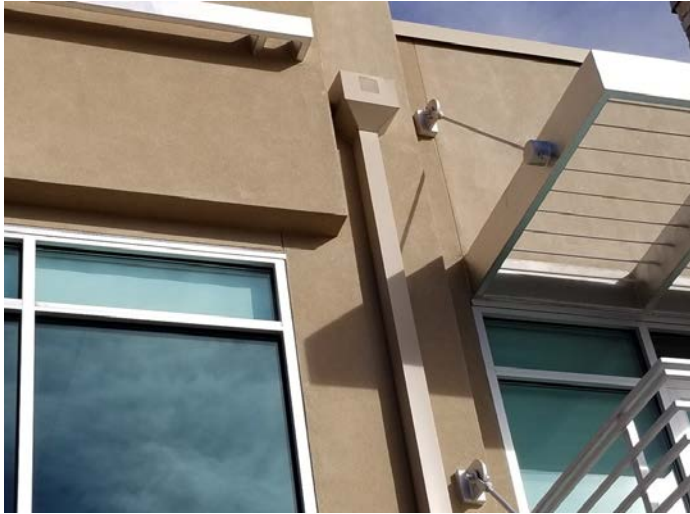
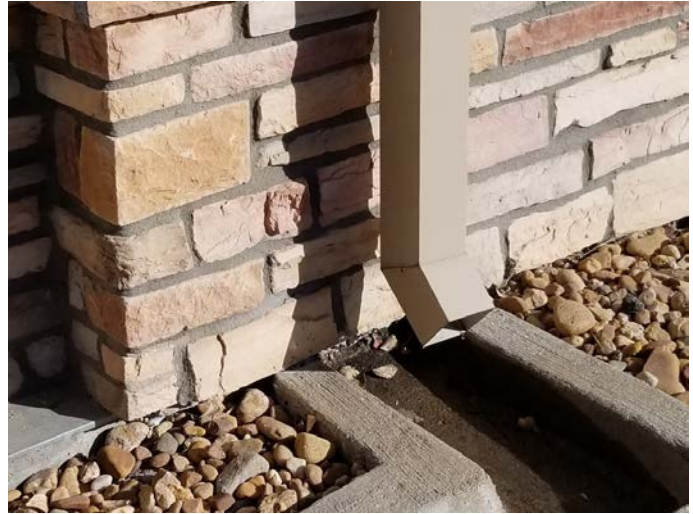
Comp #: 120 Downspouts - Replace

- No unusual conditions noted at time of site visit.
- In our experience, we see this type of downspout to have an indefinite life expectancy.
- Therefore, we suggest repairing sections on an as needed basis with general operating funds.
- Separate Reserve funding is not required for this component at this time.

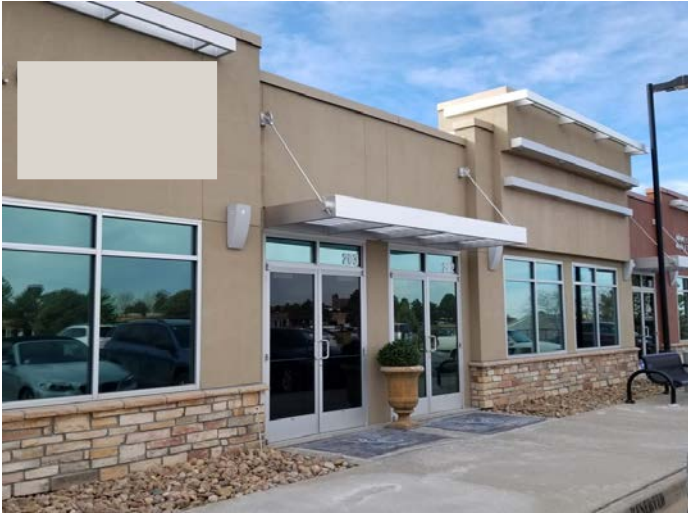
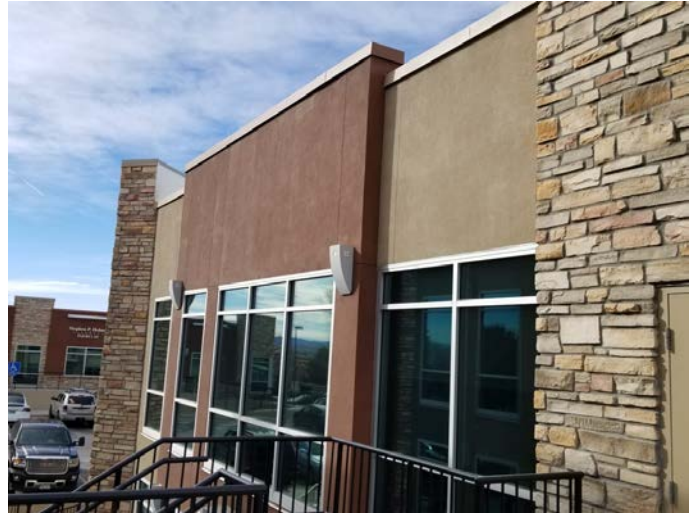
Comp #: 201 Stucco Surfaces - Repaint

- Surfaces were last painted in 2017 and are in good condition
- Stucco surfaces should typically be repainted every 10 to 12 years to protect stucco surface and maintain appearance.
- Painting is done as an alternative to re-applying the stucco for cost effectiveness.
- When stucco surfaces are painted, an elastomeric or acrylic paint should be used according to industry professionals.

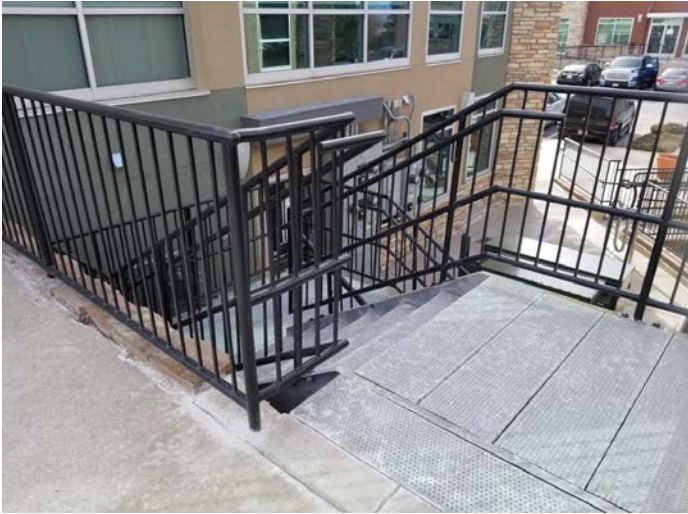
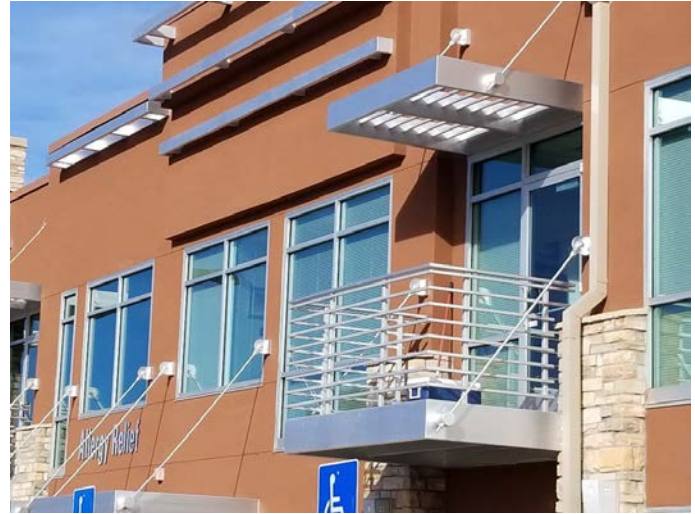
Comp #: 212 Metal Surfaces - Repaint

- Repainted in 2017
- Expect to paint these surfaces approximately every 4 - 5 years to maintain appearance and protect metal surfaces.
- Remaining life based on when surfaces were last painted

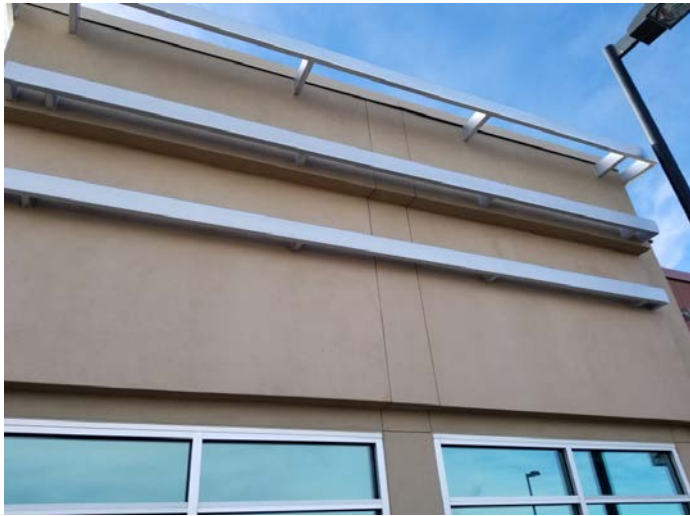
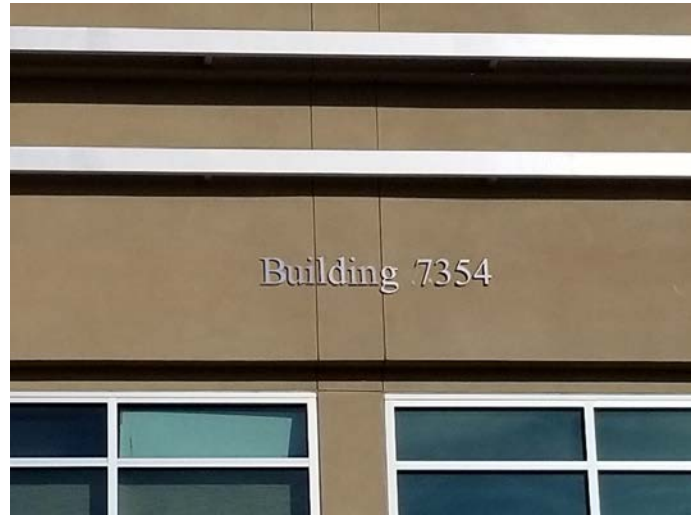
Comp #: 307 Stucco - Repair

- While stucco surfaces have a long life expectancy (typically a 10 year labor warranty), it is recommended by industry professionals to inspect and repair any cracks/voids every 5 - 6 years to prevent water intrusion.
- It is also recommended that a new coating is applied every 10 - 12 years to maintain an appropriate appearance (see component #201).
- Over a period of time, minor cracks and voids will develop that will require re-pointing.
- Coordinate these repairs with a painting cycle

Allowance for inspection and minor repairs

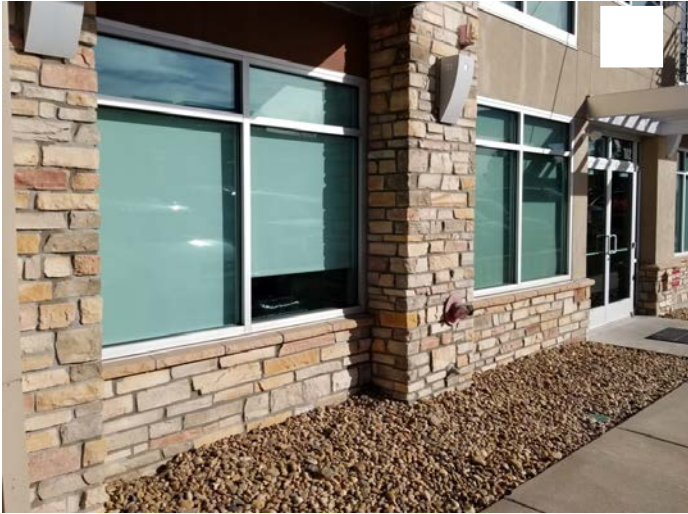
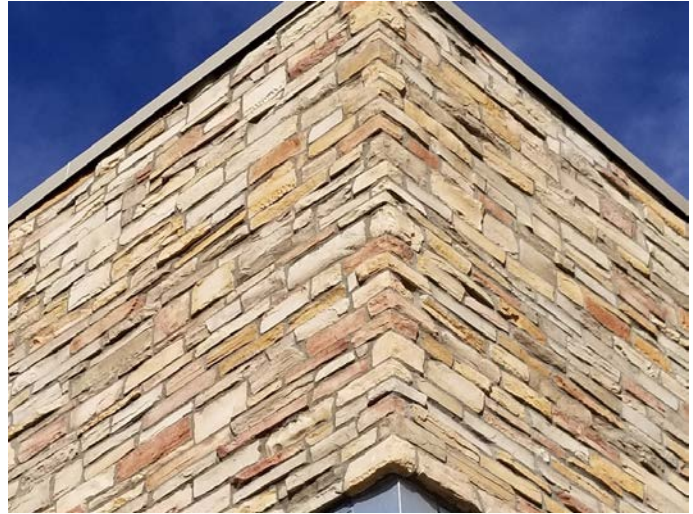
Comp #: 309 Stone/Rock Siding - Major Repairs

- Typically, these stones have an extended life expectancy and complete replacement is unlikely.
- There are times where some stones will loosen and fall off, but this is unpredictable when and how much would occur.
- Due to the age of the community, and reports of recent repairs, we recommend establishing an allowance for periodic major repairs.
- This line item is not intended to reflect complete replacement, just major repairs and partial replacement of damaged areas.

Allowance for minor repairs every 5 years

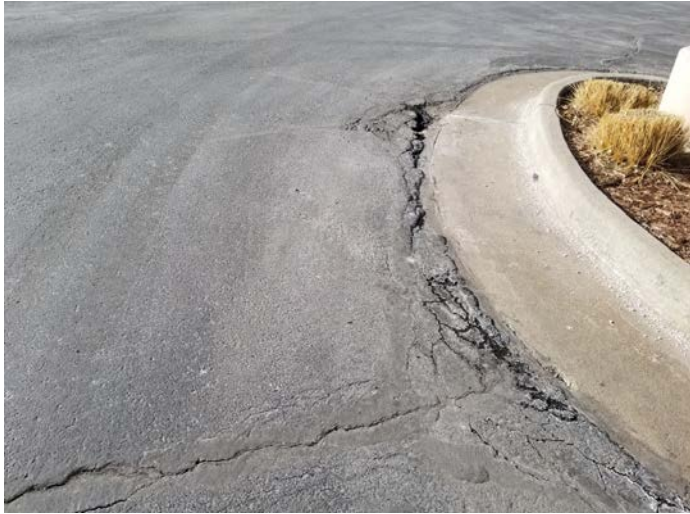
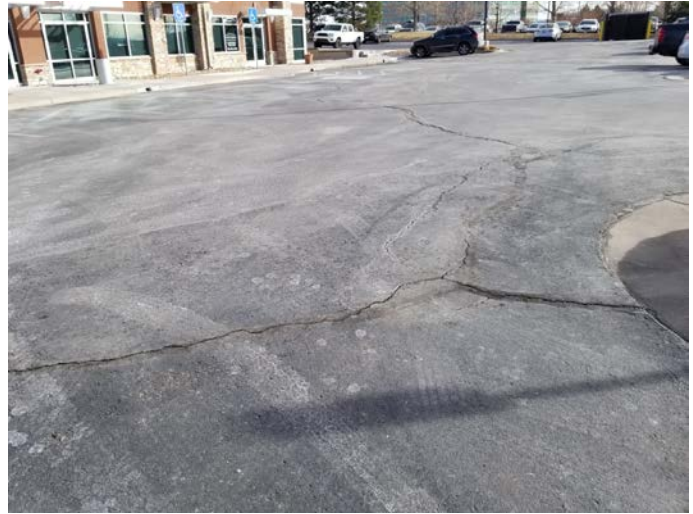
Comp #: 401 Asphalt - Overlay

- The average life expectancy for asphalt surfaces ranges between 20 - 27 years for surfaces that are maintained on a regular schedule.
- Maintenance includes crack fill and repairing small potholes annually as an operating expense.
- In addition, asphalt should be seal coated every 3 - 4 years, depending on the level of traffic and snow removing techniques.

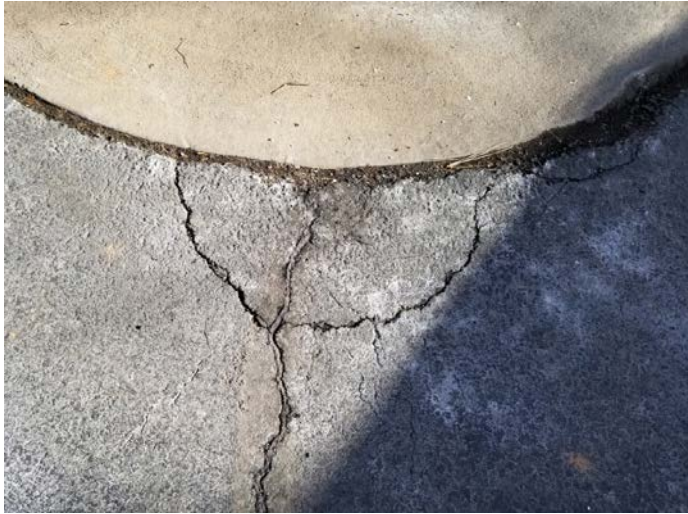
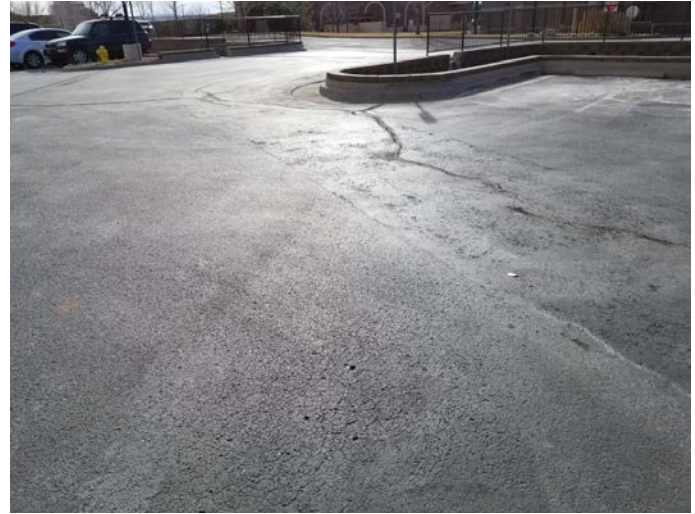
Comp #: 402 Asphalt - Seal Coat/crack fill

- It is important to maintain a proper seal cycle to protect the integrity of the asphalt and prevent extensive cracking, development of potholes, and loss of emulsion, which will lead to advanced deterioration
- Depending on the type of snow removal techniques and the level of traffic, we suggest seal coating every 3 - 4 years.
- In between seal cycles, the asphalt should be inspected and any cracking that develops should be filled, along with any minor repairs to prolong the life of the surface.

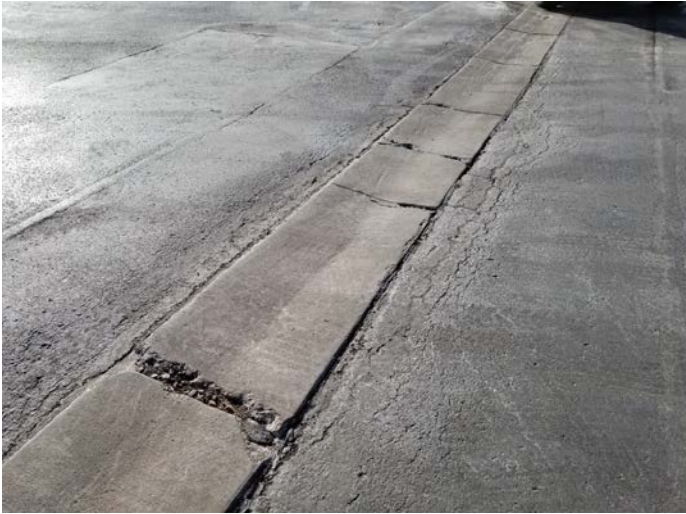
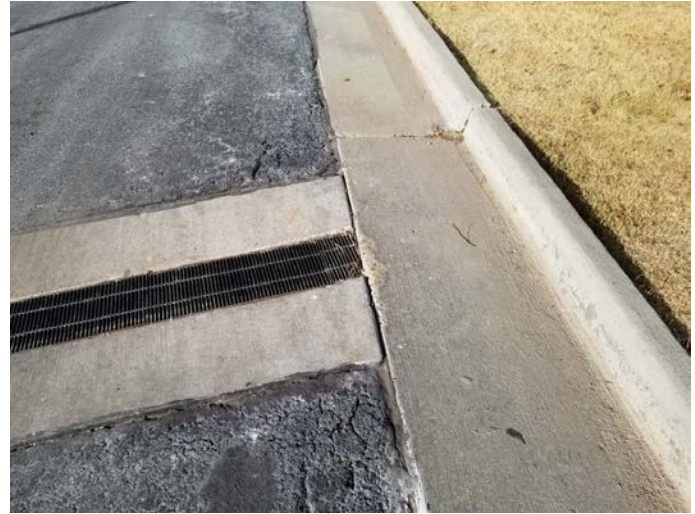
Comp #: 406 Drain Pans/Curbs/Gutters - Repair/Replace

- Curbs and gutters are subject to more advanced deterioration due to trucks and plows hitting them throughout the year.
- It is unlikely that all concrete surfaces will need to be replaced at the same time.
- Therefore, we suggest establishing a Reserve fund for periodic repairs and replacement every 8 years.
- Coordinate with other concrete or asphalt surfaces for best cost estimate.

Estimate to repair 25% of area every 8 years

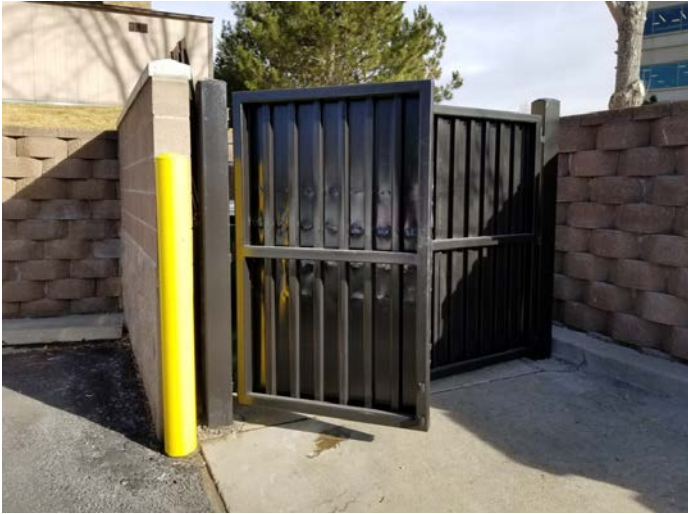
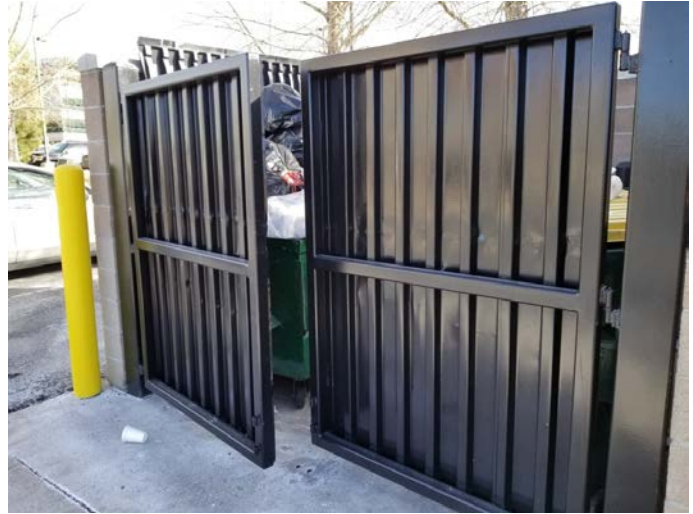
Comp #: 505 Steel Gates - Replace

- Some rusting and minor corrosion noted
- These gates will be subject to heavy abuse from rubbish collection companies.
- These are also very heavy duty gates.
- As a result, we recommend establishing Reserve funds for replacement every 10-15 years.
- The remaining life is based on observed condition and the age of the property.

Best Cost: **\$5,000**  
\$1250/gate; Estimate to replace

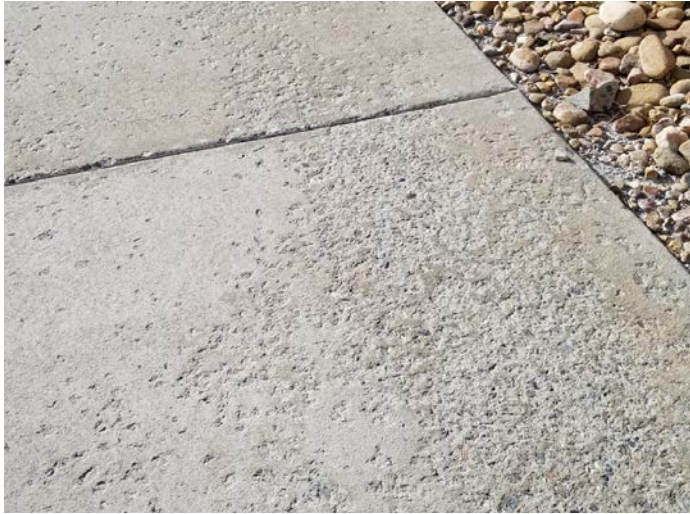
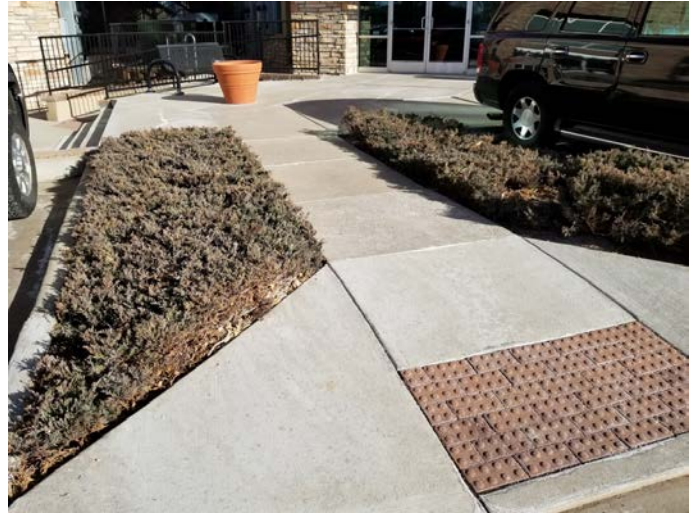
Comp #: 601 Concrete Sidewalks - Repair

- Similar to other concrete assets within the community, it is unlikely that all will fail at the same time.
- Therefore, we suggest establishing a Reserve fund for frequent repairs and replacement of a percentage of the area (20% or 2250 GSF) every 8 years.
- Coordinate this project with other concrete and/or asphalt projects for best cost estimates based on quantity of work.
- As the property ages, the frequency of repairs and/or the percentage may need to be adjusted in future Reserve Study updates.

Allowance to repair 20% of area every 8 years

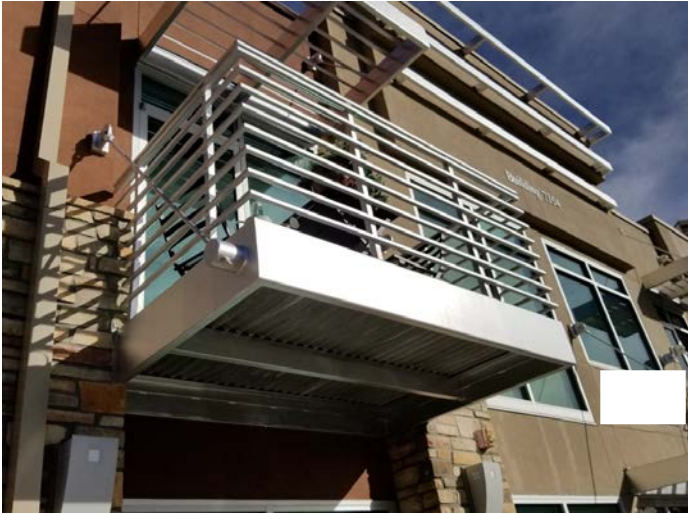
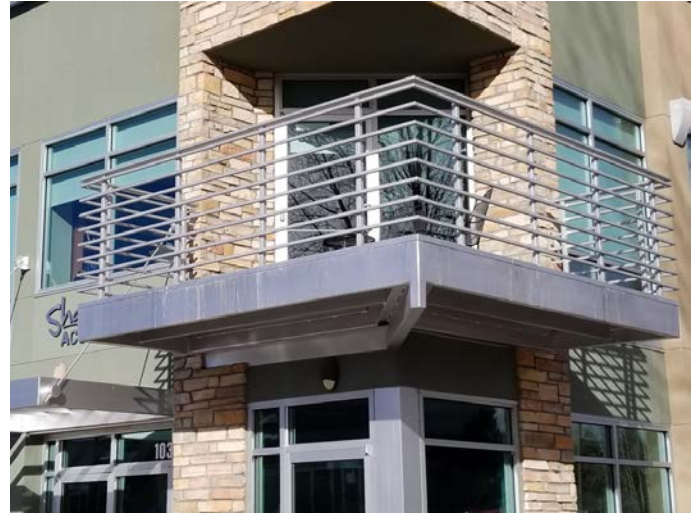
Comp #: 609 Steel Balcony - Replace

- No significant signs of deterioration or different conditions from last site visit.
- These are heavy duty materials that should have an indefinite life expectancy.
- These surfaces should be painted frequently to protect the materials from rust and corrosion.
- Based on extended life, Reserve funding is not required for replacement at this time.

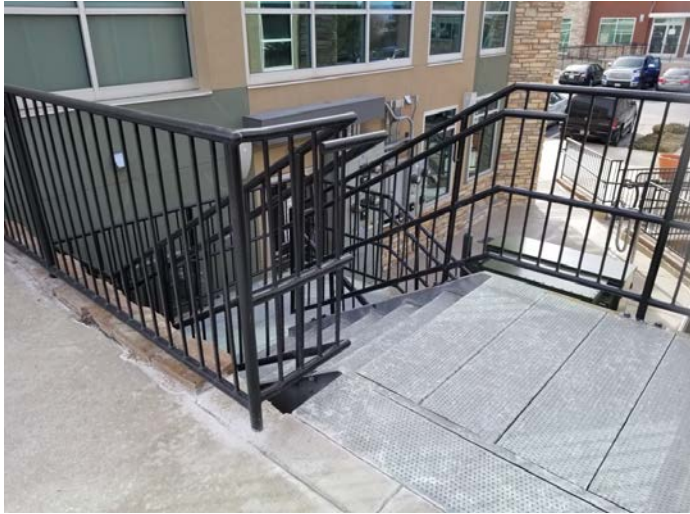
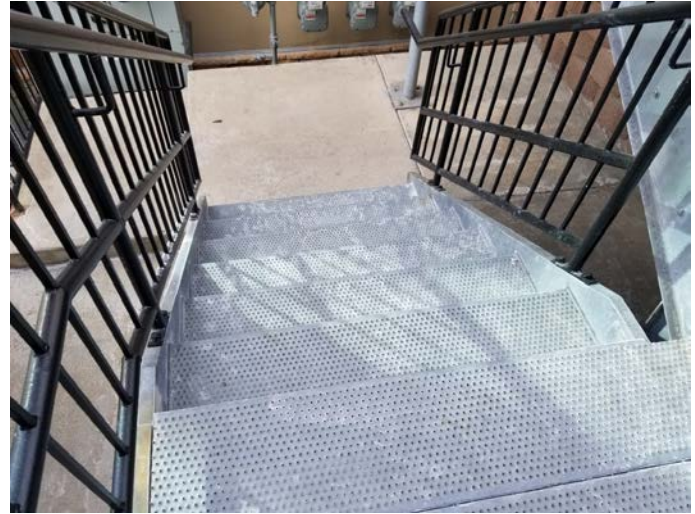
Comp #: 610 Steel Stairs - Replace

- Under normal conditions, these steel stairs have an extended life expectancy and replacement is not likely.
- Therefore, separate Reserve funding is not needed for this component.

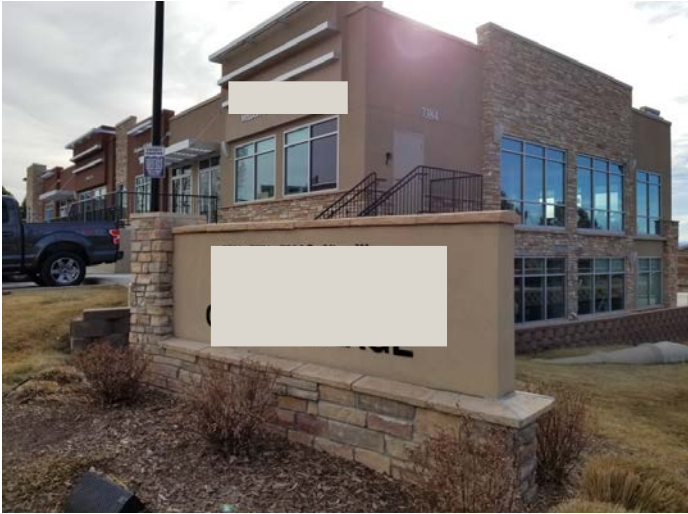
Comp #: 801 Monument - Rebuild

- While the materials used should have an indefinite life expectancy, we recommend planning on renovating monument every 20 - 25 years to maintain current trends and an appropriate appearance.
- Remaining life is based on observed conditions and approximate age of all monument.

Allowance for general repair

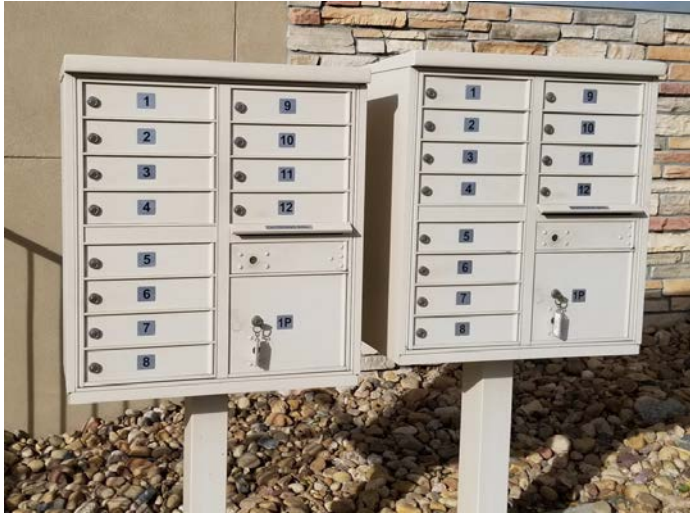
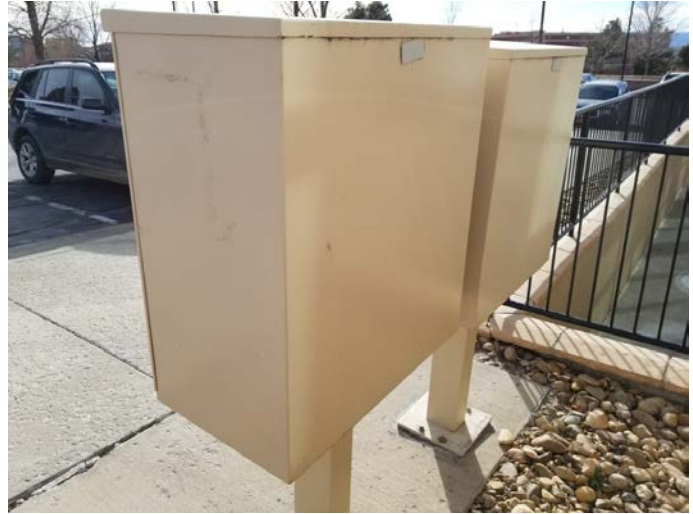
Comp #: 803 Mailboxes - Replace

- This line item is for the original mailboxes that were installed when construction of the community began.
- Per new Postal regulations effective 2012, "all customers are responsible for repairs and replacement of keys, locks, or the boxes/cluster units themselves".
- Based on our experience, these boxes will have a life expectancy of 15 - 20 years due to location and quality.
- Remaining life is based on age and observed condition.

**Best Cost:** \$3,700  
 \$1850/CBU; Estimate to replace

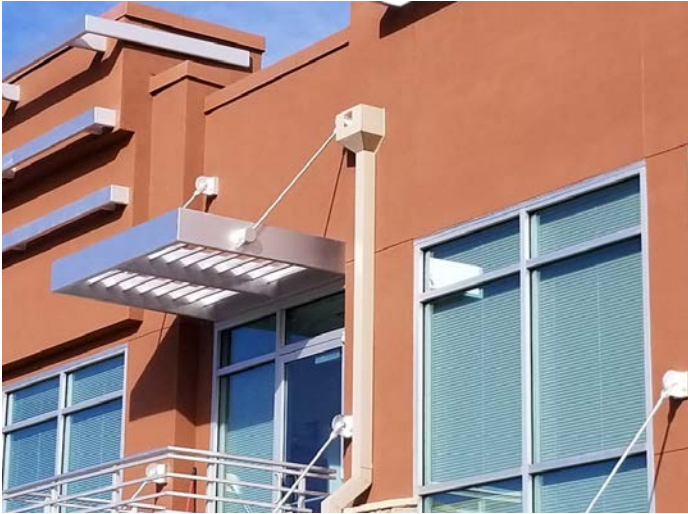
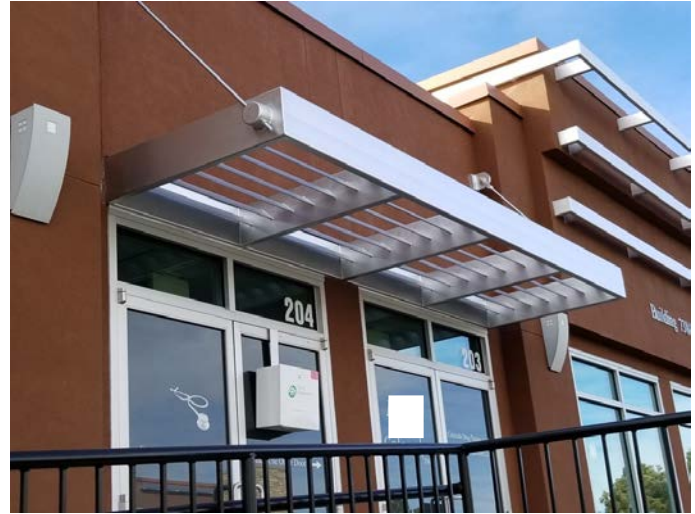
Comp #: 804 Steel Awnings - Replace

- These are heavy duty materials that should have an indefinite life expectancy.
- These surfaces should be painted frequently to protect the materials from rust and corrosion.
- Based on extended life, Reserve funding is not required for replacement at this time.

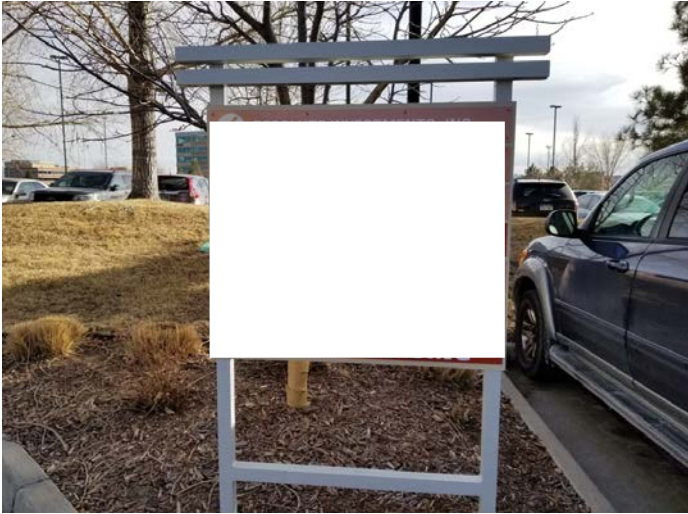
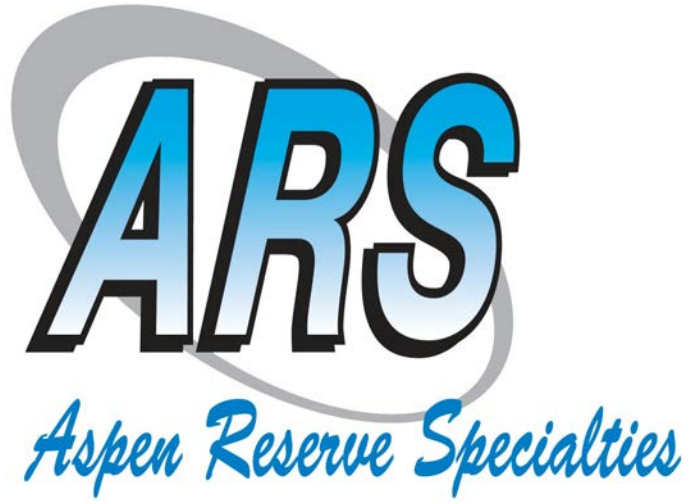
Comp #: 805 Direction Signs - Replace

- Sign is starting to exhibit some fading and minor deterioration.
- This type of sign is designed for periodic replacement of the office signs when tenants move out/in.
- Eventually, the signs will fade and discolor, and as a result, replacement will be required to ensure legibility of the signs.
- Remaining life is based on observed conditions and age of sign

Estimate to replace

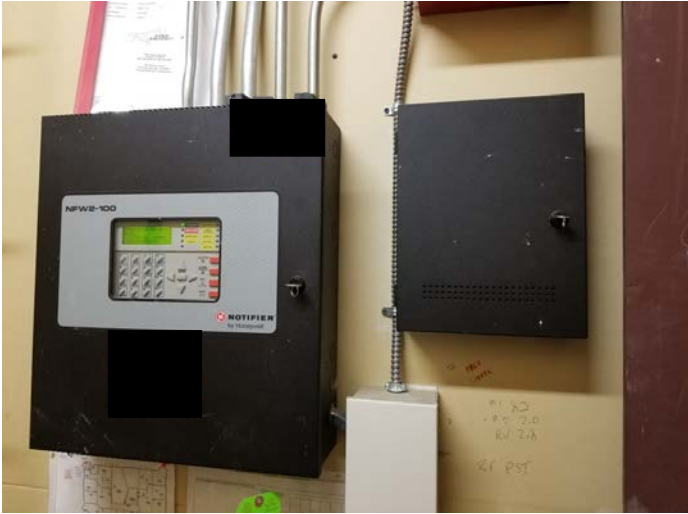
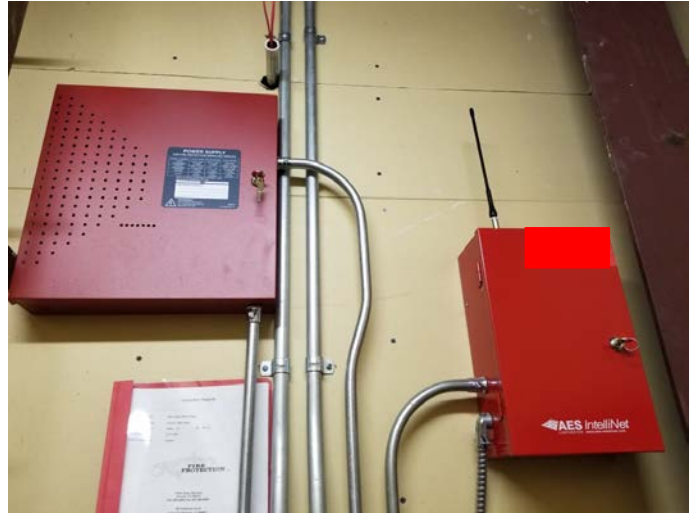
Comp #: 901 Fire Protection System - Replace

- Once the system is installed, it is unlikely that any rewiring will be required; replacement costs are least replacement of the panels only.
- Expect to replace these panels every 15 - 20 years depending on levels of maintenance and under normal conditions.
- System should be tested annually by a professional to ensure functioning conditions during an emergency.

Best Cost: **\$11,250**  
\$3750/panel; Estimate to replace

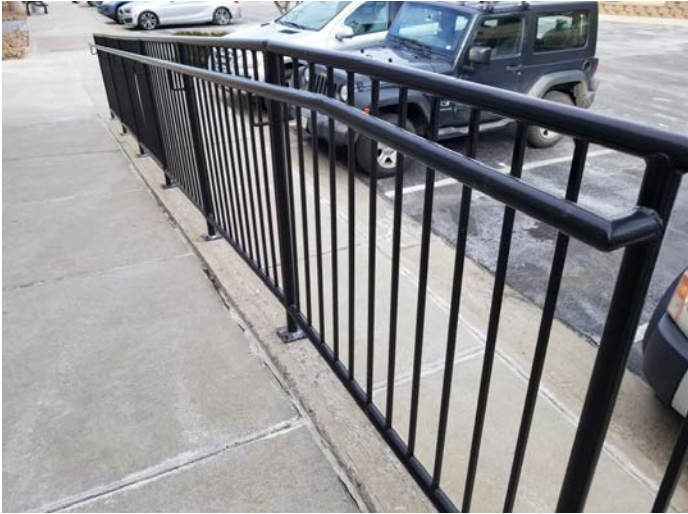
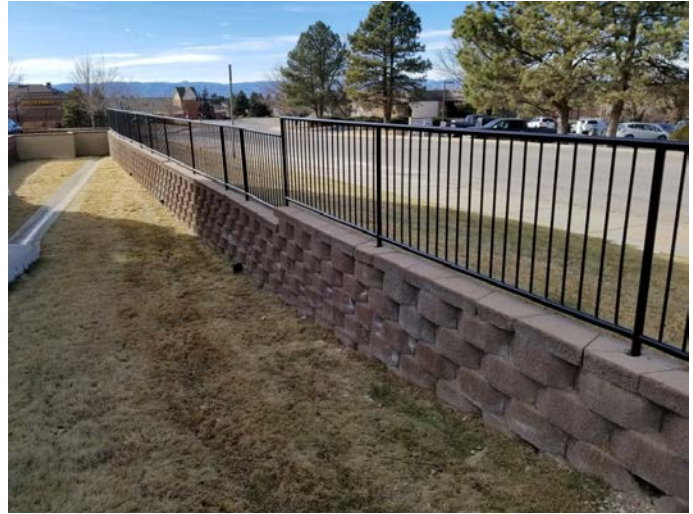
Comp #: 1002 Iron Railing/Fence - Replace

- The average life expectancy for metal fences ranges between 25 - 30 years, depending on maintenance schedules and exposure to elements.
- The remaining life is based on age of fence and observed conditions

Best Cost: **\$51,750**  
 \$45/LF; Estimate to replace

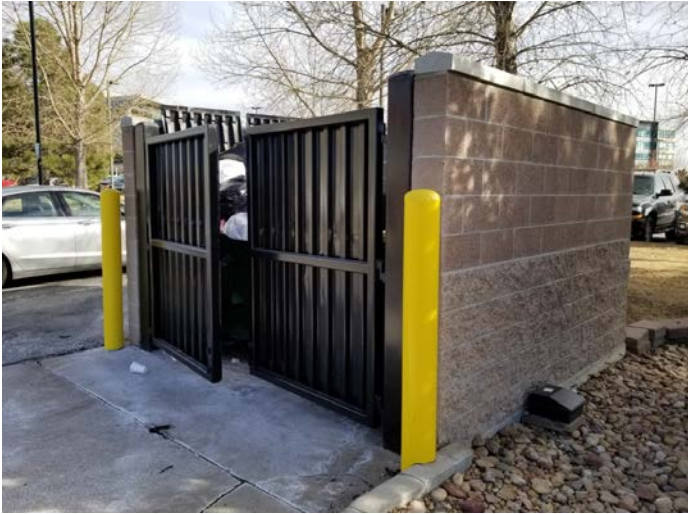
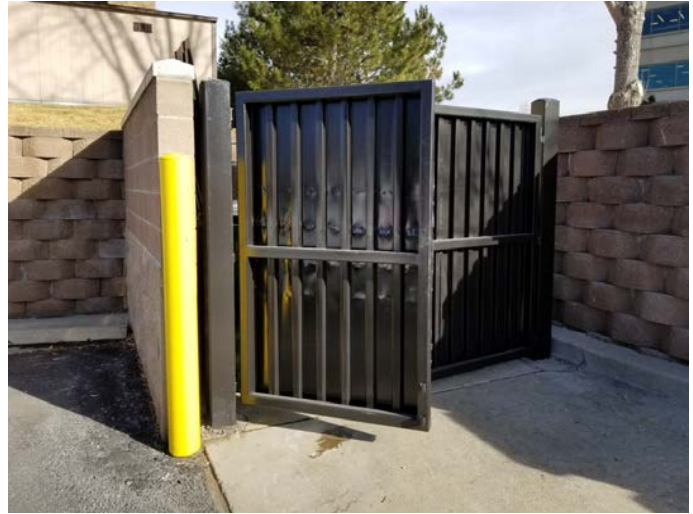
Comp #: 1005 Block Wall - Replace

- These should have an indefinite life expectancy and not need replacement or major repairs.
- Therefore, separate Reserve funding is not needed for this component at this time.

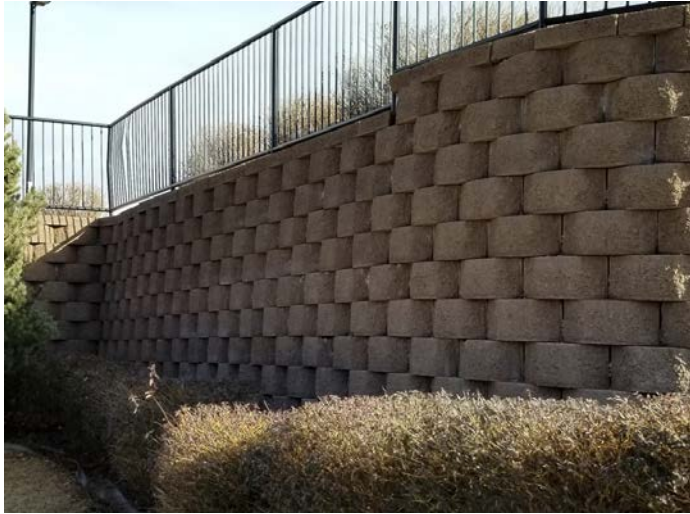
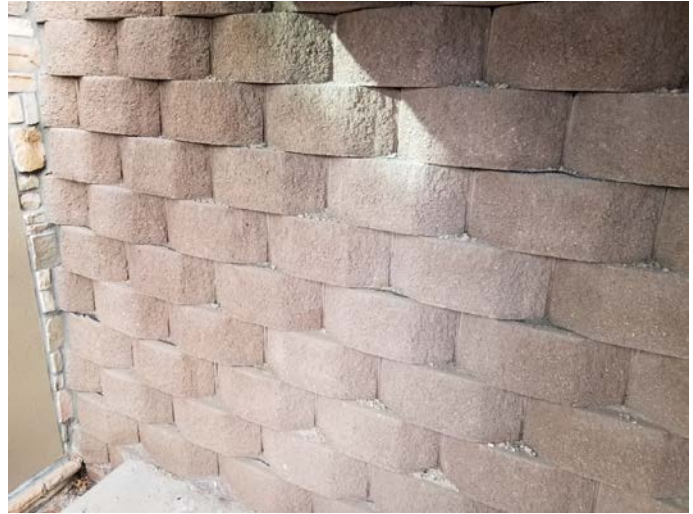
Comp #: 1011 Retaining Wall - Replace

- A few loose blocks noted by fire riser room by building 7384
- As long as block wall was installed conforming to county code requirements, this wall should have an extended useful life.
- This type of material has an indefinite life expectancy and complete replacement is unlikely.
- Therefore, Reserve funding is not required for this component.
- Continue to monitor conditions in future Reserve Study updates and adjust funding requirements if required.

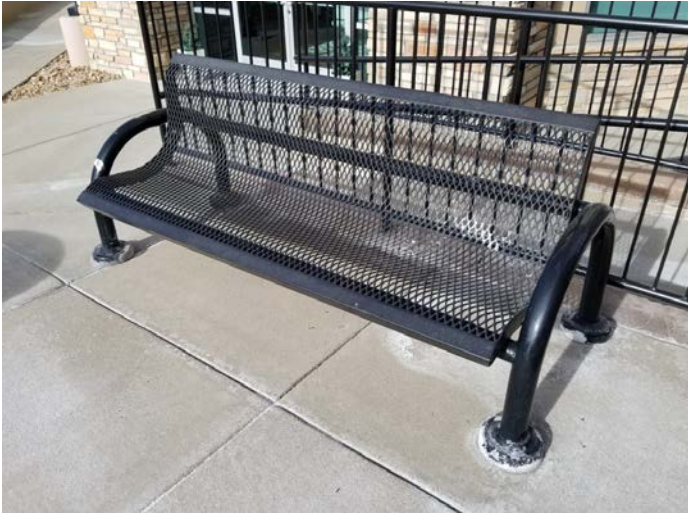
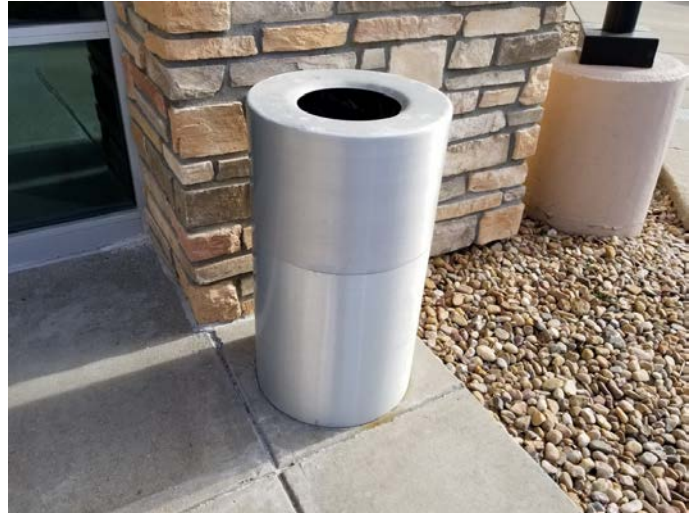
Comp #: 1308 Common Area Furniture - Replace

- The average life expectancy for these pieces of furniture typically ranges between 10 - 15 years, depending on the level of exposure to elements and the quality of care.
- The remaining life is based on the age of the furniture.

Estimate to replace with similar

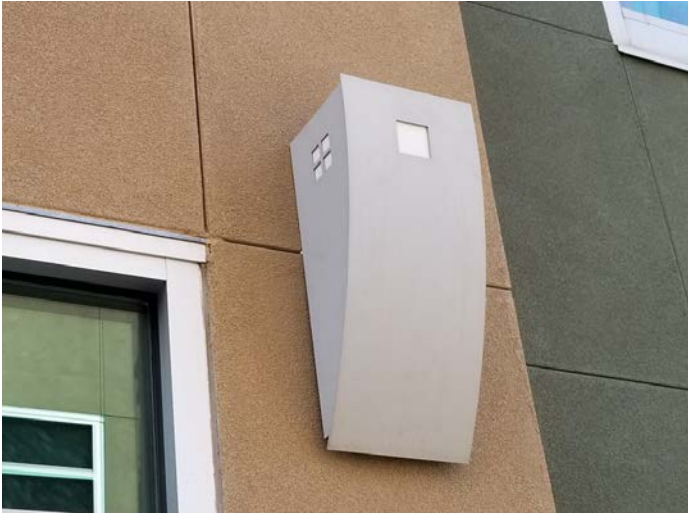
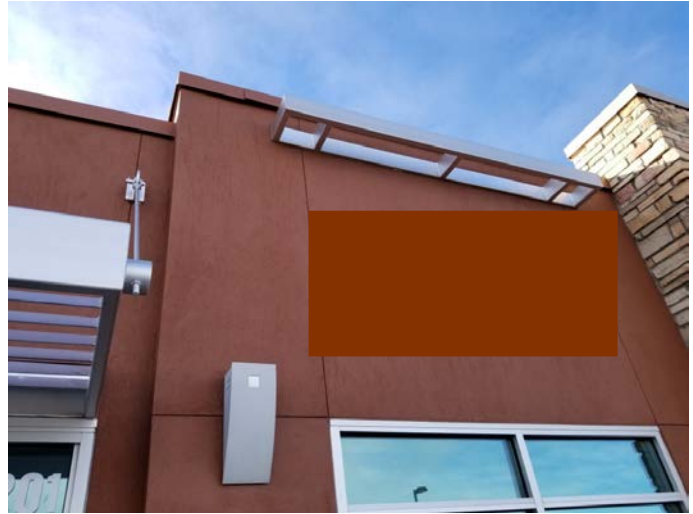
Comp #: 1602 Exterior Wall Light - Replace

- While replacement can occur on an as needed basis, it is our opinion and recommendation to replace all lights at the same time every 15 - 20 years to maintain a consistent appearance throughout the property.
- By replacing multiple fixtures, the association will be able to obtain a quantity discount on replacement and installation of the fixtures.

\$275/light; Estimate to replace

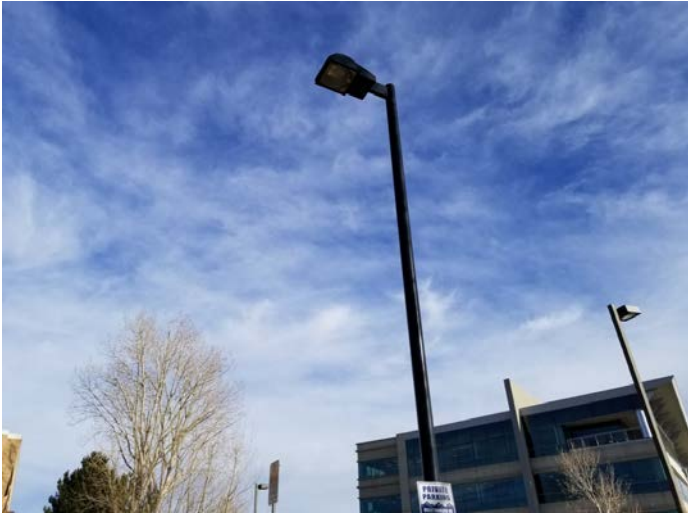
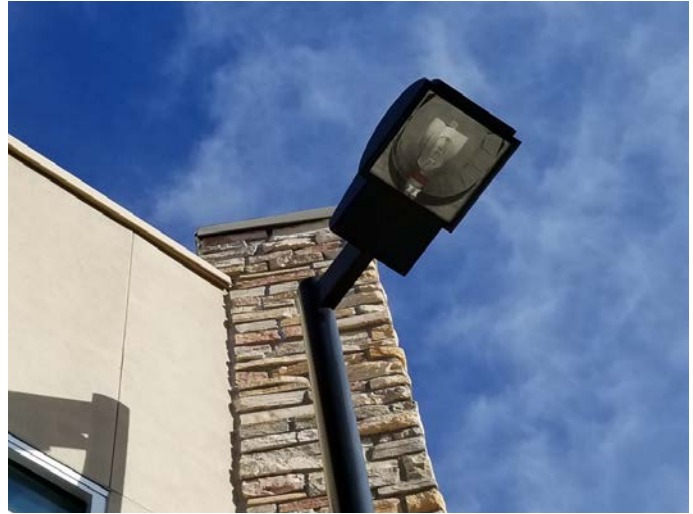
Comp #: 1609 Street Lights - Replace

- The average replacement cycle for this type of light ranges between 25 - 30 years.
- Depending on the level of deterioration, periodically, the heads of the fixtures could be replaced instead of the entire pole and fixture.
- Some communities are deciding to replace with LED fixtures (about \$1200 - \$1500 each head)
- Continue to monitor deterioration rates and adjust accordingly in future updates.

*Best Cost:* **\$40,000**  
\$2500/fixture; Estimate to replace

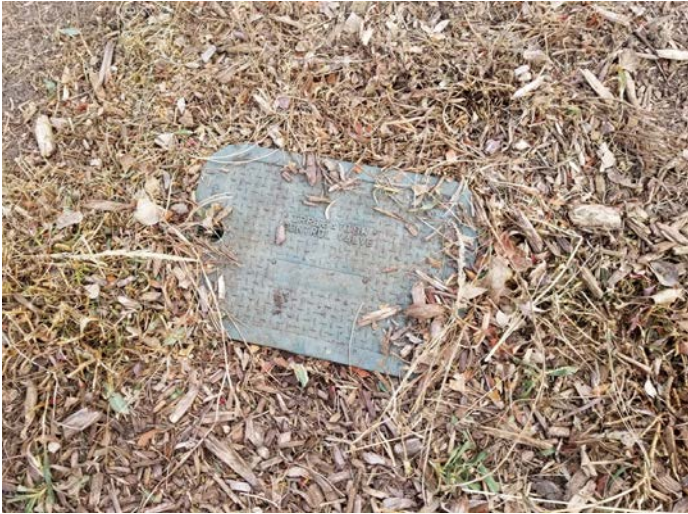
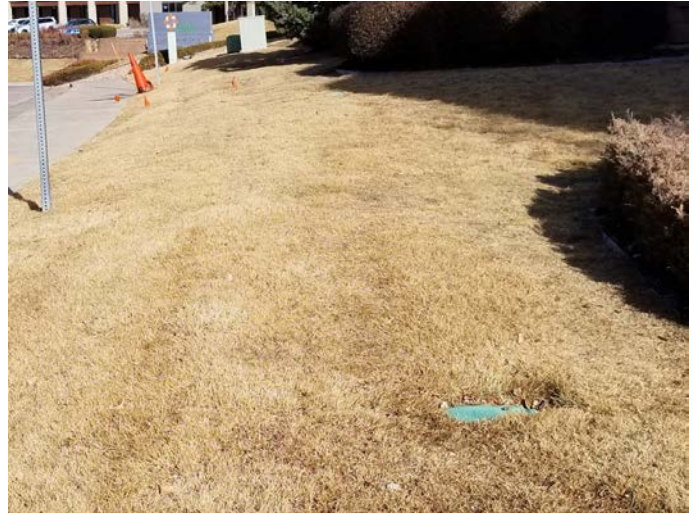
Comp #: 1701 Irrigation System - Rebuild

- This line item is for repairs and replacement that lies outside the scope of routine maintenance: bulk sprinkler head replacement, bulk valve replacement, rerouting lateral lines, rewiring, etc.
- In order to ensure the funds are available for major repairs, we recommend reserving funds for these projects every 4 - 5 years.
- The funding on this line item is for major repairs and is not to be interpreted as complete irrigation system replacement.

Estimate for major repairs and renovating system

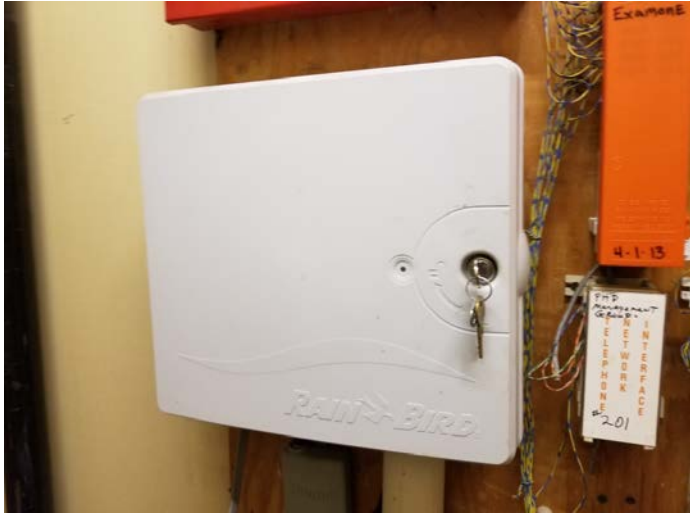
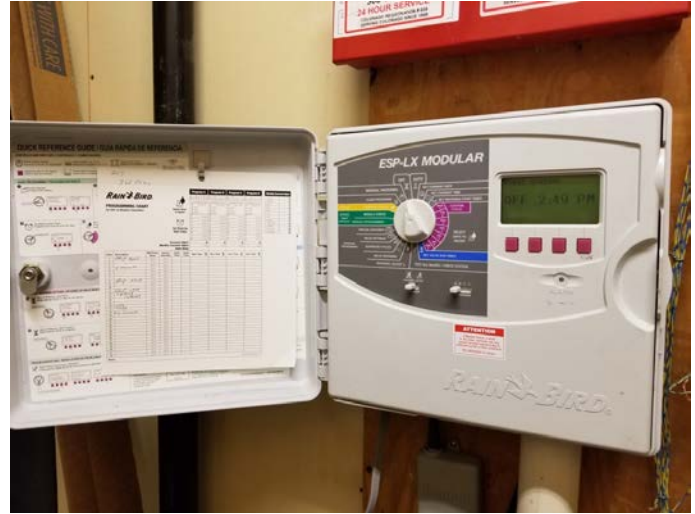
Comp #: 1703 Irrigation Controllers - Replace

- Expect to replace irrigation controllers every 10 - 15 years if properly maintained and under normal conditions.
- Funding is for replacement with a similar controller.
- Evapotranspiration (also known as ET) based controllers are also available, but cost significantly more. ET timers are more efficient and can be controlled remotely by landscaping experts, saving the association irrigation water costs.

Best Cost: **\$2,500**  
\$2500/clock; Estimate to replace

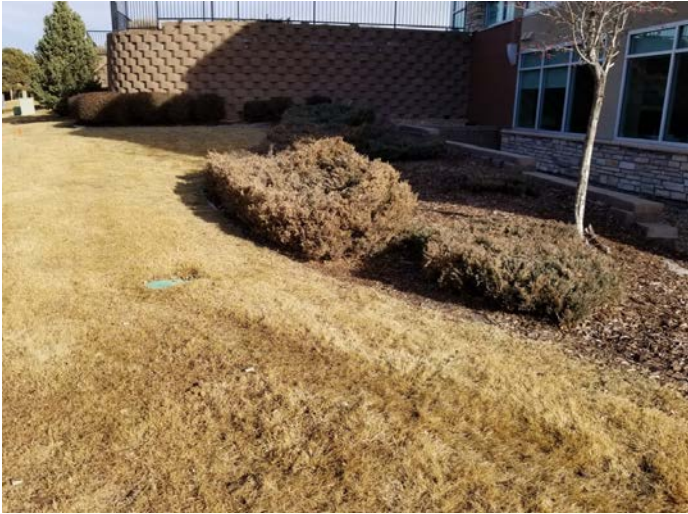
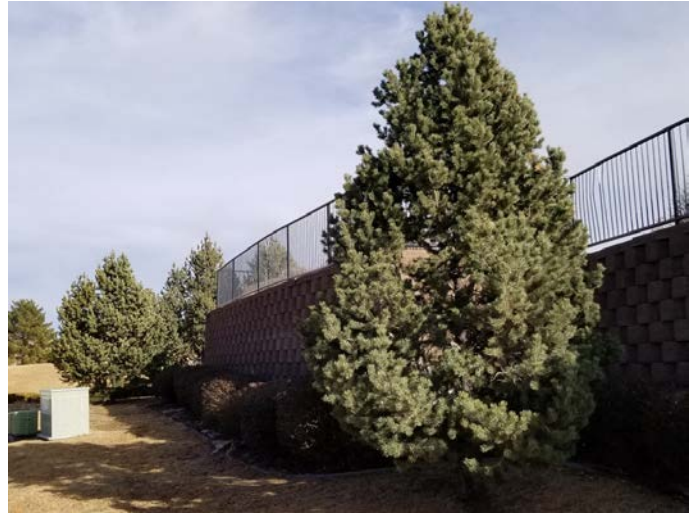
Comp #: 1801 Groundcover/Trees - Replenish

- This line item, similar to irrigation repairs, is for projects that lie outside the scope of routine maintenance.
- In order to preserve an attractive curb appeal and to maintain the health of the plants and shrubs, we recommend reserving for refurbishment projects every 5 - 7 years.
- This line item is for cyclical refurbishment and should not be considered as complete landscaping replacement.
