**Level 1, Platinum Reserve Analysis**  
**Report Period – 01/01/18 – 12/31/18**

**Client Reference Number - \$\$\$\$**  
**Property Type – Paired Homes**

**Fiscal Year End –** December 31  
**Number of units-** 82  
**Date of Property Observation -** September 19, 2017

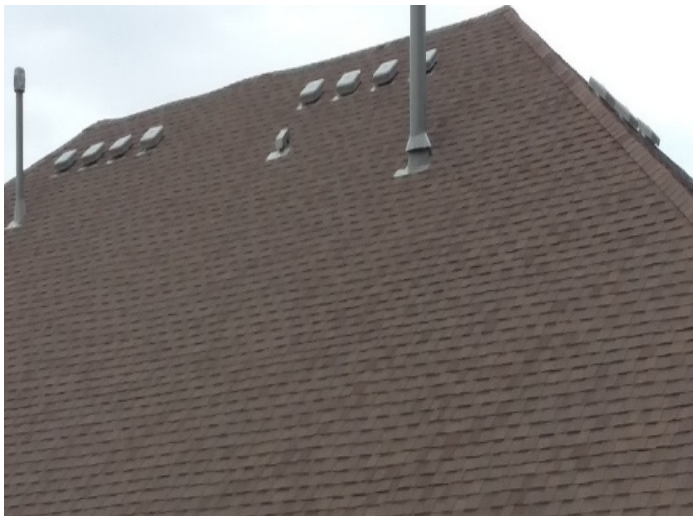
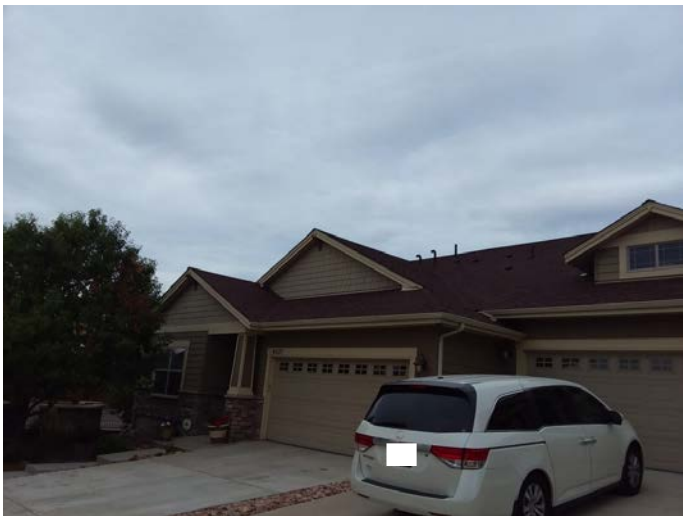
Comp #: 105 Comp Shingle Roof - Replace (PH1)

- This line item includes the buildings that were built in 2005 and 2006.
- The roofs on these buildings were in fair condition at the time of the site observation, with some deterioration noted.
- It appears this roof material is rated as a 30 - 40 year product. Despite this rating, a life expectancy of 20 - 25 years is expected in this environment.
- Due to the potentially harsh winters, extensive freeze/thaw cycle, and likelihood of hail events over the useful life of the roof, we typically see associations replacing roofs sooner than the manufacturer's suggested useful life.
- Remaining life is based on age of roof and observed conditions.

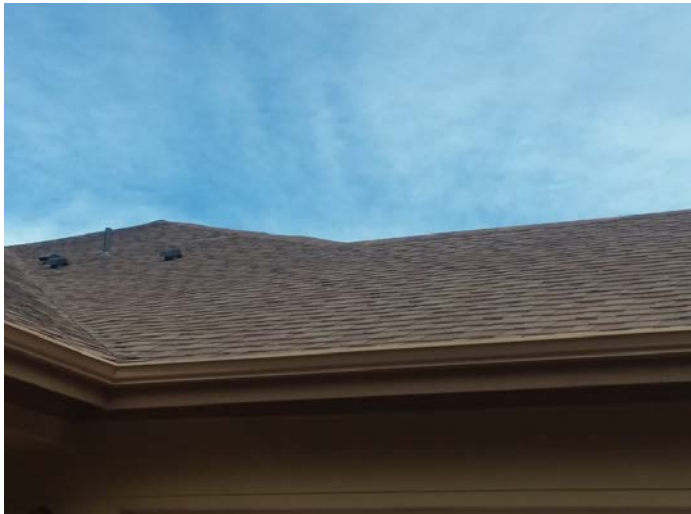
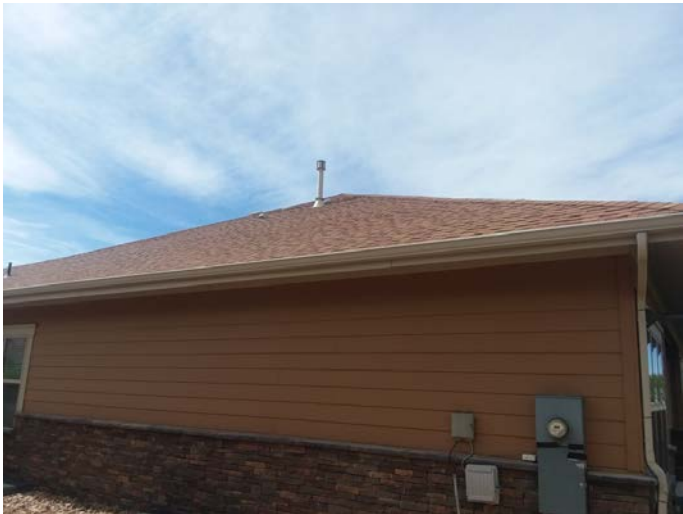
Comp #: 106 Comp Shingle Roof - Replace (PH2)

- This line item is for the buildings that were built in 2010 and 2011.
- These roofs were in good to fair condition at the time of the site observation, with minimal deterioration noted or reported.
- It appears this roof material is rated as a 30 - 40 year product. Despite this rating a life expectancy of 20 - 25 years is expected in this environment.
- Due to the potentially harsh winters, extensive freeze/thaw cycle, and wind, rain or hail events over the useful life of the roof, we typically see associations replacing roofs sooner than the manufacturer's suggested useful life.

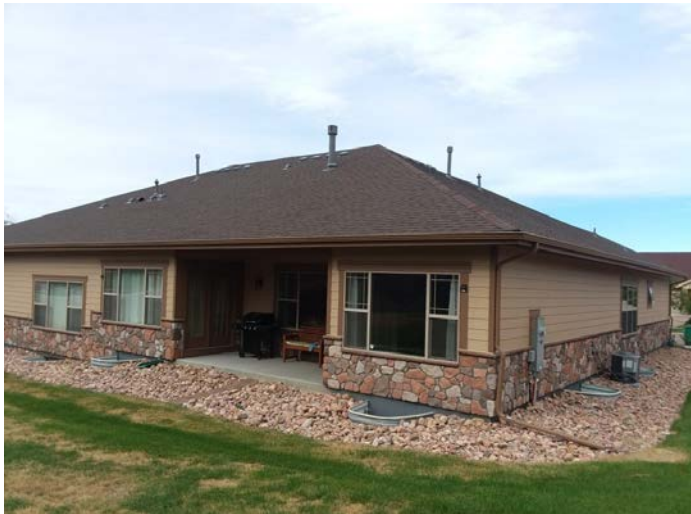
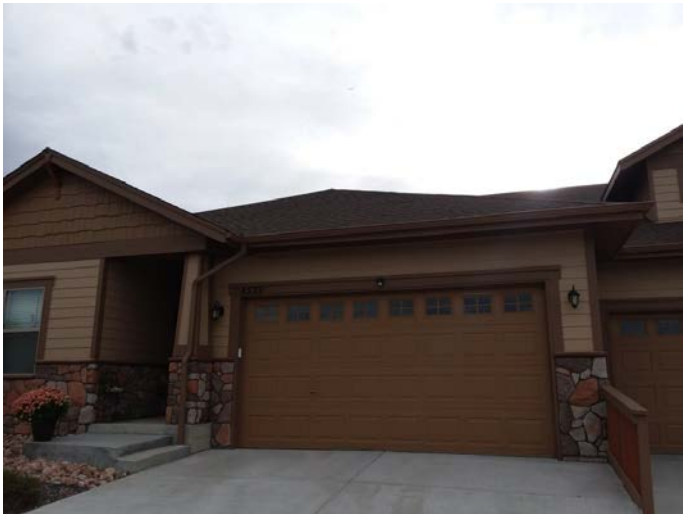
Comp #: 107 Comp Shingle Roof - Replace (PH3)

- This line item is for the buildings that were constructed in 2013 and 2014.
- The roofs appeared to be in good condition, with no issues or deterioration noted at the time of the site observation.
- It appears this roof material is rated as a 30 - 40 year product. Despite this rating, a life expectancy of 18 - 20 years is expected in this environment.
- Due to the potentially harsh winters, extensive freeze/thaw cycle, and likelihood of hail events over the useful life of the roof, we typically see associations replacing roofs sooner than the manufacturer's suggested useful life.
- Remaining life is based on age of roof and observed conditions.

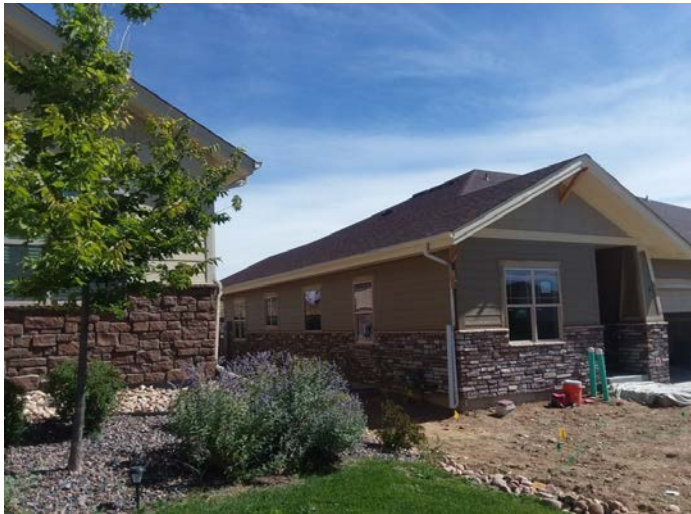
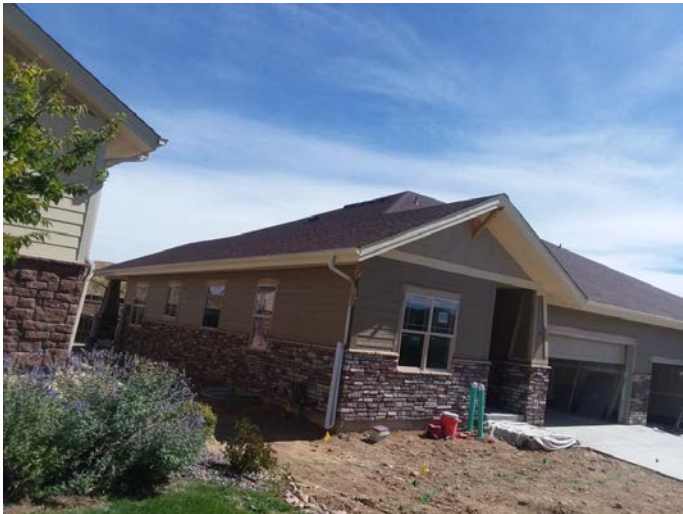
Comp #: 108 Comp Shingle Roof - Replace (PH4)

- This line item is for the buildings that were constructed in 2015, 2016, and 2017.
- The roofs on these buildings were in very good condition.
- It appears this roof material is rated as a 30 - 40 year product. Despite this rating, a life expectancy of 18 - 20 years is expected in this environment.
- Due to the potentially harsh winters, extensive freeze/thaw cycle, and likelihood of hail events over the useful life of the roof, we typically see associations replacing roofs sooner than the manufacturer's suggested useful life.
- Remaining life is based on age of roof and observed conditions.

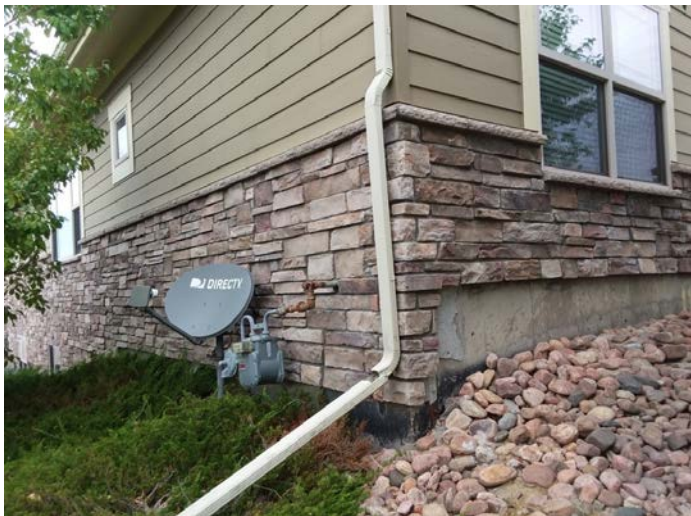
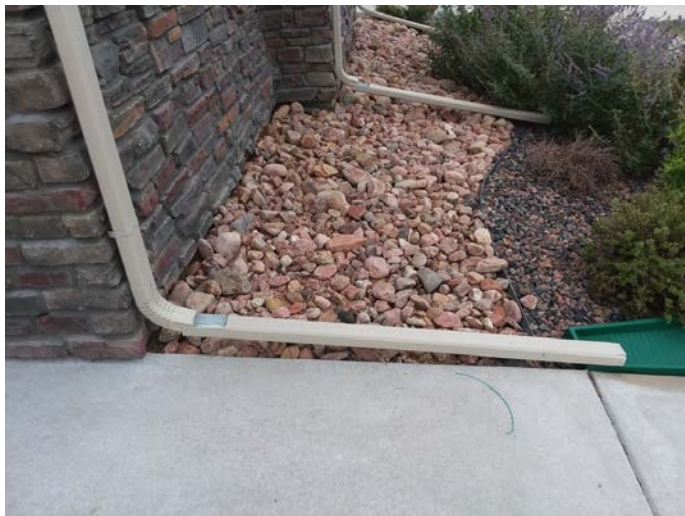
Comp #: 120 Gutters/Downspouts - Replace (PH1)

- These buildings were constructed in 2005 and 2006.
- The gutters and downspouts appeared to be in fair condition with no major signs of leaking or rusting noted. Some did have dents and other minor damage, but the overall condition of this phase was fair.
- It is typical to replace gutters and downspouts at the same time as roofing materials.
- Therefore, the remaining life reflects the remaining life of the roof as well.
- We recommend cleaning debris out of lines at least once a year to prevent clogging and moisture retention that can lead to advanced deterioration.

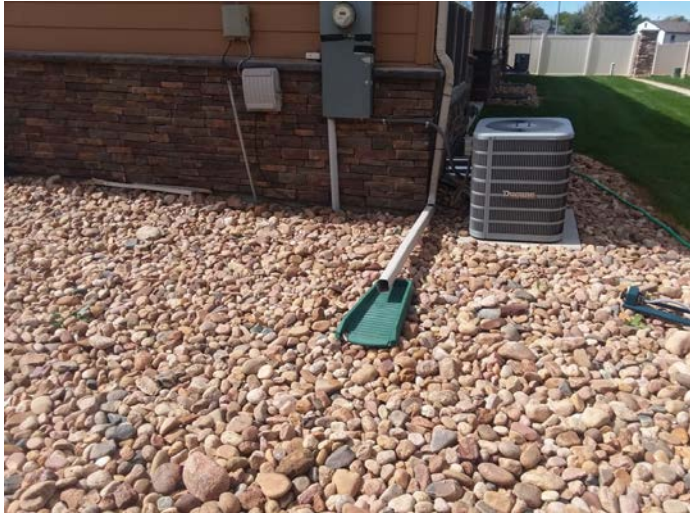
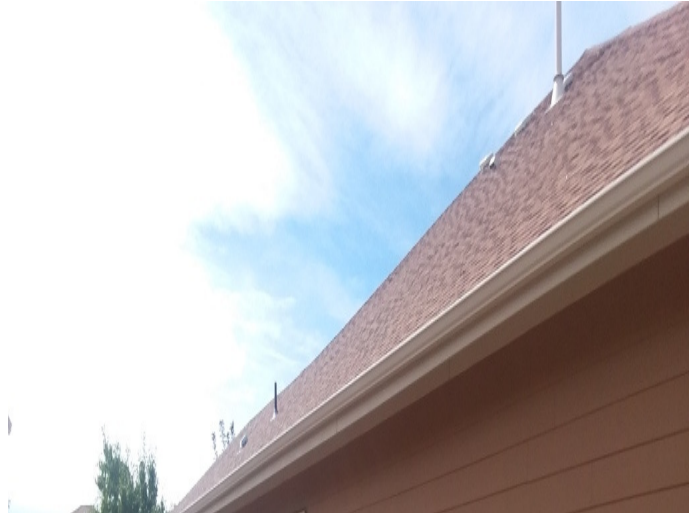
Comp #: 121 Gutters/Downspouts - Replace (PH2)

- The buildings in this phase were constructed in 2010 and 2011.
- The gutters and downspouts in this phase were in good to fair condition with minimal signs of damage noted during the site observation.
- It is typical to replace gutters and downspouts at the same time as roofing materials.
- Therefore, the remaining life reflects the remaining life of the roof as well.
- We recommend cleaning debris out of lines at least once a year to prevent clogging and moisture retention that can lead to advanced deterioration.

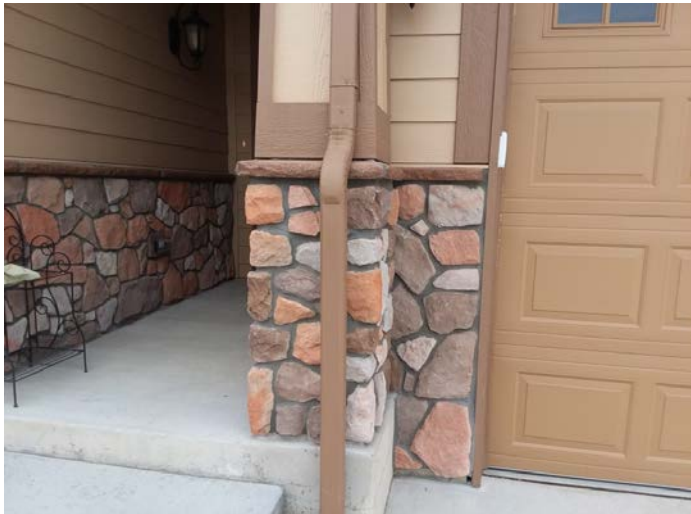
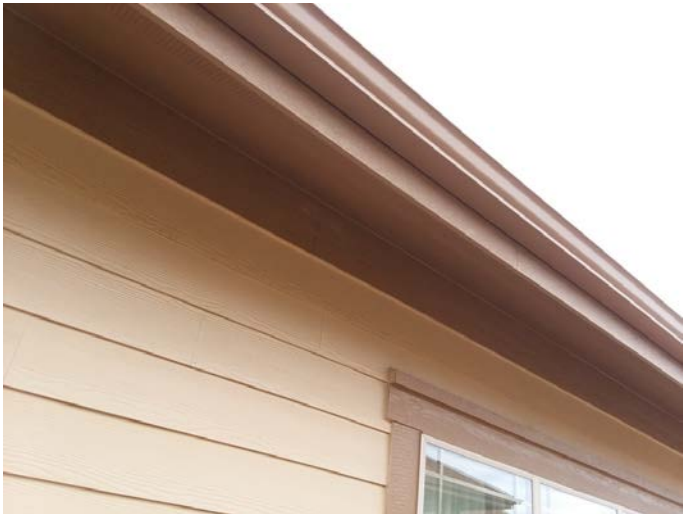
Comp #: 122 Gutters/Downspouts - Replace (PH3)

- The buildings in this phase were constructed in 2013 and 2014.
- Gutters and downspouts in this phase are in good condition with no signs of deterioration or damage noted.
- It is typical to replace gutters and downspouts at the same time as roofing materials.
- Therefore, the remaining life reflects the remaining life of the roof as well.
- We recommend cleaning debris out of lines at least once a year to prevent clogging and moisture retention that can lead to advanced deterioration.

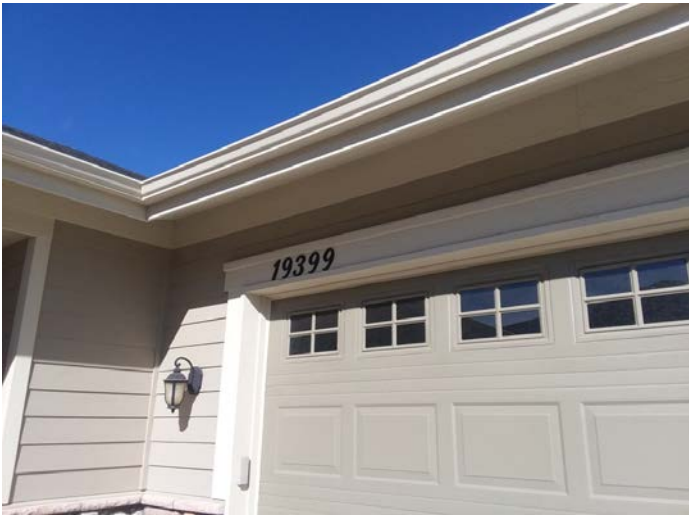
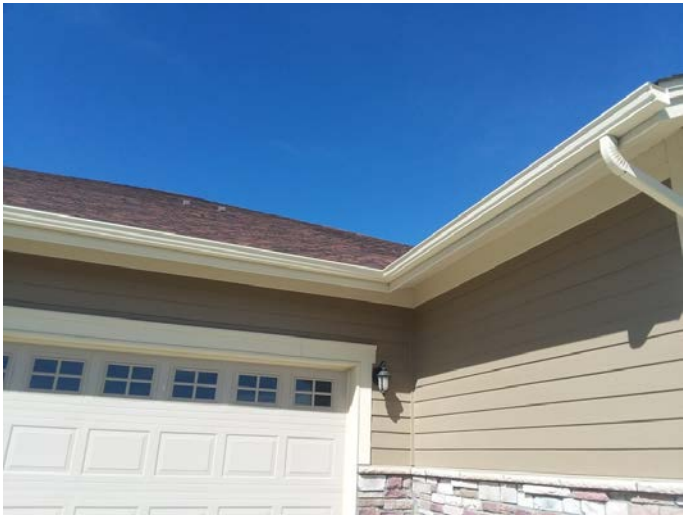
Comp #: 123 Gutters/Downspouts - Replace (PH4)

- The buildings in this phase were constructed in 2015, 2016, and 2017.
- The gutters and downspouts in this phase were in good and like new condition.
- It is typical to replace gutters and downspouts at the same time as roofing materials.
- Therefore, the remaining life reflects the remaining life of the roof as well.
- We recommend cleaning debris out of lines at least once a year to prevent clogging and moisture retention that can lead to advanced deterioration.

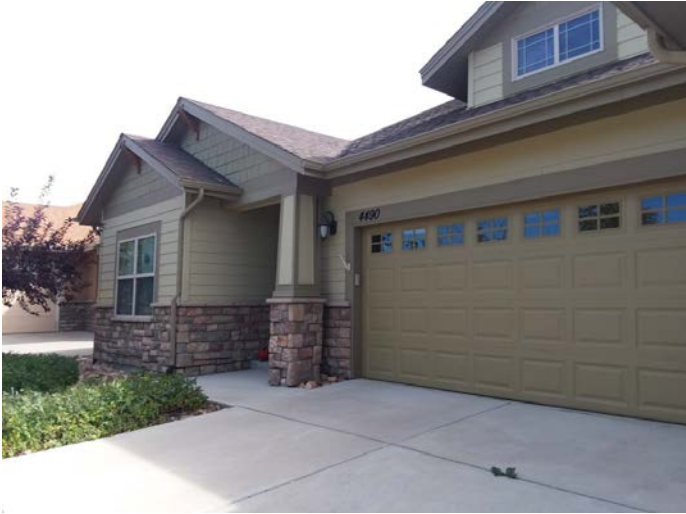
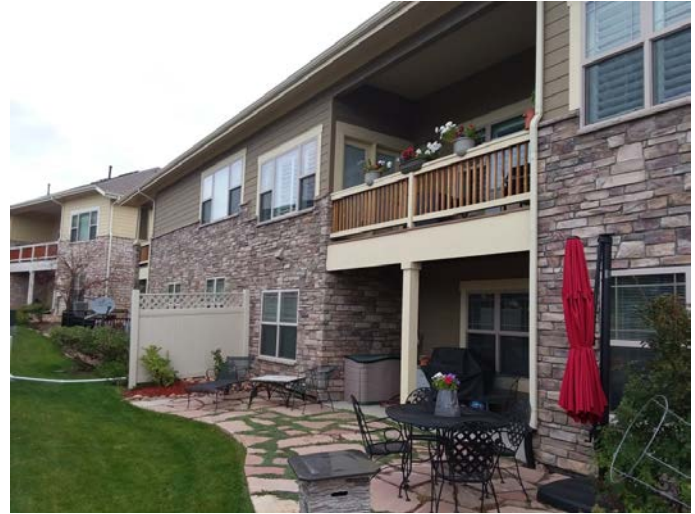
Comp #: 204 Building Ext Surfaces - Repaint (PH1 and PH2)

- This paint phase includes the buildings that were constructed in 2005 and 2006, as well as 2010 and 2011.
- Because there are only two buildings that were built in the 2010 and 2011 phase, and they have not been painted recently, we have included them with the 2005/2006 buildings.
- The exterior paint on these buildings was in fair to poor condition at the time of the site observation.
- In this climate, it is recommended that exterior surfaces are painted every 5-7 years.
- The exact timeframe depends on the color chosen and the level of exposure to elements, as well as the quality of past paint jobs.

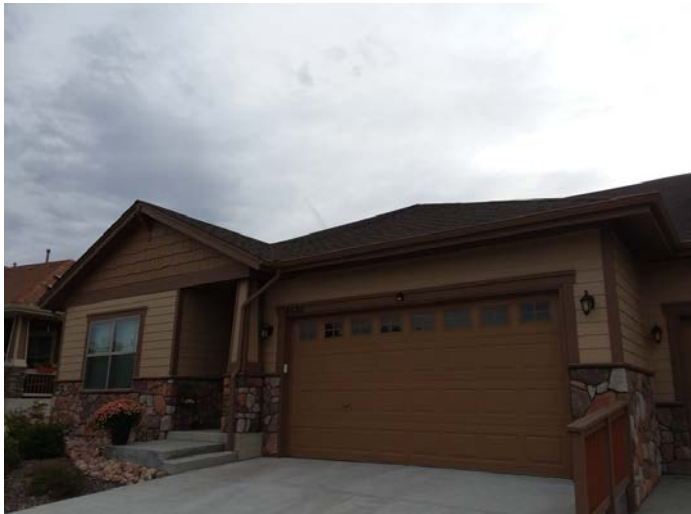
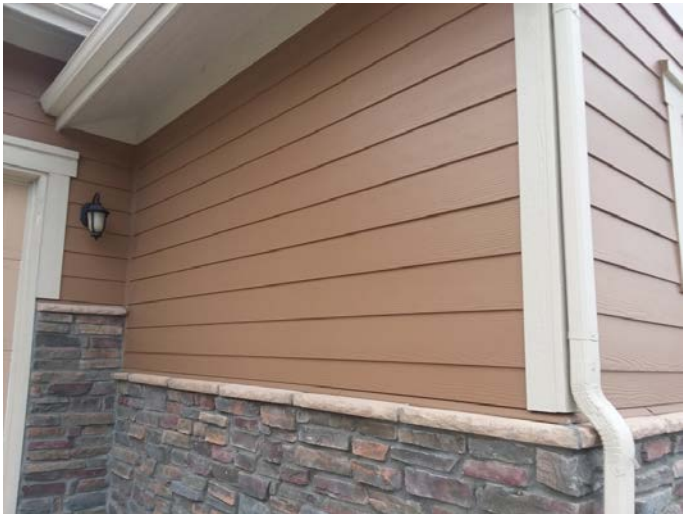
Comp #: 205 Building Ext Surfaces - Repaint (PH3)

- This paint phase includes the buildings that were constructed in 2013 and 2014
- The exterior paint on these buildings was in fair condition at the time of the site observation, with some deterioration and fading noted.
- In this climate, it is recommended that exterior surfaces are painted every 5 - 7 years.
- The exact timeframe depends on the color chosen and the level of exposure to elements, as well as the quality of past paint jobs.

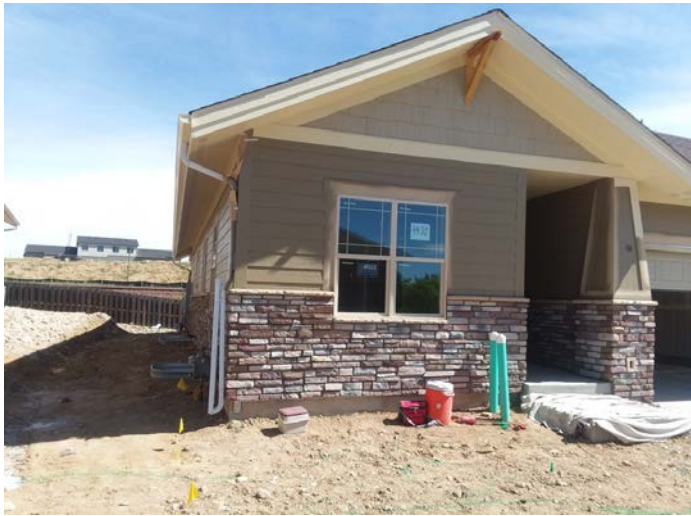
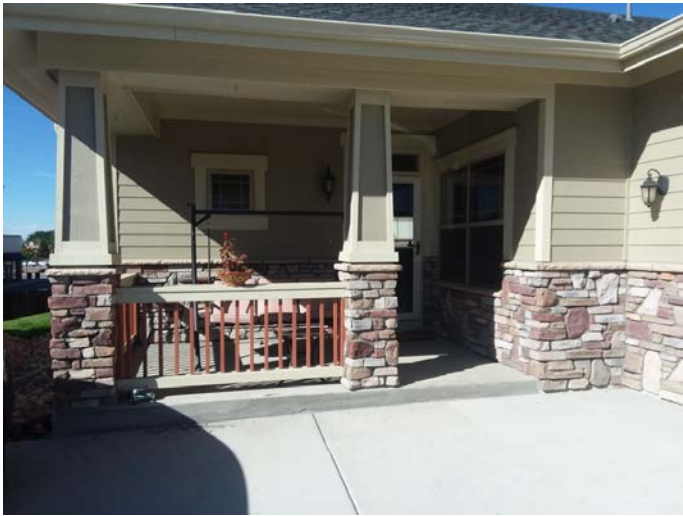
Comp #: 206 Building Ext Surfaces - Repaint (PH4)

- This paint phase includes the buildings that were constructed in 2015, 2016, and 2017.
- The exterior paint on these buildings was in good to new condition at the time of the site observation.
- In this climate, it is recommended that exterior surfaces are painted every 5 - 7 years.
- The exact timeframe depends on the color chosen and the level of exposure to elements, as well as the quality of past paint jobs.

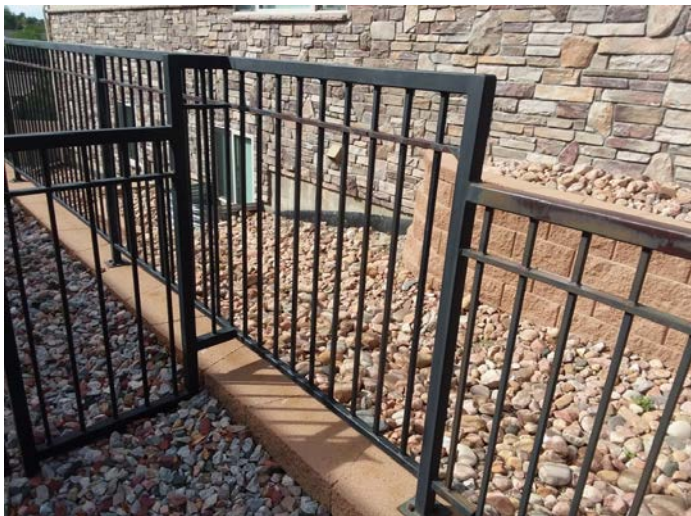
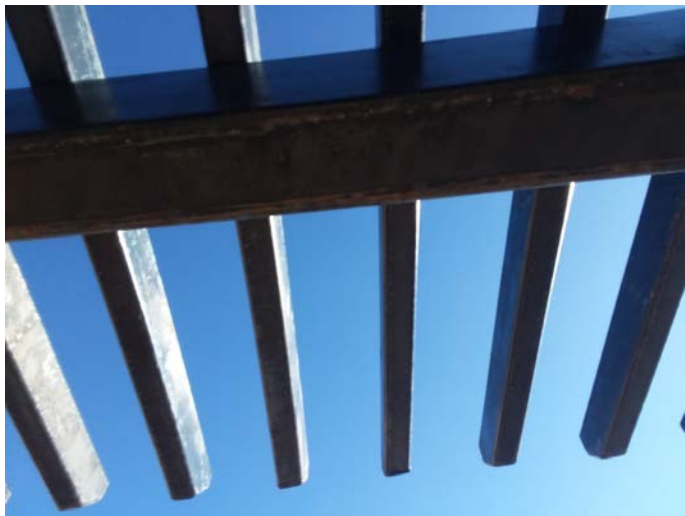
Comp #: 207 Metal Surfaces - Repaint

- The paint metal fencing and pergolas at the entrances to the property were in poor condition, with several signs of rust, corrosion, and faded or chipped paint noted.
- In this climate, we recommend repainting this component every 3 - 4 years to maintain appearance and protect metal surfaces.
- Remaining life based on current condition.

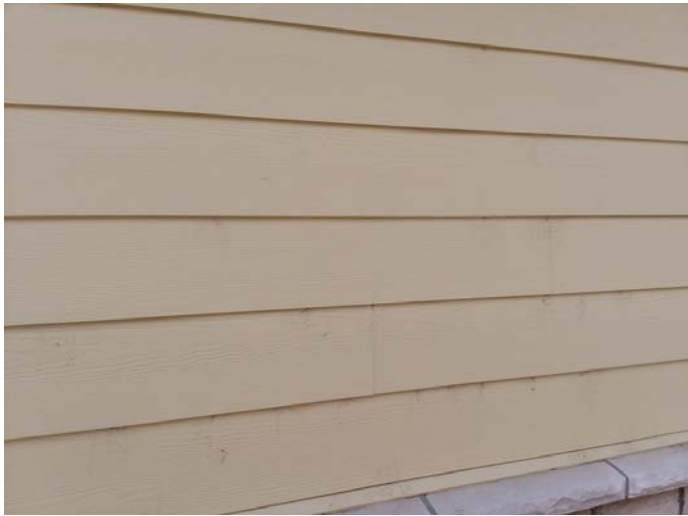
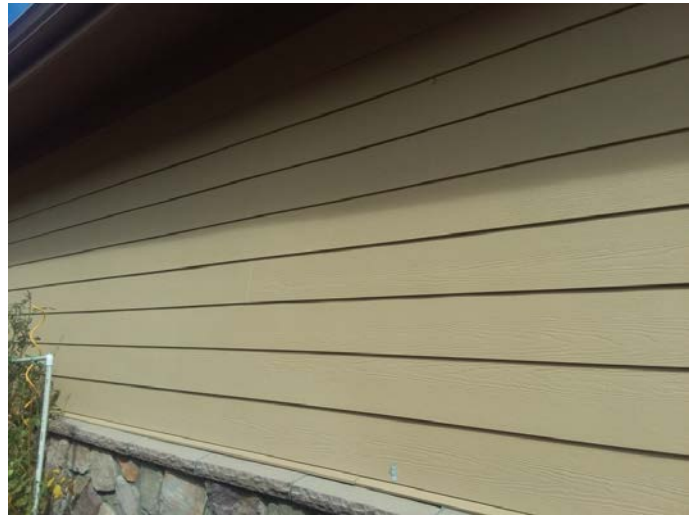
Comp #: 304 Fiber Cement Siding - Replace (PH1 and PH2)

- The fiber cement siding on the buildings in this phase was in good to fair condition.
- As the property ages, this type of material has been known to start delaminating if not painted on a proper cycle.
- We suggest establishing Reserve funds for major repairs every other painting cycle.
- The remaining life is based on the observed conditions at the time of our site evaluation and the timing of the next paint job.

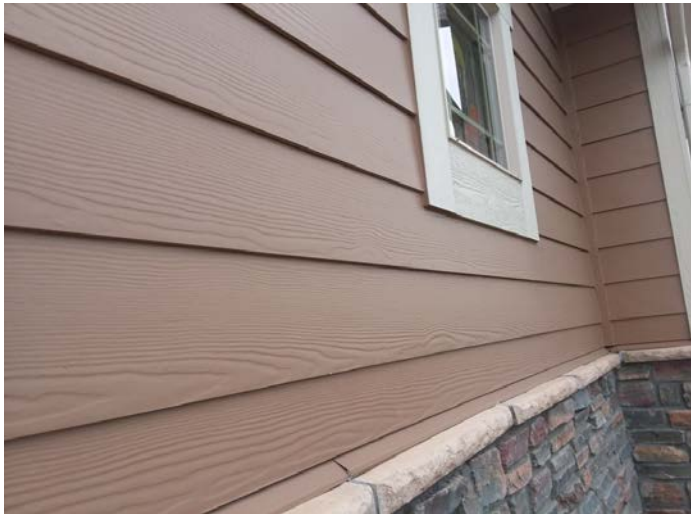
Comp #: 305 Fiber Cement Siding - Replace (PH3)

- The fiber cement siding on the buildings in this phase was in good condition during the site visit, with little to no damage or deterioration noted.
- As the property ages, this type of material has been known to start delaminating if not painted and caulked on a proper cycle.
- We suggest establishing Reserve funds for major repairs every other painting cycle.
- The remaining life is based on the observed conditions at the time of our site evaluation and the timing of the next paint job.

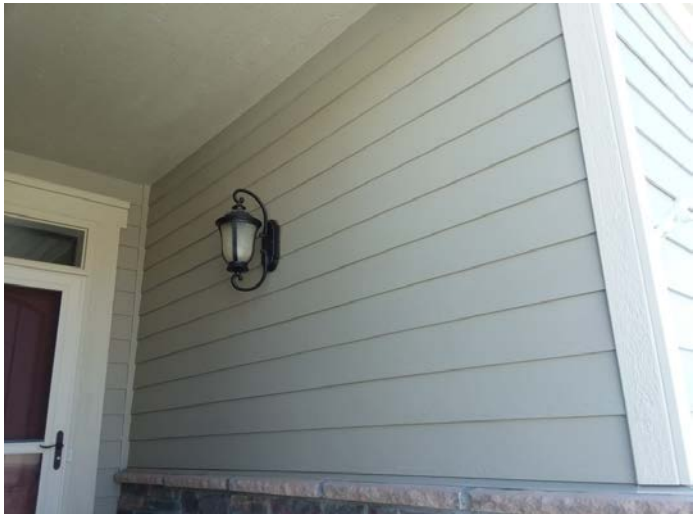
Comp #: 306 Fiber Cement Siding - Replace (PH4)

- The fiber cement siding on the buildings in this phase was in good condition during the site visit.
- As the property ages, this type of material has been known to start delaminating if not painted and caulked on a proper cycle.
- We suggest establishing Reserve funds for major repairs every other painting cycle.
- The remaining life is based on the observed conditions at the time of our site evaluation and the timing of the next paint job.

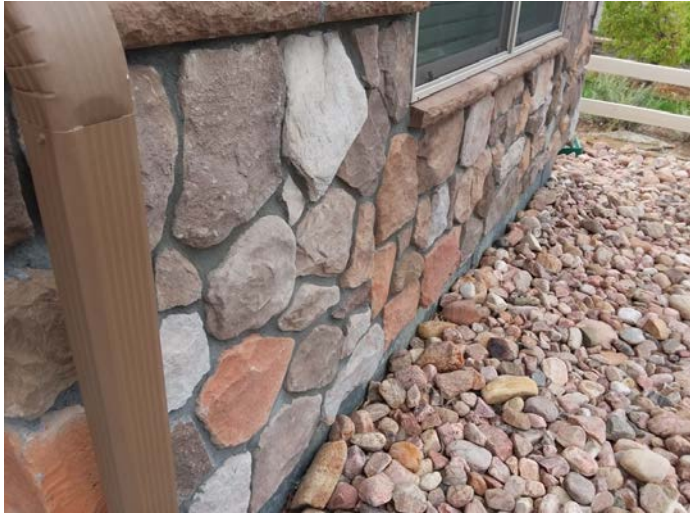
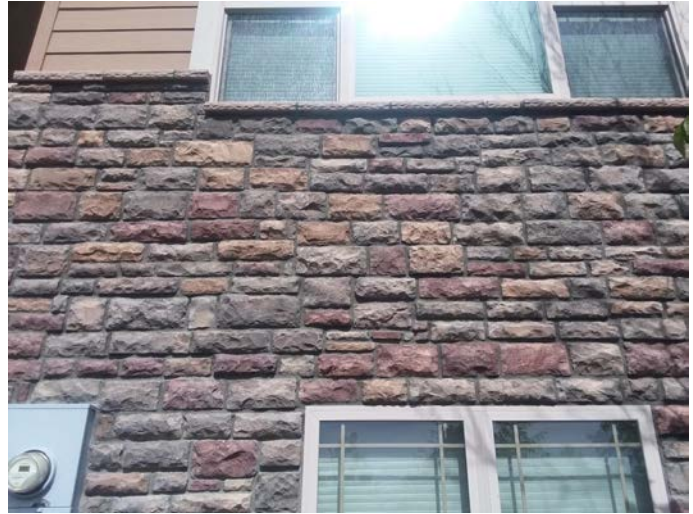
Comp #: 309 Stone/Rock Siding - Major Repairs

- The stone siding on the buildings was in good condition at the time of the site observation.
- Typically, this siding has an extended life expectancy and complete replacement is unlikely.
- There are times where some stones will loosen and fall off, but this is unpredictable when and how much would occur.
- Repairs should be handled as a maintenance issue on an as needed basis.
- If it later turns out that frequent repairs are necessary, then funding could be added in future Reserve Study updates.

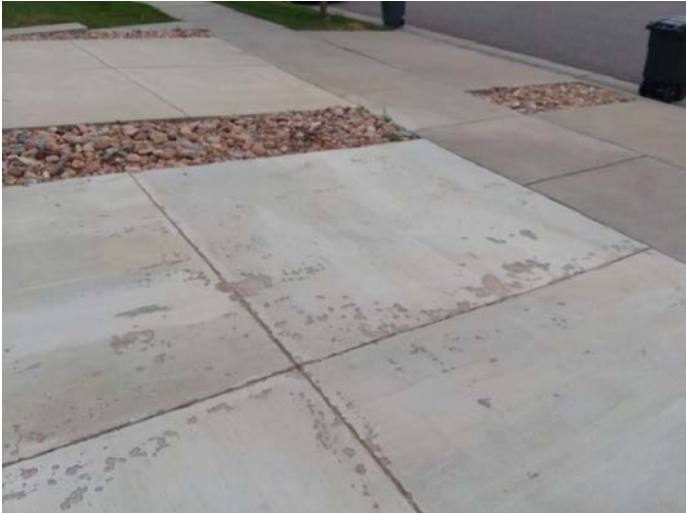
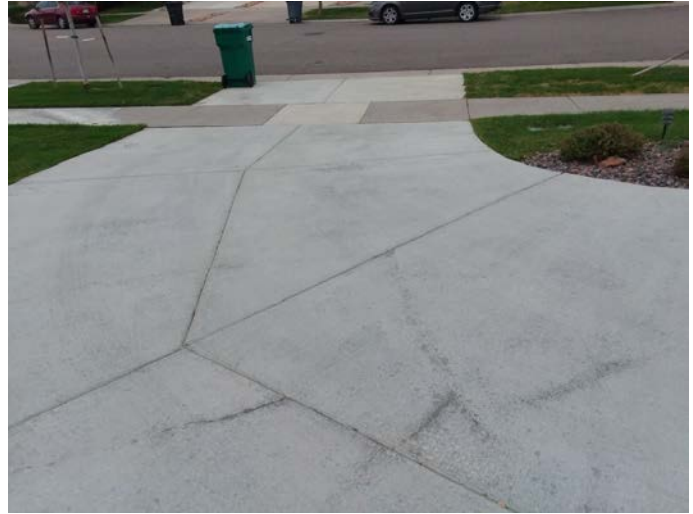
Comp #: 403 Concrete - Partial Replace

- During the site observation several areas were noted to having tripping hazards.
- Since it is unlikely that all concrete surfaces will fail at the same time, we suggest establishing a Reserve fund for periodic repairs and replacement to approximately 5% of the total area (3,140 GSF) every 4 years.
- Repairs should be coordinated with other concrete surfaces and asphalt for better estimate since most asphalt companies can also perform concrete work.

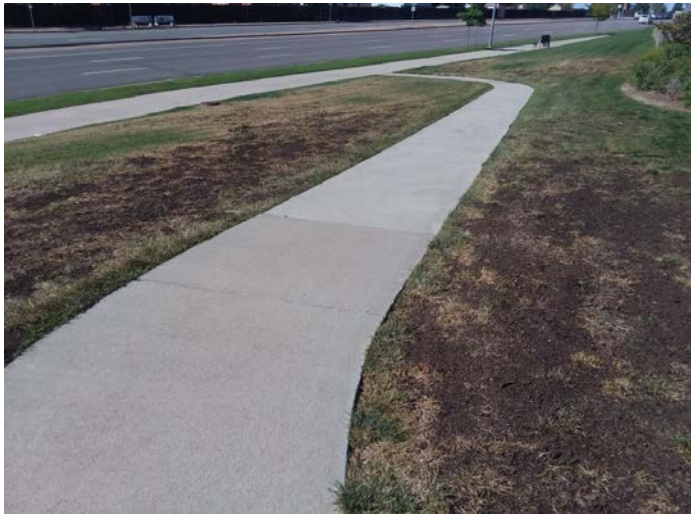
Comp #: 601 Concrete Flatwork - Partial Replace

- The concrete walking surfaces were in fair condition with some cracking, spalling, and settling noted during the site observation.
- Similar to other concrete surfaces, it is unlikely that all concrete surfaces will fail and need to be replaced at the same time.
- Therefore, we suggest establishing a Reserve fund for frequent repairs and replacement to a percentage of the area (5% or 930 GSF) every 4 years.
- According to the Board any back porches with alterations, such as flagstone, are the responsibility of the homeowner.

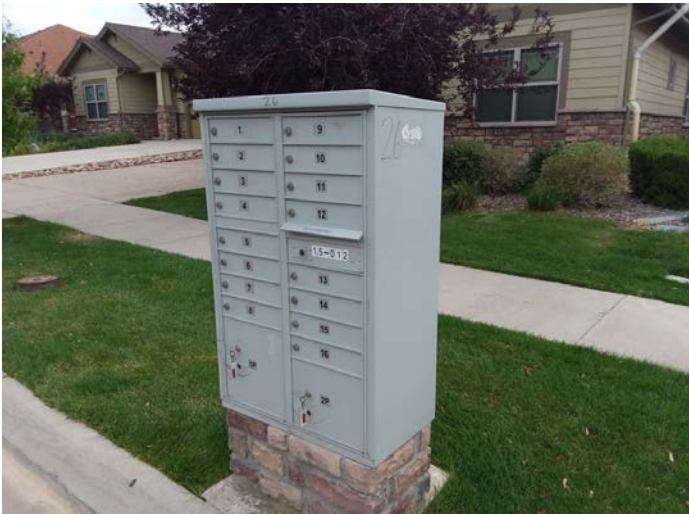
Comp #: 803 Mailboxes - Replace (A)

- These mailboxes were in good to fair condition at the time of the site observation, with some signs of damage noted.
- According to several manufacturers, the typical life expectancy for this type of mailbox is 15 - 20 years in this environment.
- Remaining life is based on average age of all units.
- Per new Postal regulations effective 2012, "all customers are responsible for repairs and replacement of keys, locks, or the boxes/cluster units themselves".

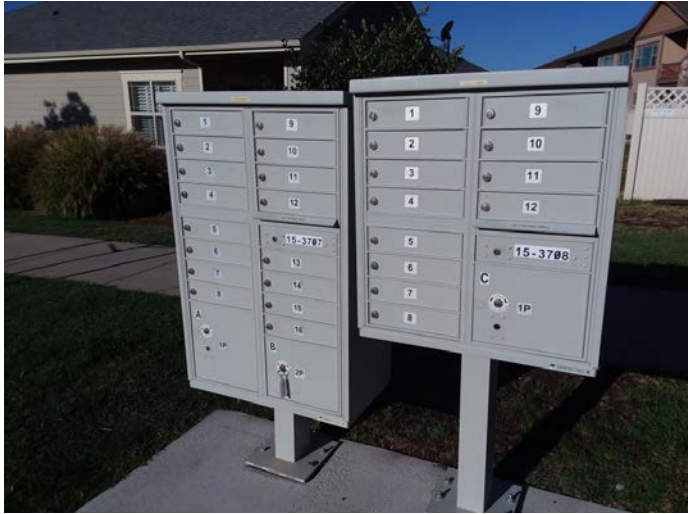
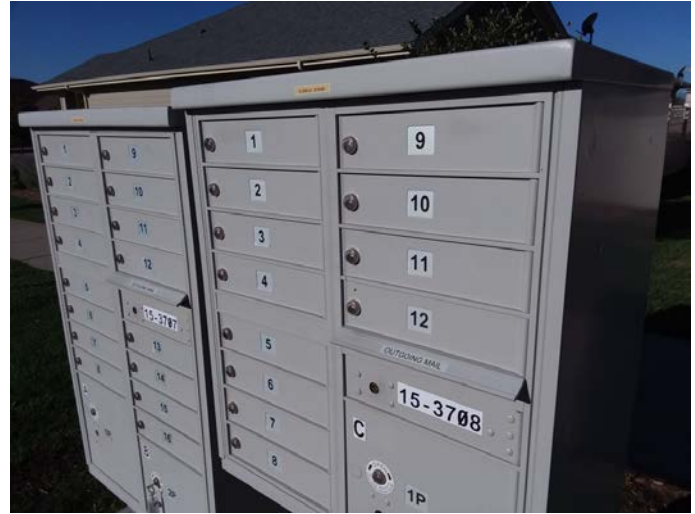
Comp #: 803 Mailboxes - Replace (B)

- The mailboxes included in this line item were in good condition at the time of the site observation.
- According to several manufacturers, the typical life expectancy for this type of mailbox is 15 - 20 years in this environment.
- Remaining life is based on average age of all units.
- Per new Postal regulations effective 2012, "all customers are responsible for repairs and replacement of keys, locks, or the boxes/cluster units themselves".

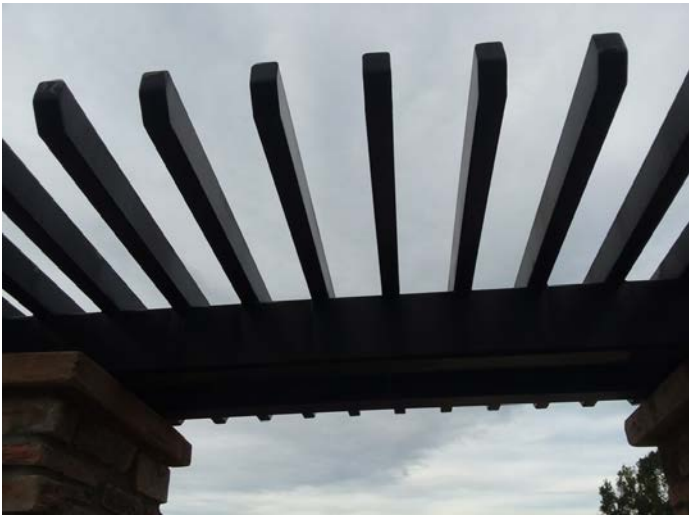
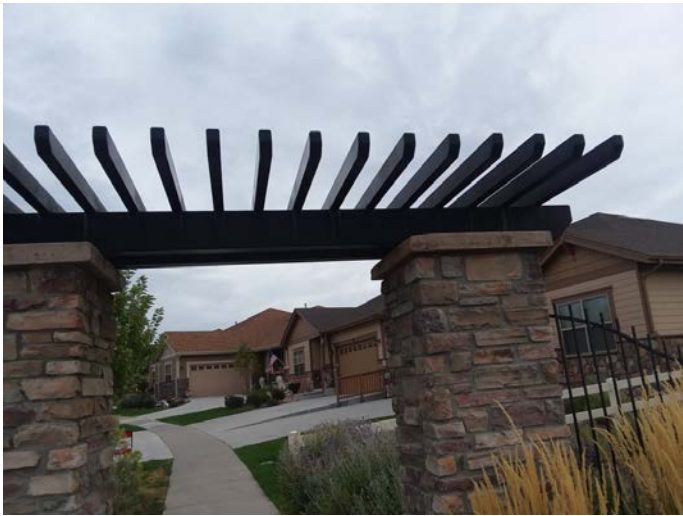
Comp #: 804 Pergolas - Replace

- The metal pergolas were in good condition structurally during the site observation.
- As long as the pergolas are painted and maintained correctly, they should have an extended life expectancy.
- Therefore, Reserve funding is not necessary at this time, continue to monitor conditions in future updates.

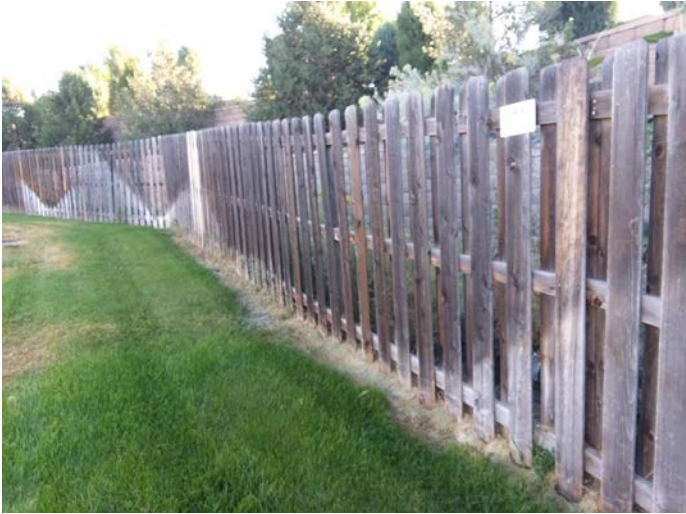
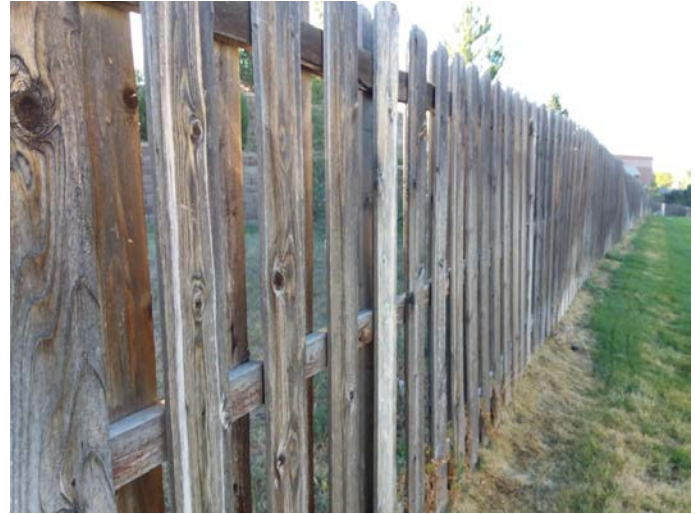
Comp #: 1001 Wood Fencing - Replace

- The wood perimeter fencing was in fair to poor condition throughout the property, with approximately 60 linear feet being replaced.
- The replacement cycle is based on the observed quality of fence installed and the current condition.
- The fence is currently not stained, so the replacement cycle is shortened to reflect the expected effects the elements will have on exposed materials.
- Remaining life is based on the age of the fence and the observed condition.

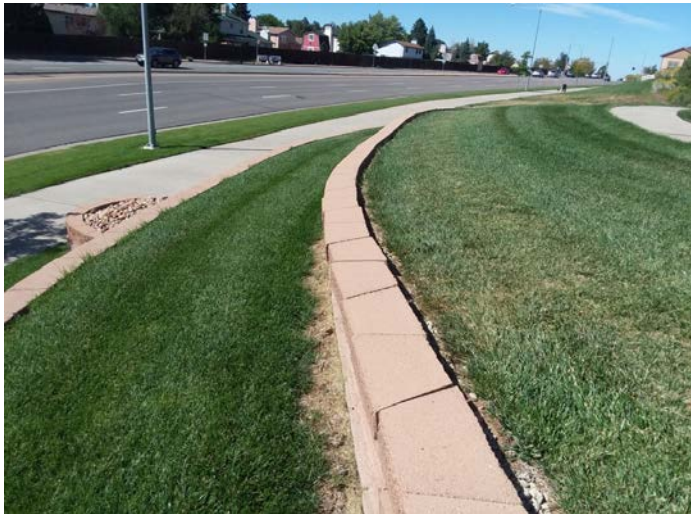
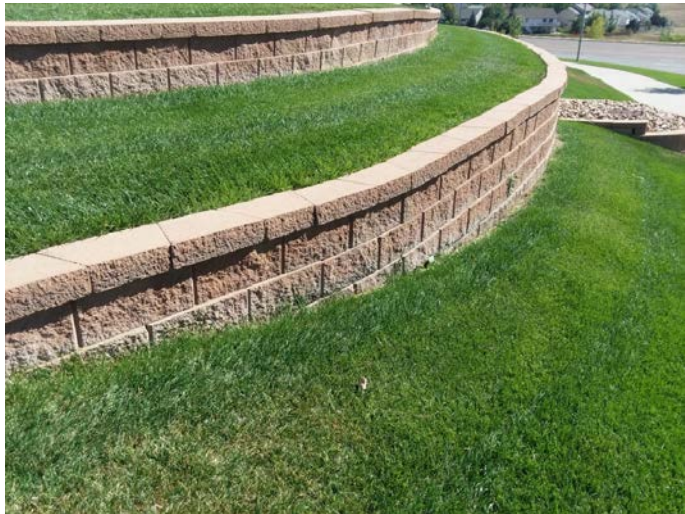
Comp #: 1005 Block Wall - Major Repairs

- These walls typically have an extended life expectancy, however, there was some reported leaning to the wall at the end of Radcliff in the common area.
- While it is unlikely that the walls will need to be replaced, it is likely that major repairs will be necessary.
- Depending on the effects from weather and potential vandalism, we suggest establishing a Reserve fund for periodic repairs to all walls every 10 years.

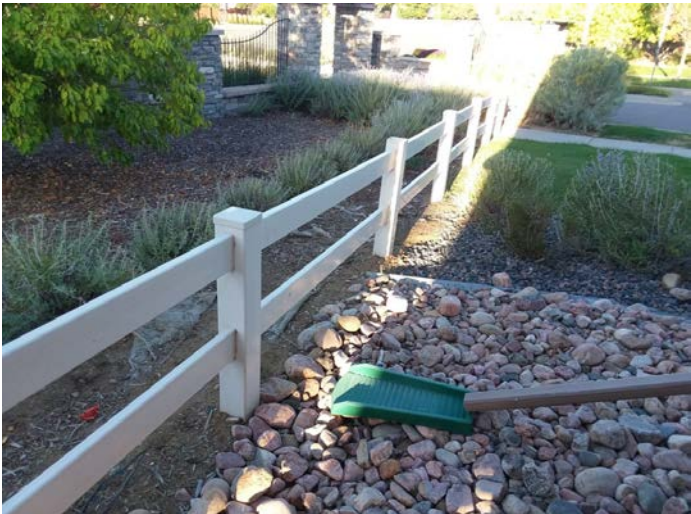
Comp #: 1008 PVC Vinyl Split Rail Fencing - Replace

- The split rail fencing was also in good to fair condition.
- Similar to other vinyl fences, these are subject to damage during winter months from becoming frozen and brittle, and during summer from landscaping equipment.
- This type of fence has a realistic life expectancy of 20 - 25 years in this environment according to several local companies.

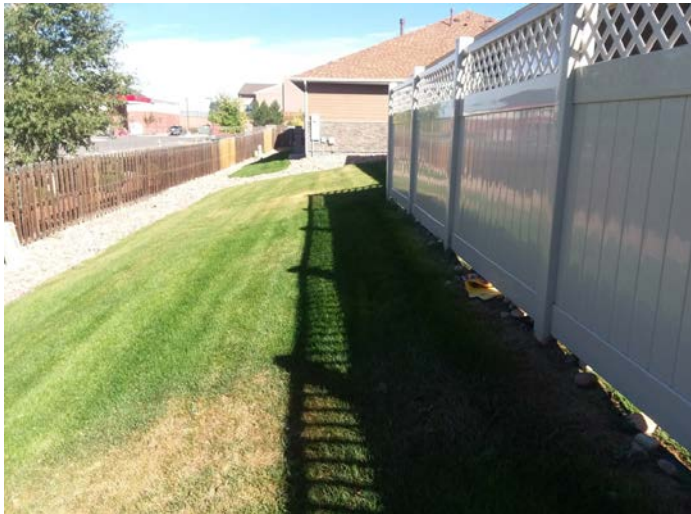
Comp #: 1008 PVC Vinyl Privacy Fencing - Replace

- Fencing appeared to be in good to fair condition with no major signs of damage or deterioration noted. There was one section that appeared to have been replaced.
- Similar to other vinyl fences, these are subject to damage during winter months from becoming frozen and brittle, and during summer from landscaping equipment.
- This type of fence has a realistic life expectancy of 20 - 25 years in this environment according to several local companies.

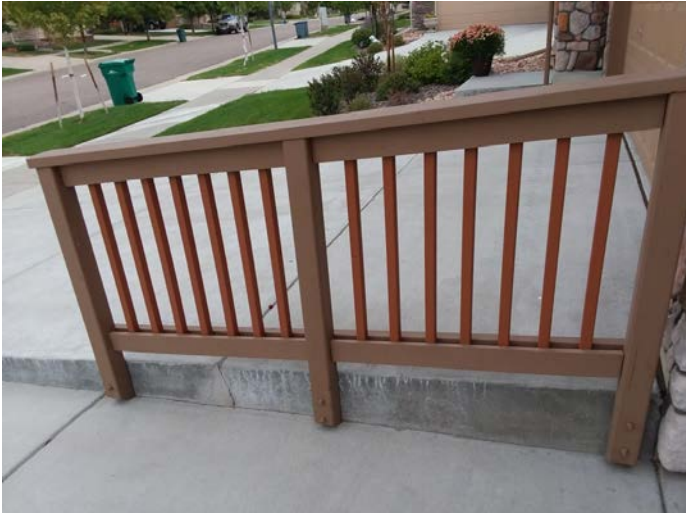
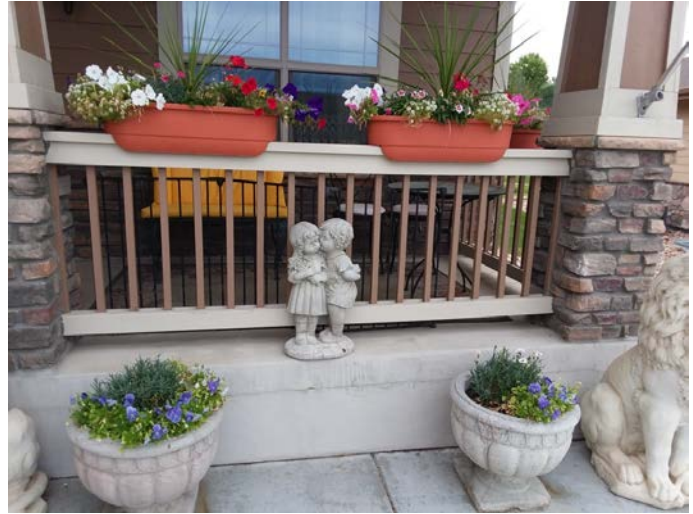
Comp #: 1009 Wood Railing - Major Repairs

- The wood railing around the units was in good condition at the time of the site observation.
- Due to the low quantity and location of the rail fencing, major repairs should not be necessary.
- We recommend doing any repairs at the same time as the building exterior repairs (comp #1004 - #1006).

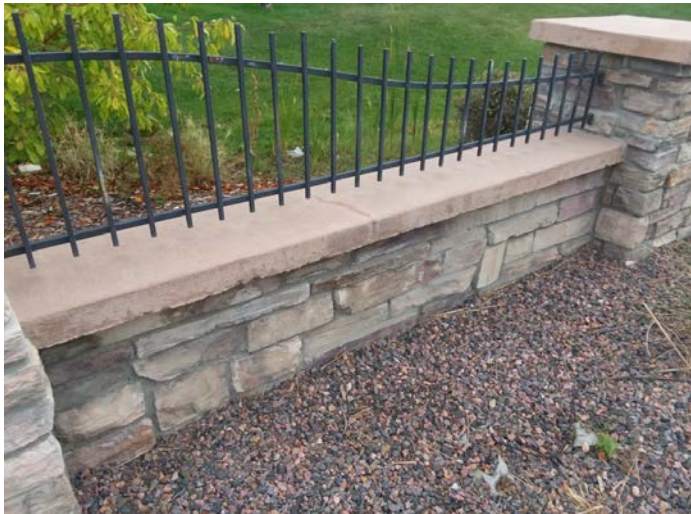
Comp #: 1013 Stonework - Major Repairs

- The stonework at the monuments and fence columns was in good condition at the time of the site observation.
- While it is unlikely that all the stonework will need to be replaced, it is likely that major repairs will be necessary to replace loose or missing stones.
- Depending on the effects from weather and potential vandalism, we suggest establishing a Reserve fund for periodic repairs to the stonework every 10 years.

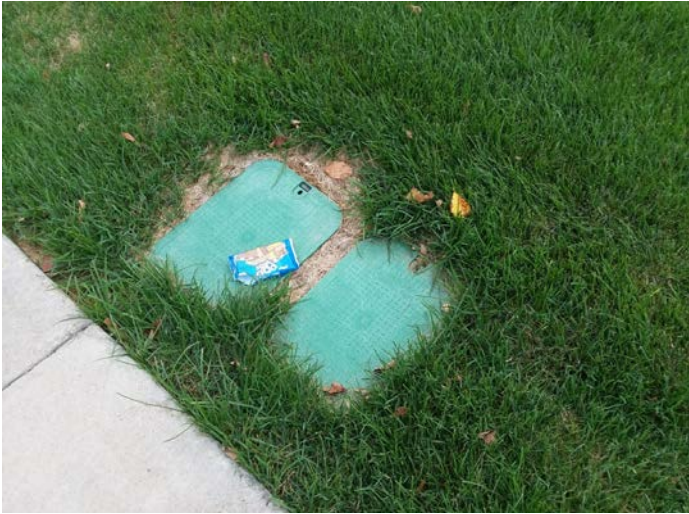
Comp #: 1701 Irrigation System - Major Repairs

- It was reported that the irrigation system underwent many repairs this past year to fix issues due to poor installation.
- We typically see systems that are this age needing more frequent repairs.
- This line item is for repairs and replacement that lies outside the scope of routine maintenance: bulk sprinkler head replacement, bulk valve replacement, rerouting lateral lines, rewiring, etc.
- In order to ensure the funds are available for major repairs, we recommend reserving funds for these projects every 4 - 6 years.
- The funding on this line item is for major repairs and is not to be interpreted as complete irrigation system replacement.

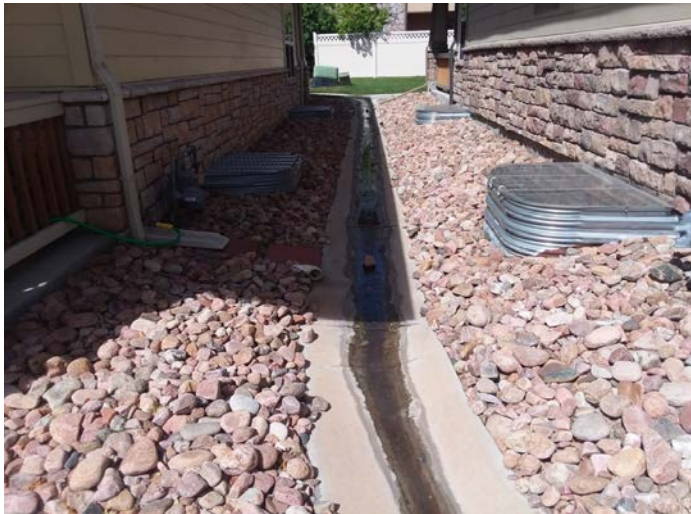
Comp #: 1811 Concrete Drain Swales - Repair

- The concrete landscaping drain pans were in good condition at the time of the site observation.
- Periodic repairs are still required every 5 - 10 years. Coordinate with other concrete surfaces for best cost estimate.
