**567 Condo Assoc
 10000%& 10000%& 10000%& 10000%& 10000%&
 Mci fck bžCO. 80\$\$\$**

**Level 1, Premium Reserve Analysis
 Report Period – 01/01/19 – 12/31/19**

**FINAL
 Version**

**Fiscal Year End – December 31
 Number of units- 32
 Date of Property Observation - June 14, 2018**

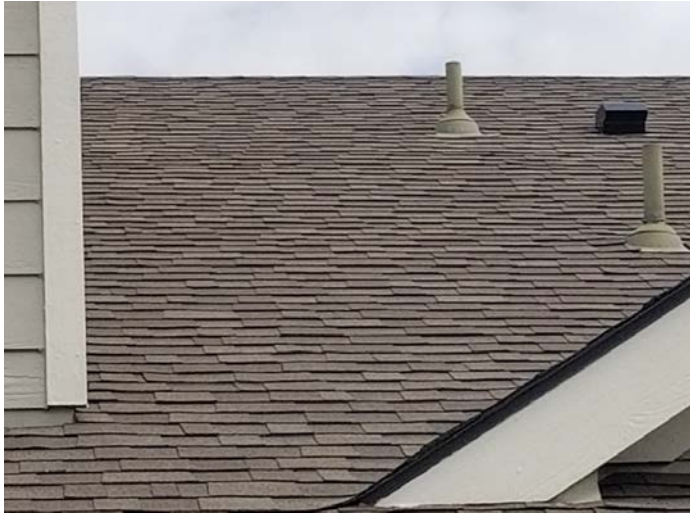
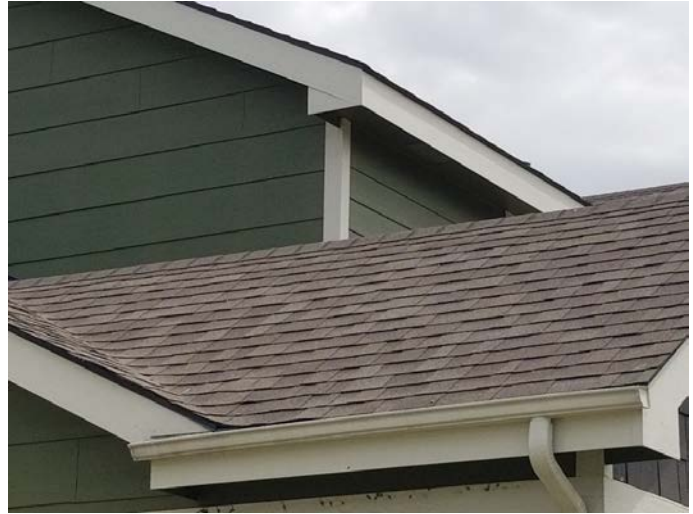
Comp #: 105 Comp Shingle Roof - Replace

Observations:

- It appears this roof material is rated as a 30 - 40 year product. Despite this rating, a life expectancy of 15 - 20 years is expected in this environment.
- Due to the potentially harsh winters, extensive freeze/thaw cycle, and likelihood of hail events over the useful life of the roof, we typically see associations replacing roofs sooner than the manufacturer's suggested useful life.
- Remaining life is based on age of roof and observed conditions.

Location: Unit Building Roofs

Quantity: Approx. 546 Square

Life Expectancy: 20 Remaining Life: 13

Best Cost: \$204,750
 \$375/square; Estimate to remove and replace

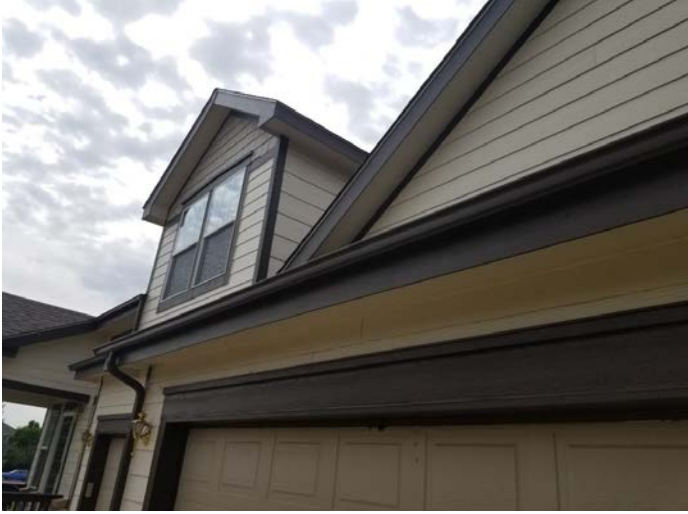
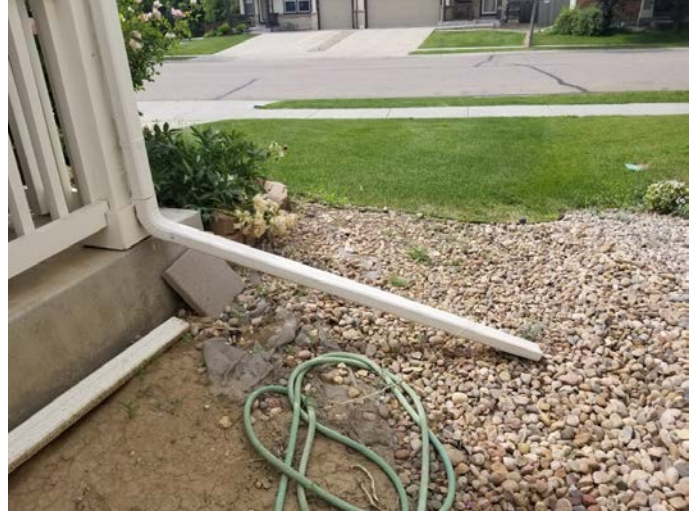
Comp #: 120 Gutters/Downspouts - Replace

Observations:

- Although it is typical to replace gutters and downspouts at the same time as the roof materials, it does not appear these were replaced with the roofs.
- Therefore, the remaining life reflects the age of the gutters and downspouts.
- We recommend cleaning debris out of lines at least once a year to prevent clogging and moisture retention that can lead to advanced deterioration.

Location: Condominium Exteriors

Quantity: Approx. 2,250 LF

Life Expectancy: 25 Remaining Life: 9

Best Cost: \$21,950
 \$6.75/LF; Estimate to replace

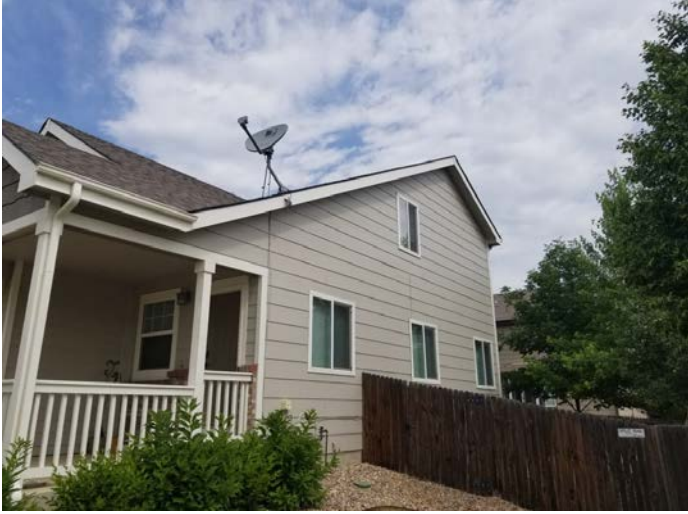
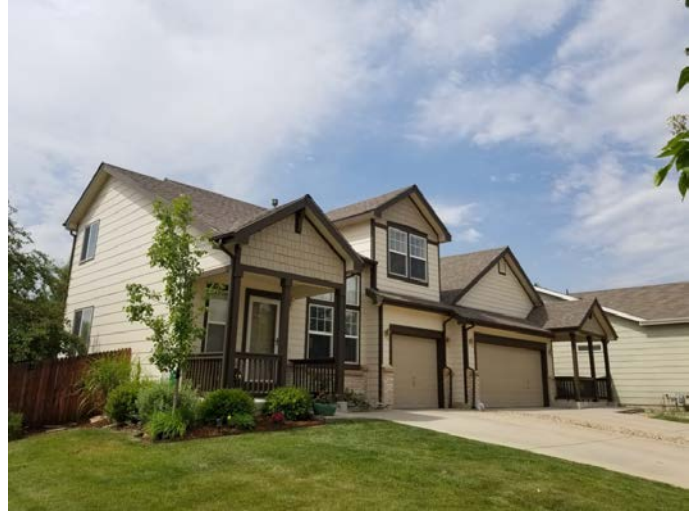
Comp #: 204 Building Ext Surfaces - Repaint (1)

Observations:

- In this climate, it is recommended that exterior surfaces are painted every 4 - 6 years.
- The exact timeframe depends on the color chosen and the level of exposure to elements, as well as the quality of past paint jobs.
- The remaining life is based on the observed conditions.

Life Expectancy: 6 Remaining Life: 3

Best Cost: \$17,200
\$2,150/unit; Estimate to repaint buildings

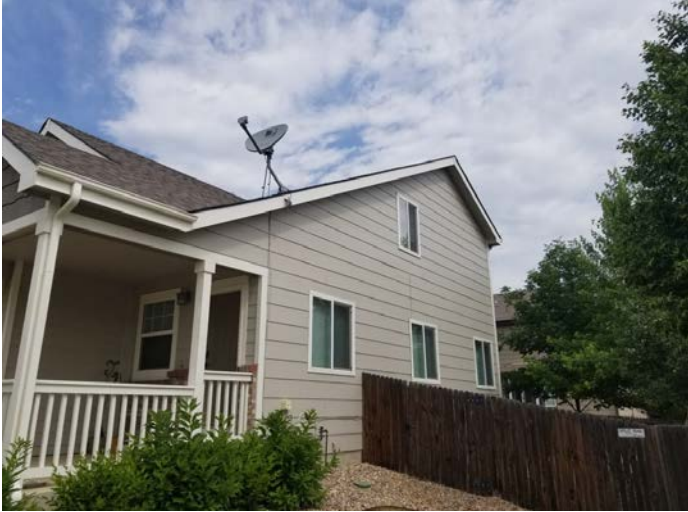
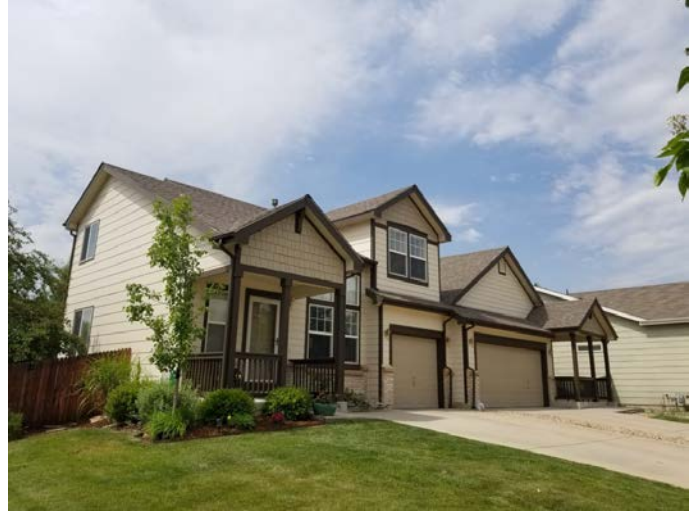
Comp #: 205 Building Ext Surfaces - Repaint (2)

Observations:

- In this climate, it is recommended that exterior surfaces are painted every 4 - 6 years.
- The exact timeframe depends on the color chosen and the level of exposure to elements, as well as the quality of past paint jobs.
- The remaining life is based on the observed conditions.

Life Expectancy: **6** Remaining Life: **0**

Best Cost: **\$17,200**
\$2,150/unit; Estimate to repaint buildings

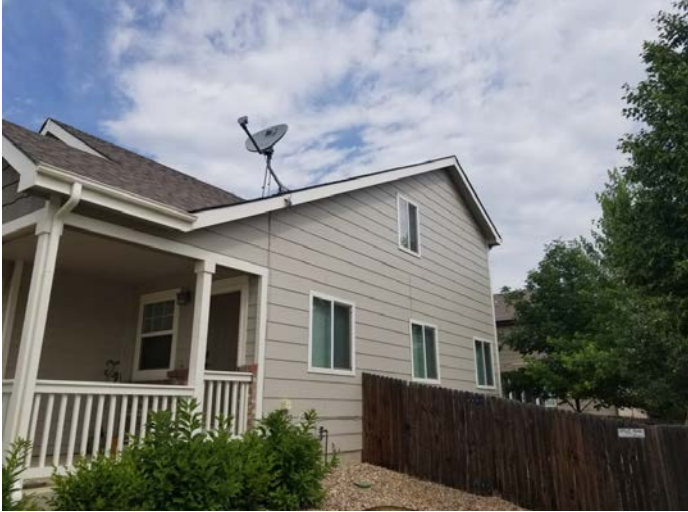
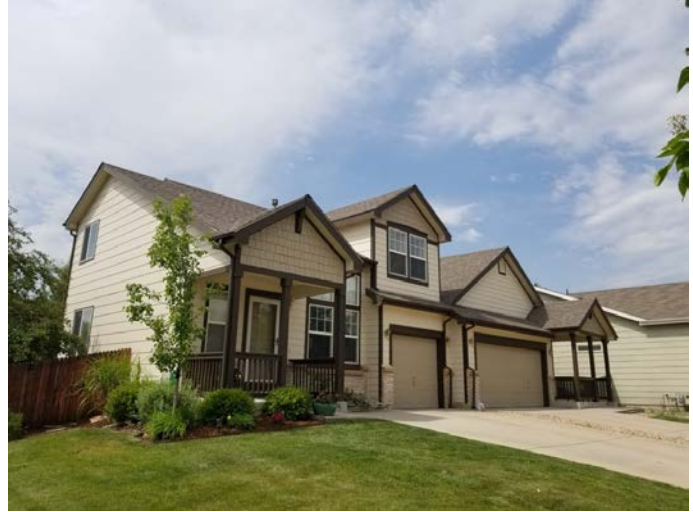
Comp #: 206 Building Ext Surfaces - Repaint (3)

Observations:

- In this climate, it is recommended that exterior surfaces are painted every 4 - 6 years.
- The exact timeframe depends on the color chosen and the level of exposure to elements, as well as the quality of past paint jobs.
- The remaining life is based on the observed conditions.

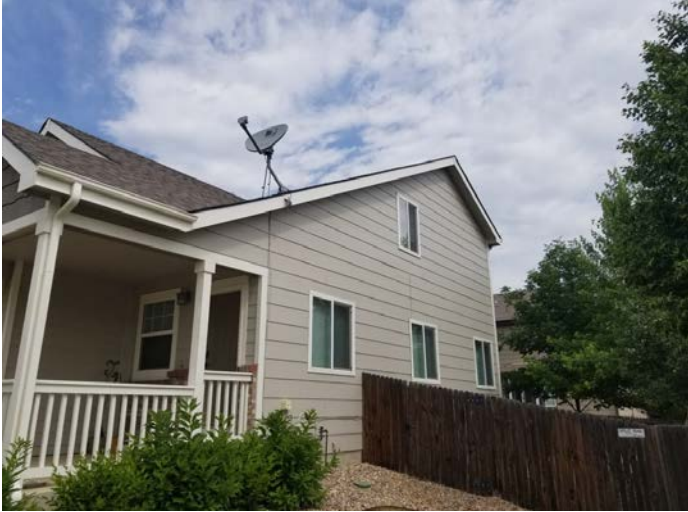
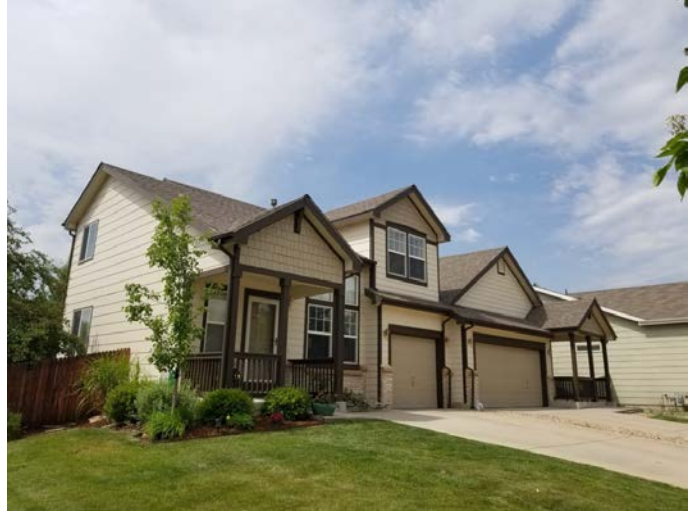
Comp #: 207 Building Ext Surfaces - Repaint (4)

Observations:

- In this climate, it is recommended that exterior surfaces are painted every 4 - 6 years.
- The exact timeframe depends on the color chosen and the level of exposure to elements, as well as the quality of past paint jobs.
- The remaining life is based on the observed conditions.

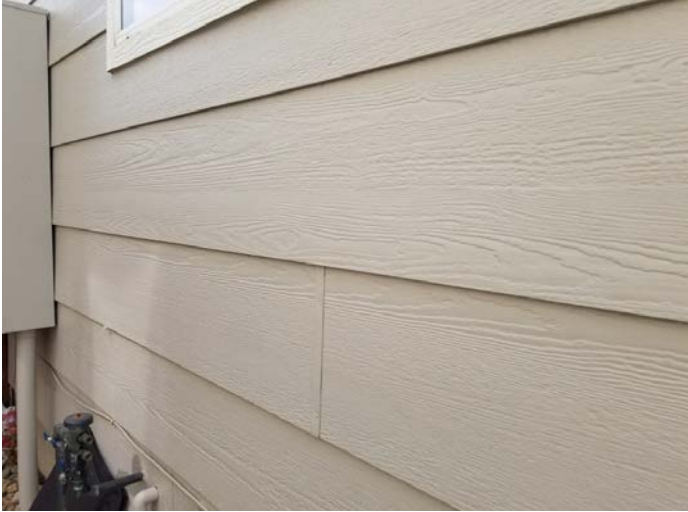
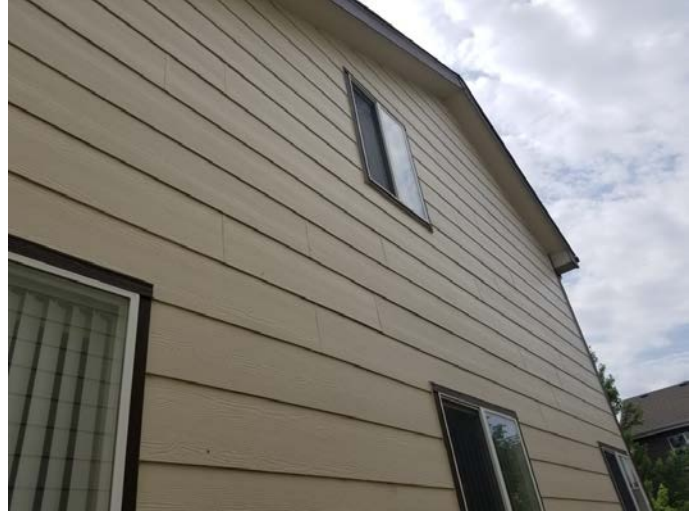
Comp #: 304 Fiber Cement Siding - Major Repairs (1)

Observations:

- As the property ages, this type of material has been known to start delaminating if not painted and caulked on a proper cycle.
- We suggest establishing Reserve funds for major repairs every other painting cycle.
- The remaining life is based on the observed conditions at the time of our site evaluation and the timing of the next paint job.

\$350/Unit; Allowance for major repairs

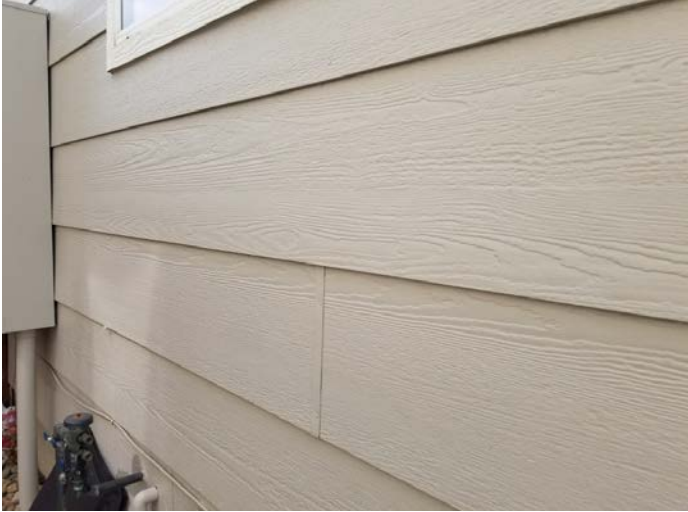
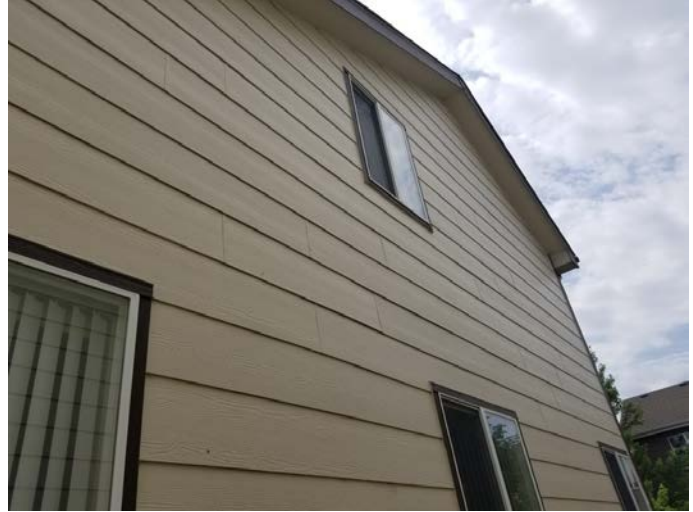
Comp #: 305 Fiber Cement Siding - Major Repairs (2)

Observations:

- As the property ages, this type of material has been known to start delaminating if not painted and caulked on a proper cycle.
- We suggest establishing Reserve funds for major repairs every other painting cycle.
- The remaining life is based on the observed conditions at the time of our site evaluation and the timing of the next paint job.

\$350/Unit; Allowance for major repairs

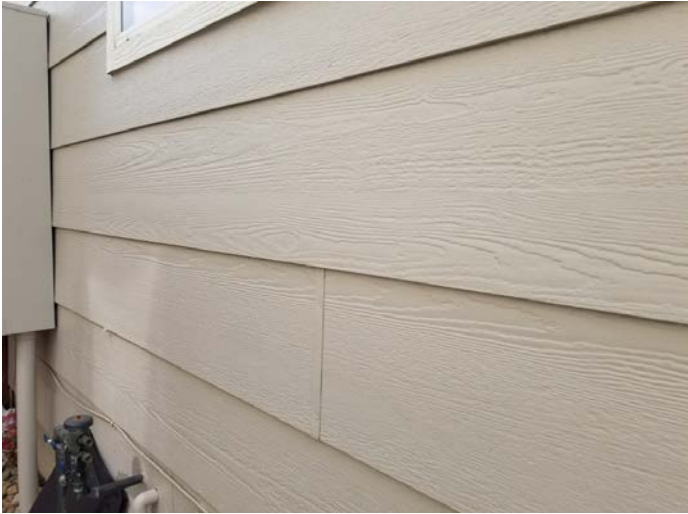
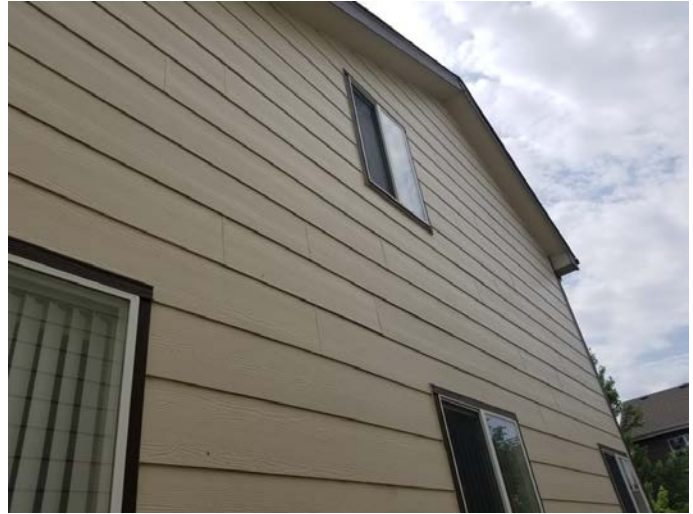
Comp #: 306 Fiber Cement Siding - Major Repairs (3)

Observations:

- As the property ages, this type of material has been known to start delaminating if not painted and caulked on a proper cycle.
- We suggest establishing Reserve funds for major repairs every other painting cycle.
- The remaining life is based on the observed conditions at the time of our site evaluation and the timing of the next paint job.

\$350/Unit; Allowance for major repairs

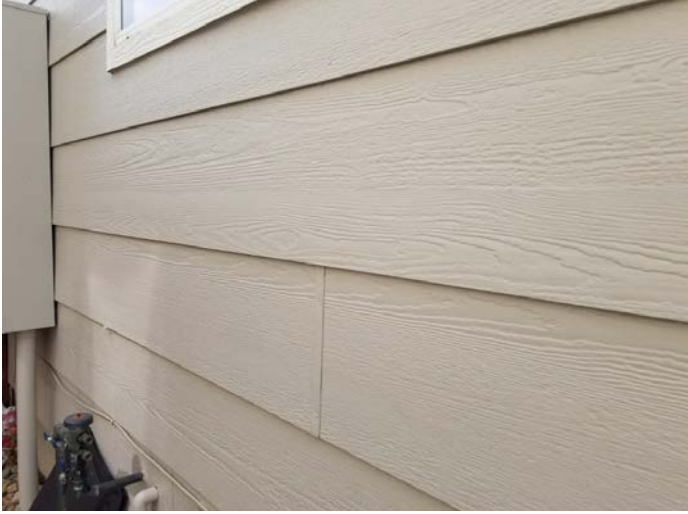
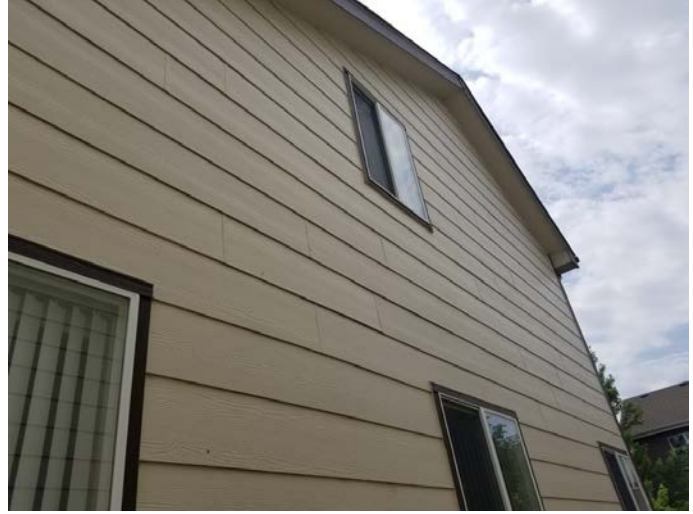
Comp #: 307 Fiber Cement Siding - Major Repairs (4)

Observations:

- As the property ages, this type of material has been known to start delaminating if not painted and caulked on a proper cycle.
- We suggest establishing Reserve funds for major repairs every other painting cycle.
- The remaining life is based on the observed conditions at the time of our site evaluation and the timing of the next paint job.

\$350/Unit; Allowance for major repairs

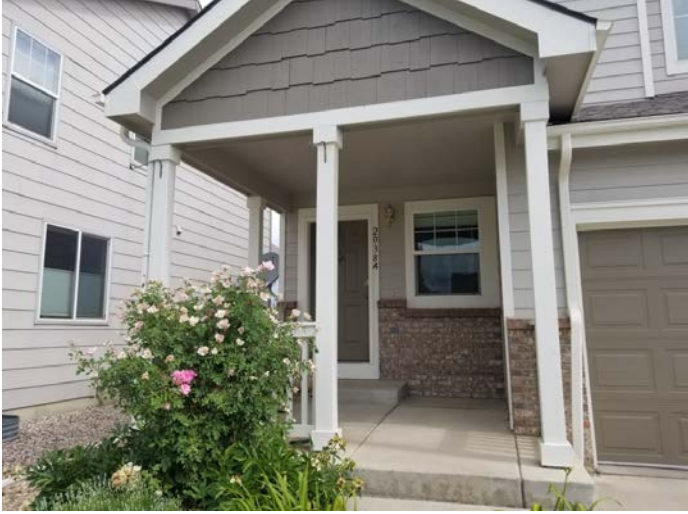
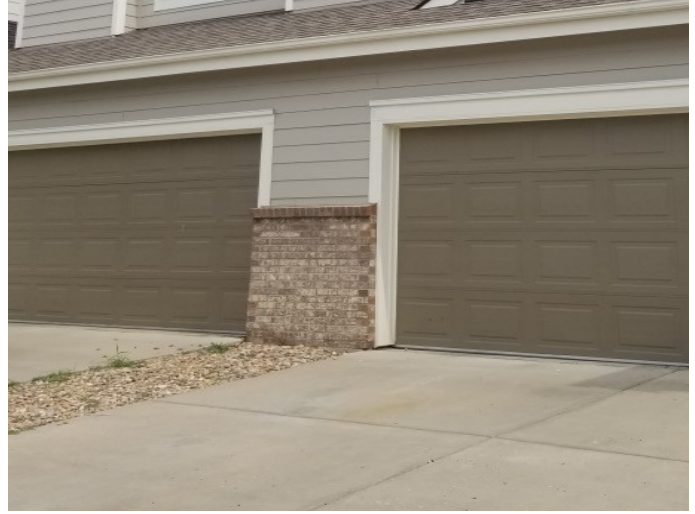
Comp #: 308 Brick - Replace

Observations:

- Typically, this material has an extended life expectancy and complete replacement is unlikely.
- There are times where minor repairs may become necessary, but this is unpredictable when and how much would occur.
- Repairs should be handled as a maintenance issue on an as needed basis.
- Reserve funding is not required for this component at this time.
- If it later turns out that frequent repairs are necessary, then funding should be included in future Reserve Study updates.

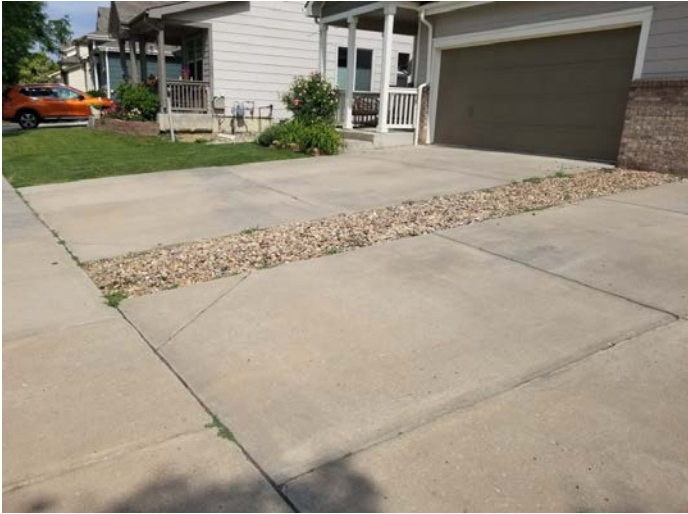
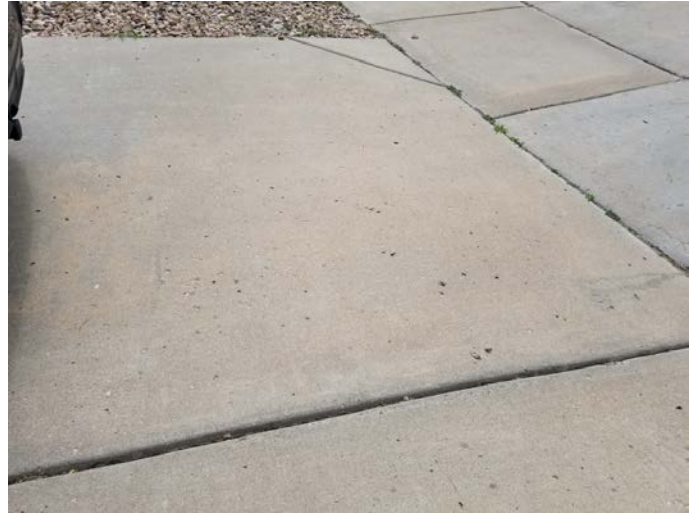
Comp #: 403 Concrete Driveways - Repair/Replace

- Per the instructions given to us by the client, we have used the Responsibility for Payment column of the Maintenance Responsibility Chart to determine whether the association is responsible.
- According to that document, driveways are the responsibility of the home owner.
- No Reserve funding is required.

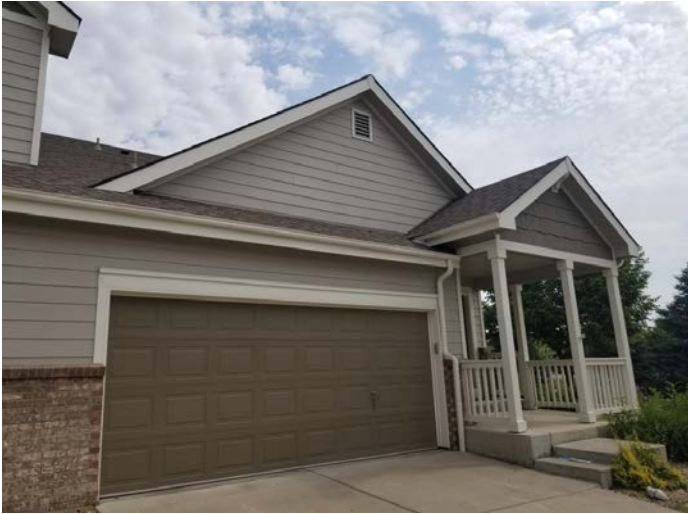
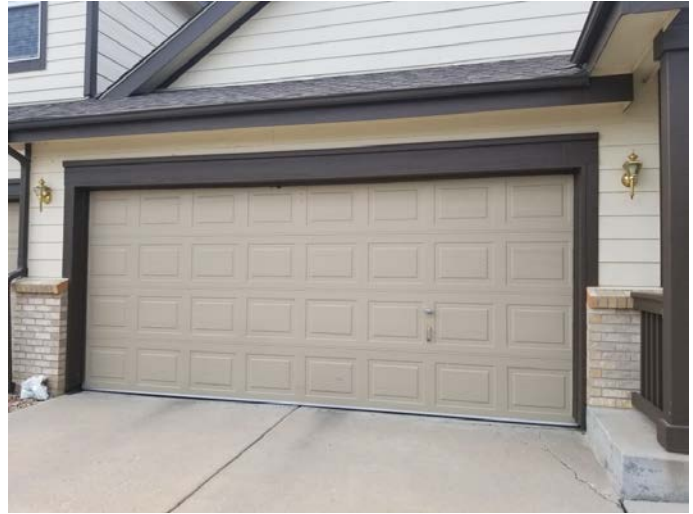
Comp #: 502 Garage Doors - Replace

- Per the instructions given to us by the client, we have used the Responsibility for Payment column of the Maintenance Responsibility Chart to determine whether the association is responsible.
- According to that document, garage doors are the responsibility of the home owner
- No Reserve funding is required.

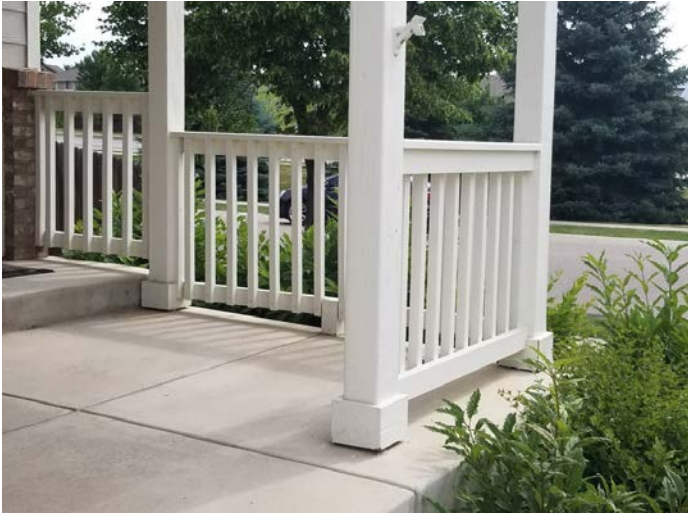
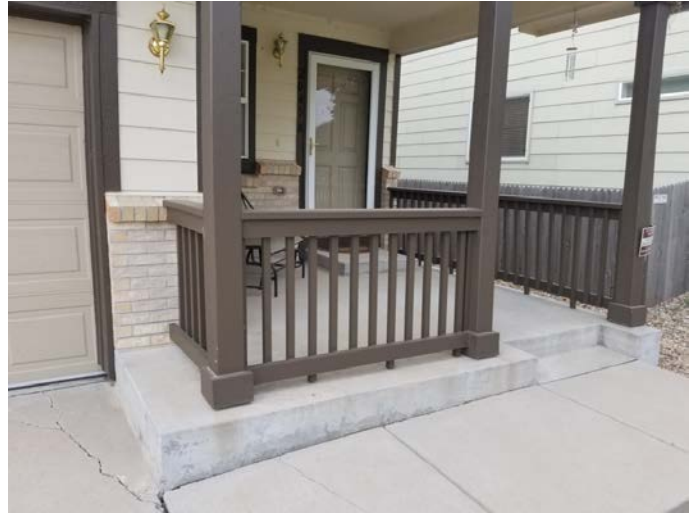
Comp #: 601 Concrete Sidewalks/Porches - Repair

- Per the instructions given to us by the client, we have used the Responsibility for Payment column of the Maintenance Responsibility Chart to determine whether the association is responsible.
- According to that document, sidewalks and porches are the responsibility of the home owner.
- No Reserve funding is required.

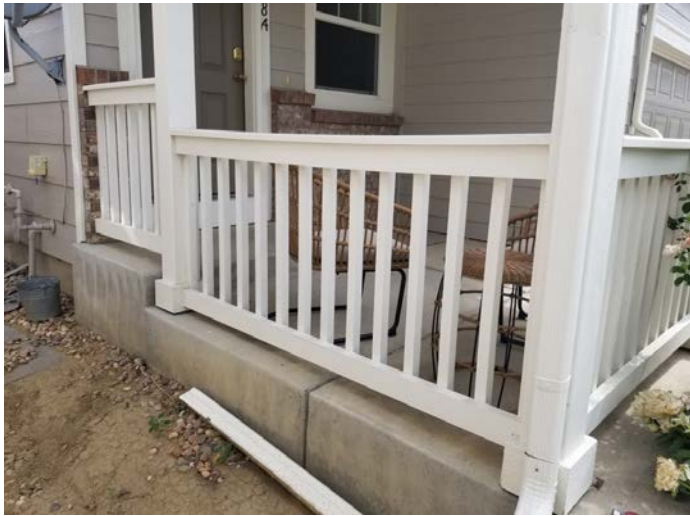
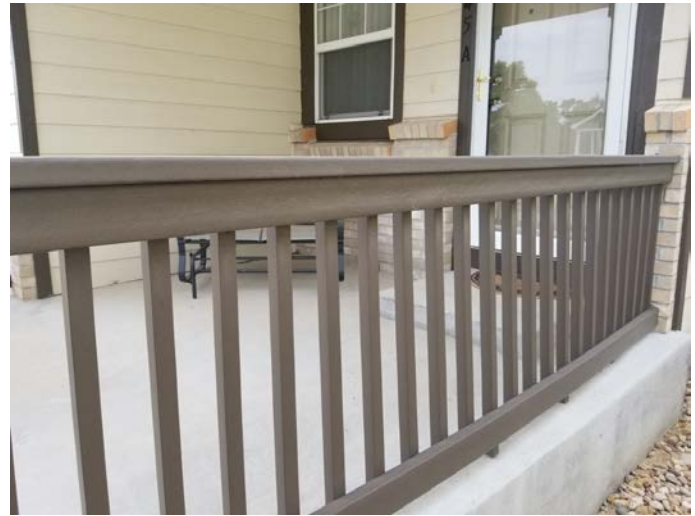
Comp #: 609 Composite Rails - Replace

- Per the instructions given to us by the client, we have used the Responsibility for Payment column of the Maintenance Responsibility Chart to determine whether the association is responsible.
- According to that document, the rails are the responsibility of the home owner.
- No Reserve funding is required.

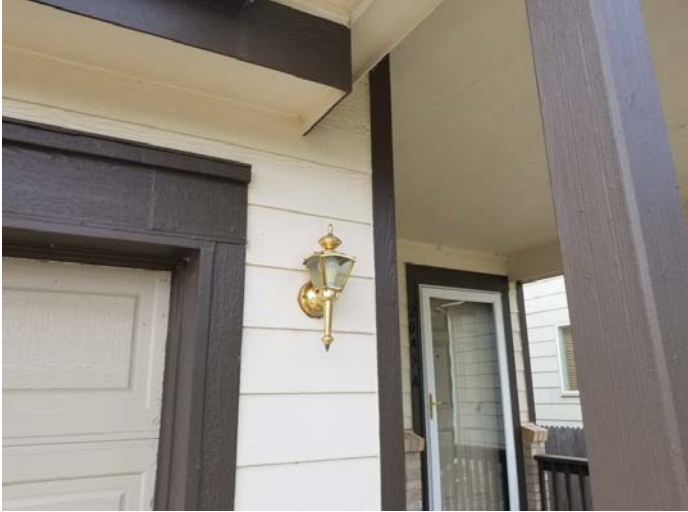
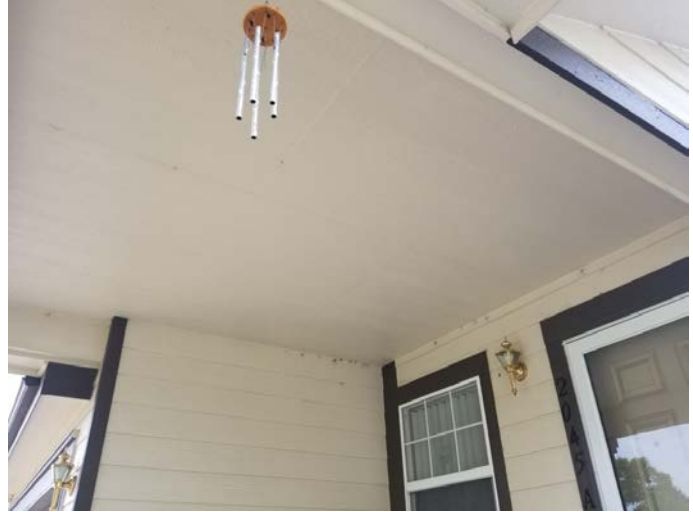
Comp #: 1602 Exterior Wall Mount - Replace

- Per the instructions given to us by the client, we have used the Responsibility for Payment column of the Maintenance Responsibility Chart to determine whether the association is responsible.
- According to that document, all exterior lights are the responsibility of the home owner.
- No Reserve funding is required.

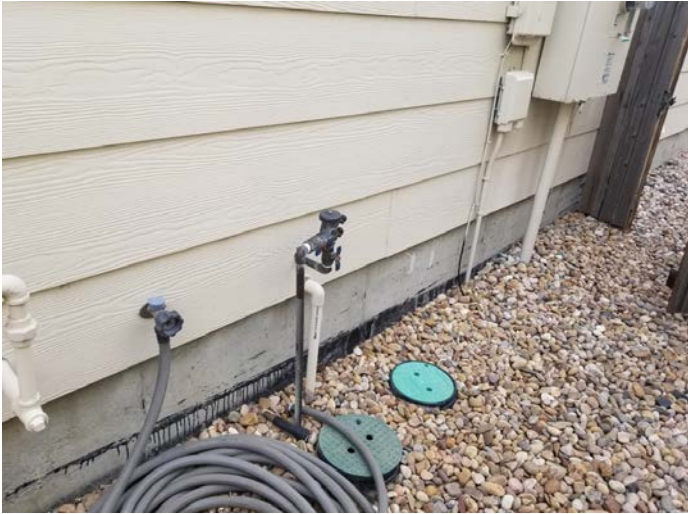
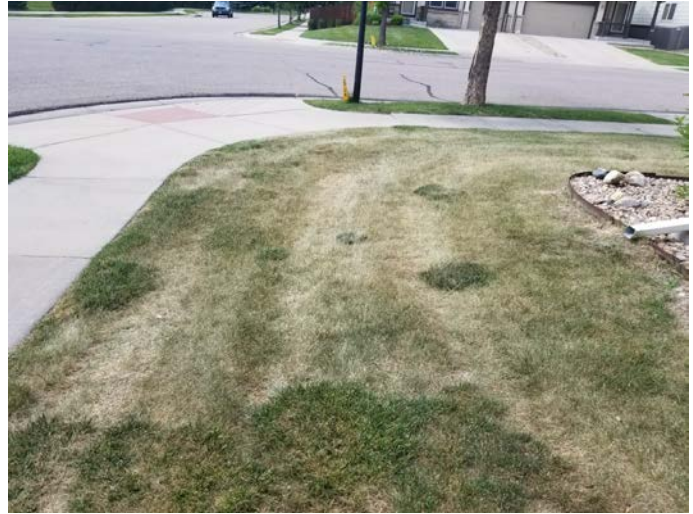
Comp #: 1701 Irrigation System - Major Repairs

Observations:

- This line item is for repairs and replacement that lies outside the scope of routine maintenance: bulk sprinkler head replacement, bulk valve replacement, rerouting lateral lines, rewiring, etc.
- This line item can be used to fund the shut off valve project that has been discussed.
- In order to ensure the funds are available for major repairs, we recommend reserving funds for these projects every 4 - 6 years.
- The funding on this line item is for major repairs and is not to be interpreted as complete irrigation system replacement.

Allowance for major repairs

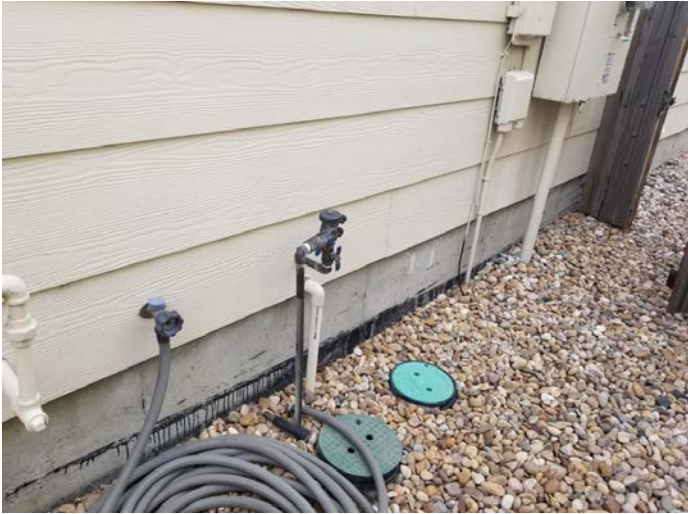
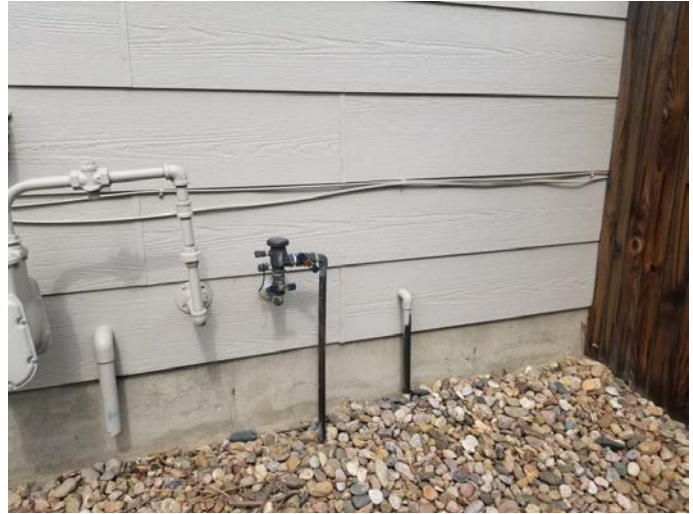
Comp #: 1706 Backflow Devices - Replace

Observations:

- Devices can be rebuilt and repaired when needed as a maintenance issue.
- It is very seldom that a complete system would need to be replaced due to normal wear and tear.
- Replacement would be as a result of freezing conditions if system is not winterized properly in a timely manner.
- No Reserve funding is required due to difficulty of predicting a life expectancy and the fact that systems can be rebuilt at a minimal cost, as opposed to being replaced.

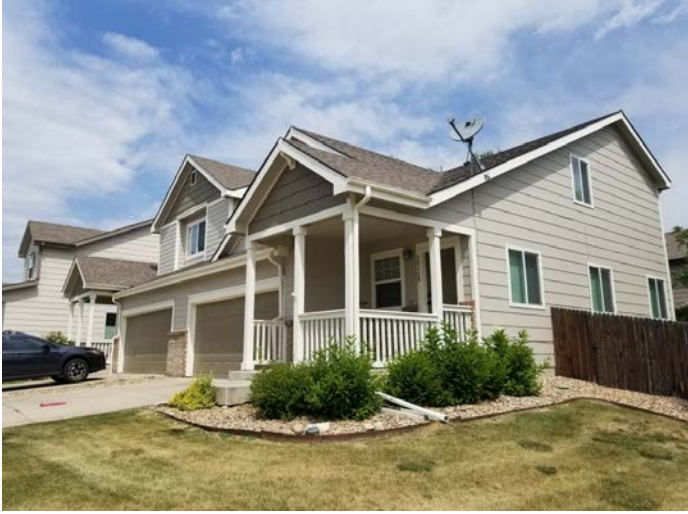
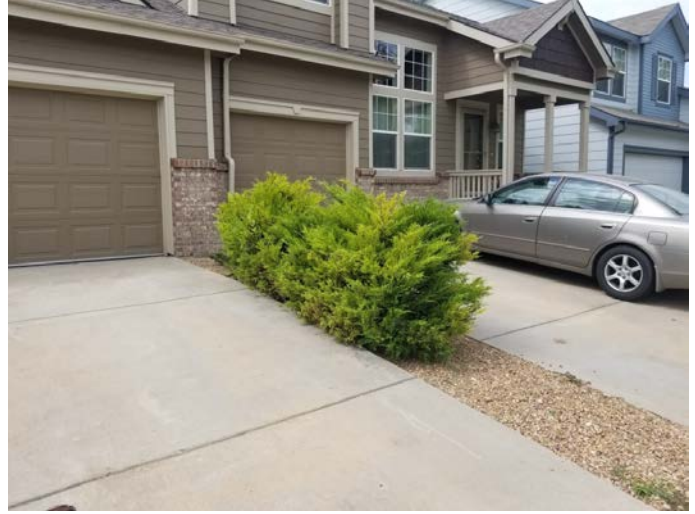
Comp #: 1801 Groundcover - Replenish

Observations:

- This line item, similar to irrigation repairs, is for projects that lie outside the scope of routine maintenance.
- In order to preserve an attractive curb appeal and to maintain the health of the plants and shrubs, we recommend reserving for refurbishment projects every 2 - 3 years.
- This line item is for cyclical refurbishment and should not be considered as complete landscaping replacement.

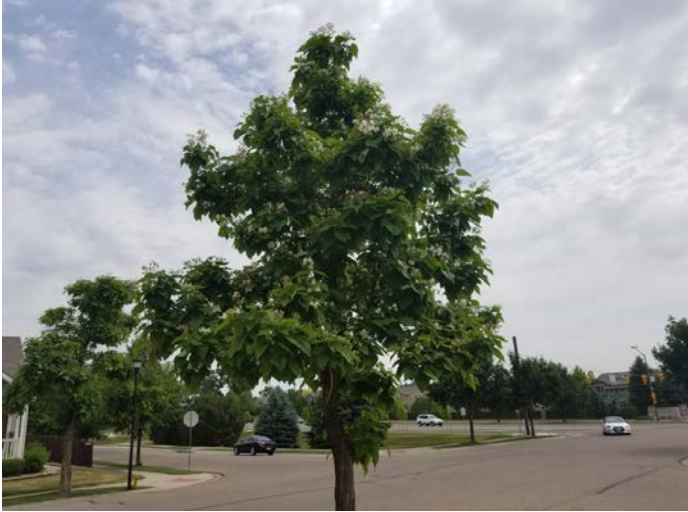
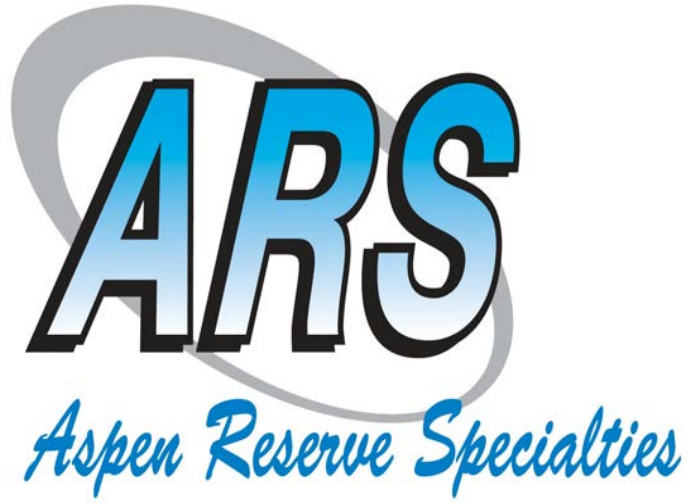
Comp #: 1804 Tree - Replacement/Major Maintenance

Observations:

- It is very difficult to predict a replacement cycle for trees as there are several factors such as disease, infestation of insects, heavy snow storms, etc. can all attribute to eventual tree replacement.
- Since it is difficult to predict when the replacement will be necessary, Reserve funding is typically not a factor.
- Therefore, unless requested by the association, Reserve funding will not be included as part of the study for this component.
