**Level 1, Platinum Reserve Analysis**  
**Report Period – 01/01/18 – 12/31/18**

**Client Reference Number - \$\$\$\$**  
**Property Type – Paired Homes**

**Fiscal Year End –** December 31  
**Number of units-** 82  
**Date of Property Observation -** September 19, 2017

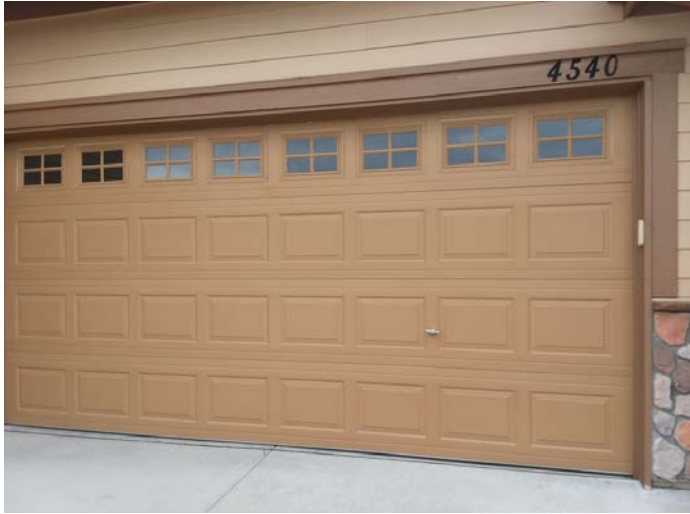
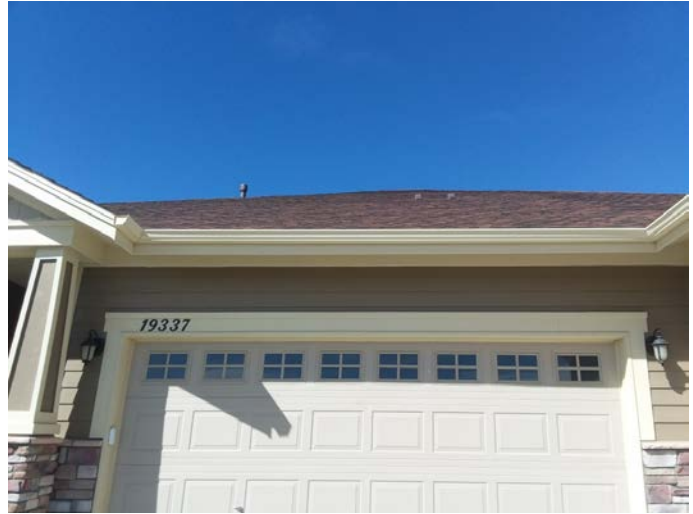
Comp #: 502 Garage Doors - Replace

- According to the declarations, the garage doors are not the responsibility of the association.
- Therefore, at this time, Reserve funding is not required for this component.
- Some associations decide to take on the responsibility as an HOA expense in order to maintain a consistent appearance and to obtain the best replacement cost possible.

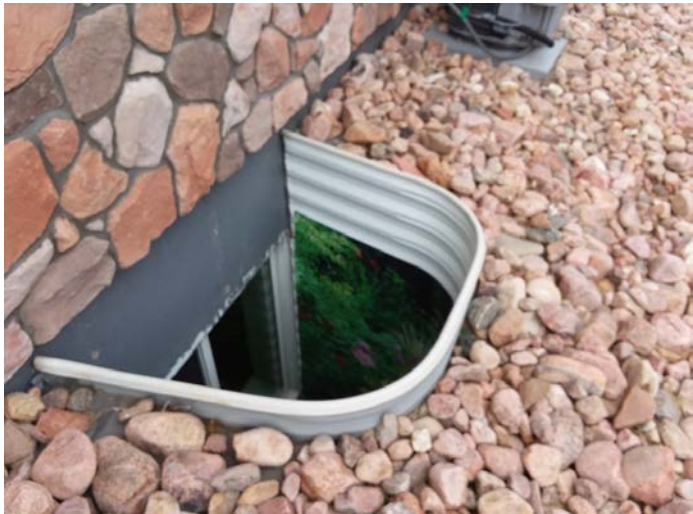
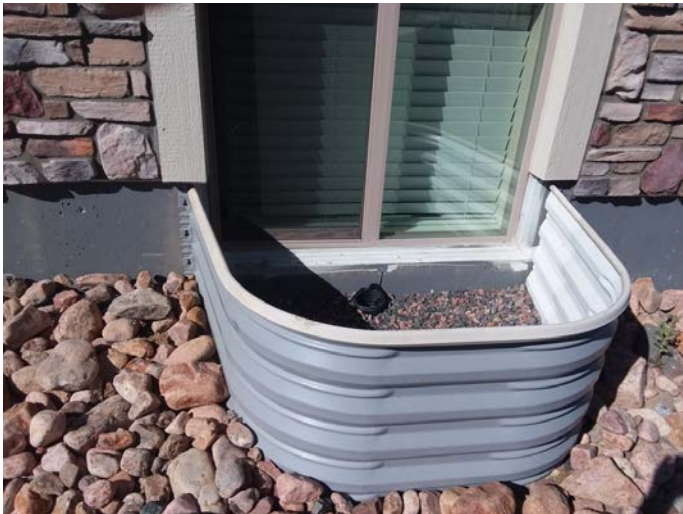
Comp #: 509 Window Wells - Replace

- Due to unpredictable life expectancy, Reserve funding is not required.
- At this time, we recommend replacing on an as needed basis with general operating funds.
- If periodic replacement becomes necessary, we can add funding in future Reserve Study Updates.

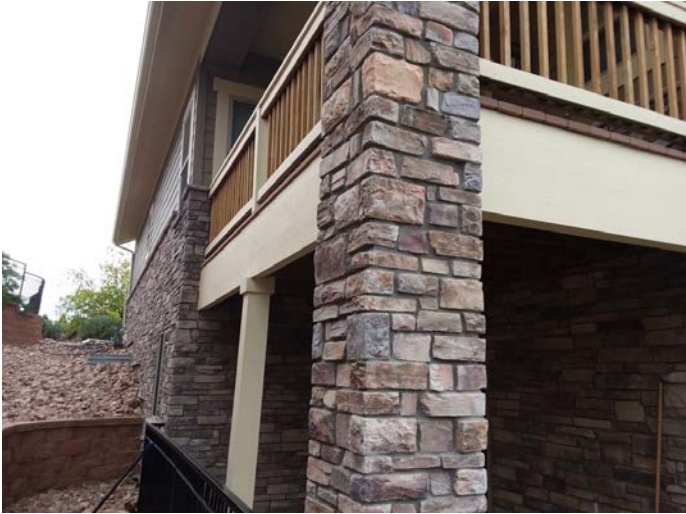
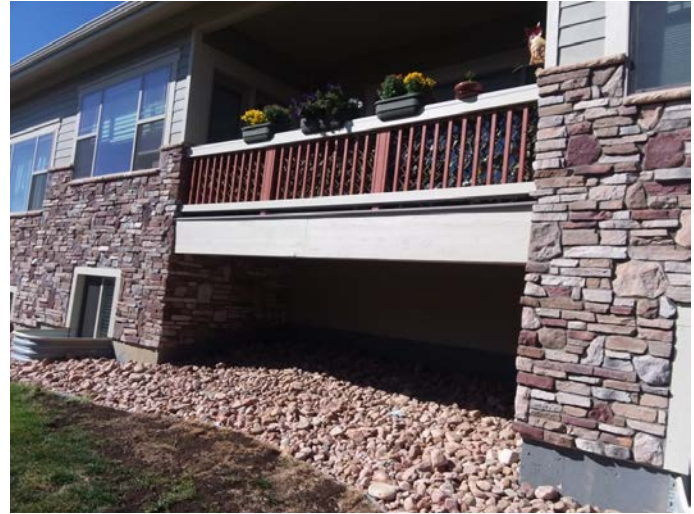
Comp #: 607 Composite Deck - Replace

- The declarations are not clear as to who is responsible for maintenance or eventual replacement of decks.
- Since these are used individually by the owner or tenants of the unit, then it is typical for the individual owner to be responsible.
- Therefore, at this time, Reserve funding is not required for this component.

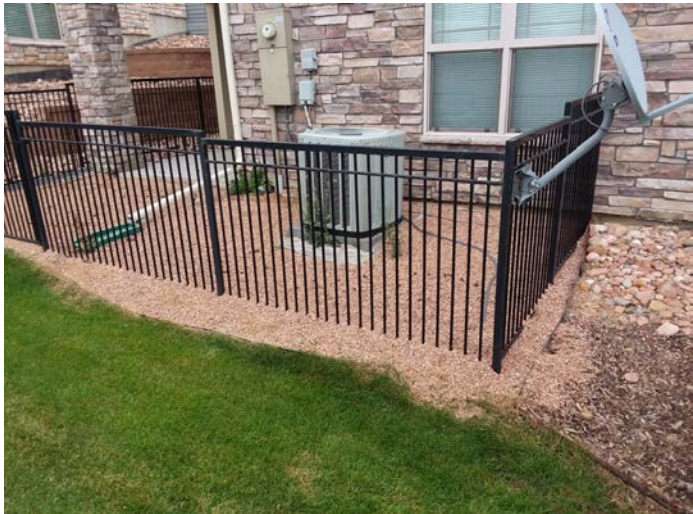
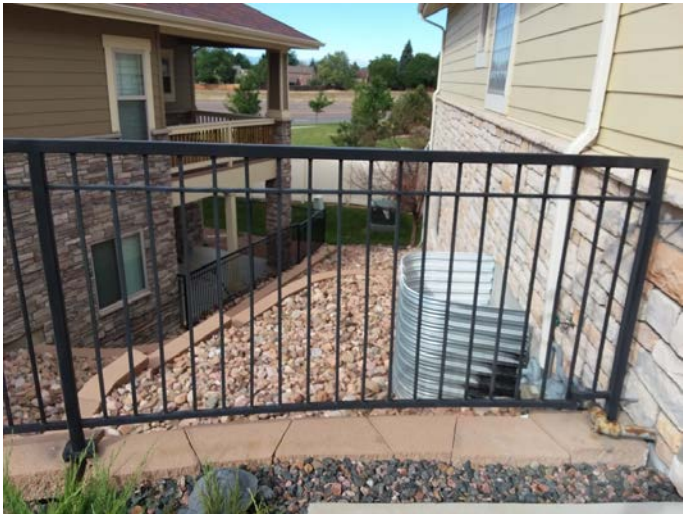
Comp #: 1002 Metal Railing/Fencing - Replace

- Due to limited direct exposure to elements and soils/moisture, the life expectancy of the metal railing should be indefinite.
- Therefore, at this time, separate Reserve funding is not required for this component.
- If it later turns out that deterioration exceeds our expectation, Reserve funding can be added in future report updates.

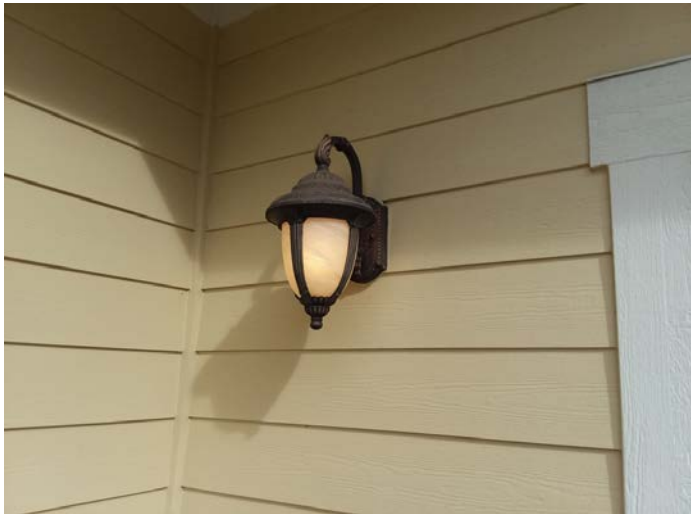
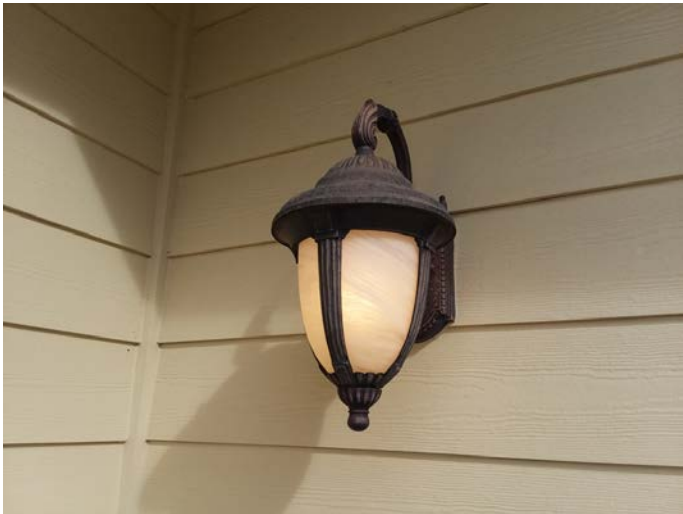
Comp #: 1602 Exterior Wall Mount - Replace (PH1)

- We were unable to test the lights due to the timing of the site observation but there were no reported issues with the lights.
- While replacement can occur on an as needed basis, it is our opinion and recommendation to replace all lights at the same time every 20 - 25 years to maintain a consistent appearance throughout the property.
- By replacing multiple fixtures, the association will be able to obtain a quantity discount for replacement and installation of the fixtures.

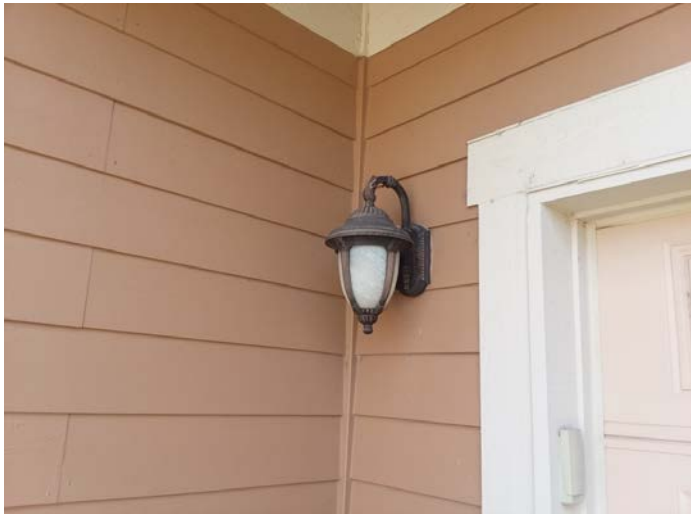
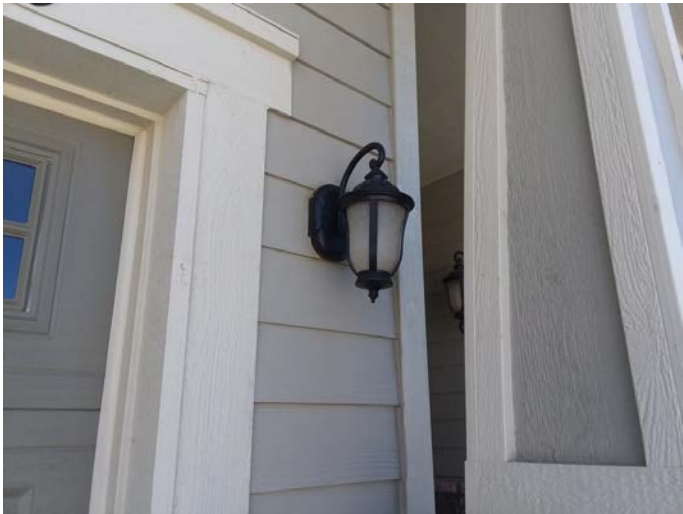
Comp #: 1603 Exterior Wall Mount - Replace (PH2)

- We were unable to test the lights due to the timing of the site observation but there were no reported issues with the lights.
- While replacement can occur on an as needed basis, it is our opinion and recommendation to replace all lights at the same time every 20 - 25 years to maintain a consistent appearance throughout the property.
- By replacing multiple fixtures, the association will be able to obtain a quantity discount for replacement and installation of the fixtures.

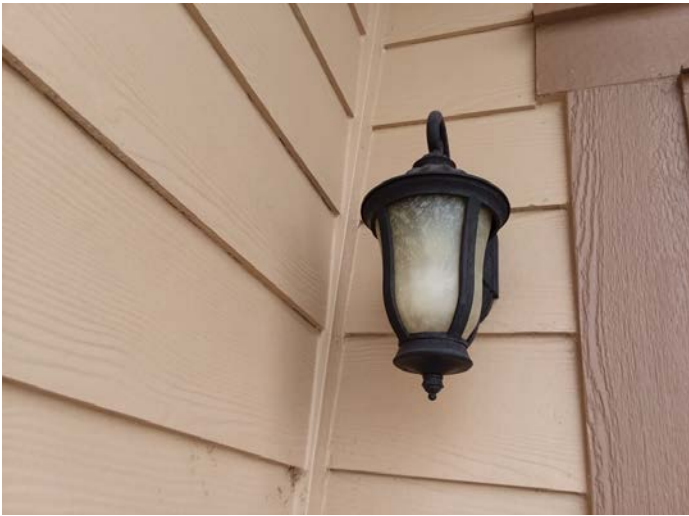
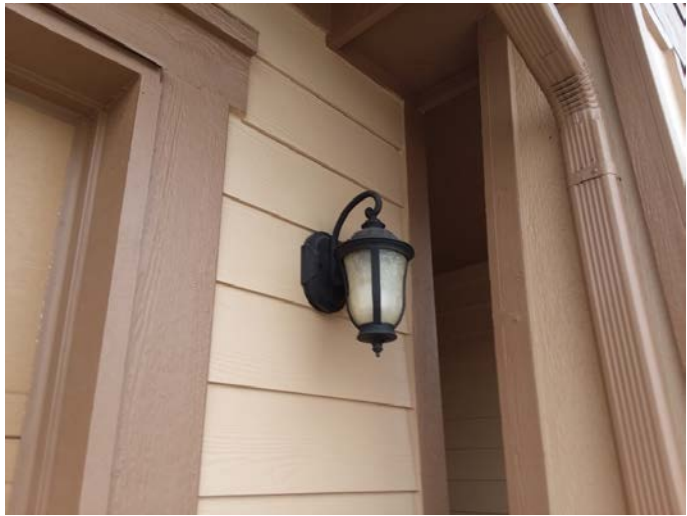
Comp #: 1604 Exterior Wall Mount - Replace (PH3)

- We were unable to test the lights due to the timing of the site observation but there were no reported issues with the lights.
- While replacement can occur on an as needed basis, it is our opinion and recommendation to replace all lights at the same time every 20 - 25 years to maintain a consistent appearance throughout the property.
- By replacing multiple fixtures, the association will be able to obtain a quantity discount for replacement and installation of the fixtures.

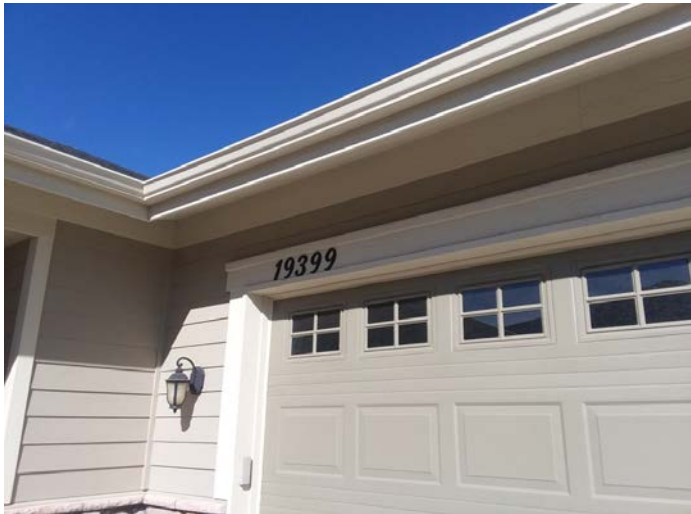
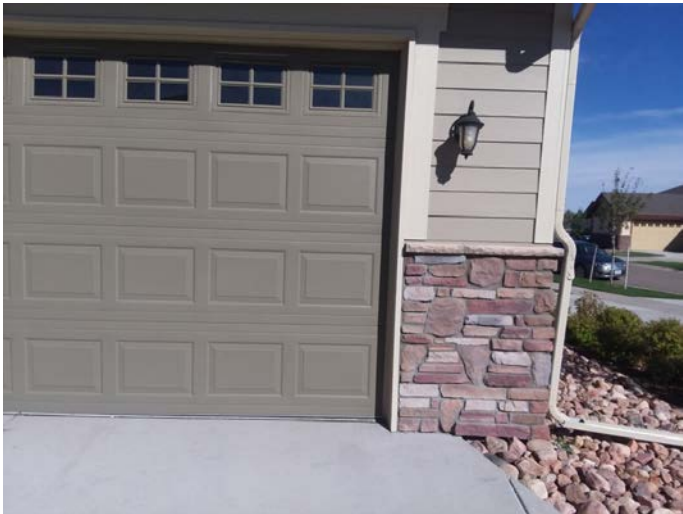
Comp #: 1605 Exterior Wall Mount - Replace (PH4)

- We were unable to test the lights due to the timing of the site observation but there were no reported issues with the lights.
- While replacement can occur on an as needed basis, it is our opinion and recommendation to replace all lights at the same time every 20 - 25 years to maintain a consistent appearance throughout the property.
- By replacing multiple fixtures, the association will be able to obtain a quantity discount for replacement and installation of the fixtures.

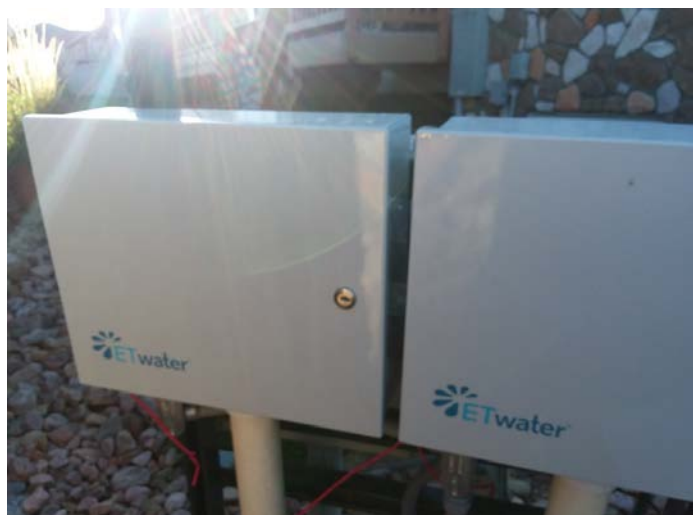
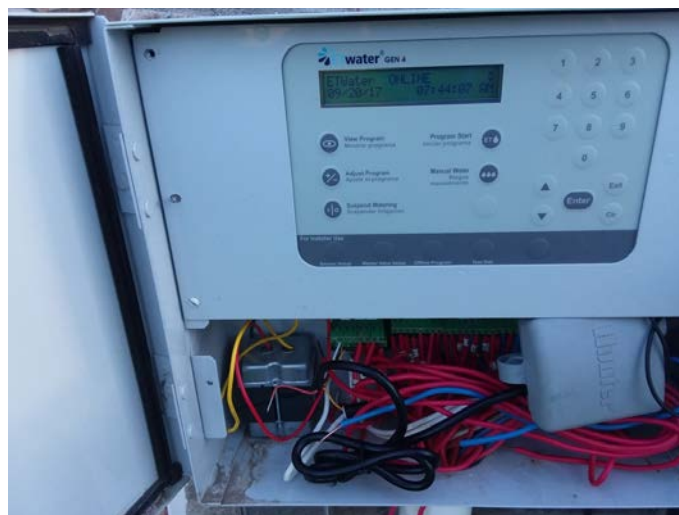
Comp #: 1703 Irrigation Controllers - Replace

- There were no reported issues with the ETWater controllers.
- These controllers can be much more efficient than standard irrigation controllers.
- Typically, these controllers have a life of 10 - 12 years.
- Remaining life is based on the age of the controllers.

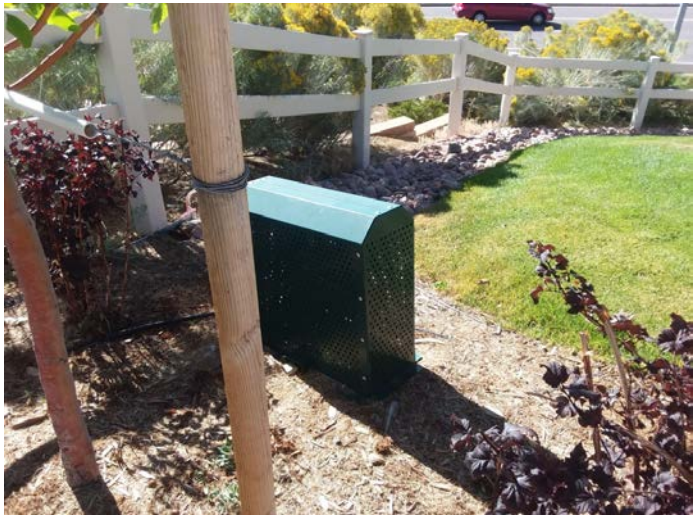
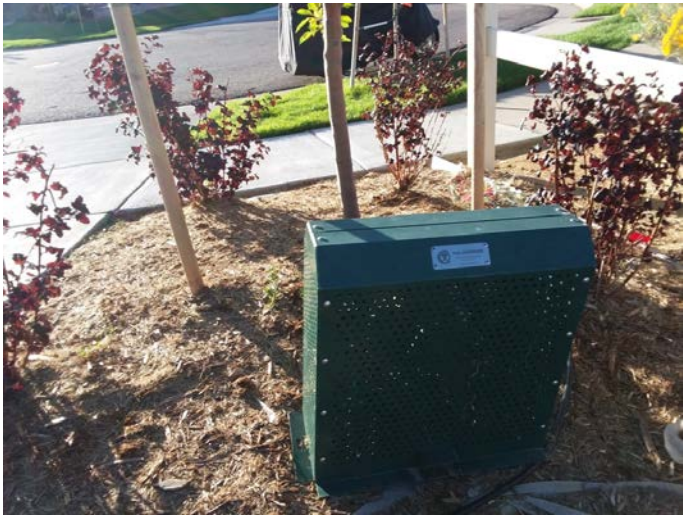
Comp #: 1706 Backflow Devices - Replace

- Devices can be rebuilt and repaired when needed as a maintenance issue.
- It is very seldom that a complete system would need to be replaced due to normal wear and tear.
- Replacement would be as a result of freezing conditions if system is not winterized properly or in a timely manner.
- No Reserve funding is required due to difficulty of predicting a life expectancy and the fact that systems can be rebuilt at a minimal cost, as opposed to being replaced.

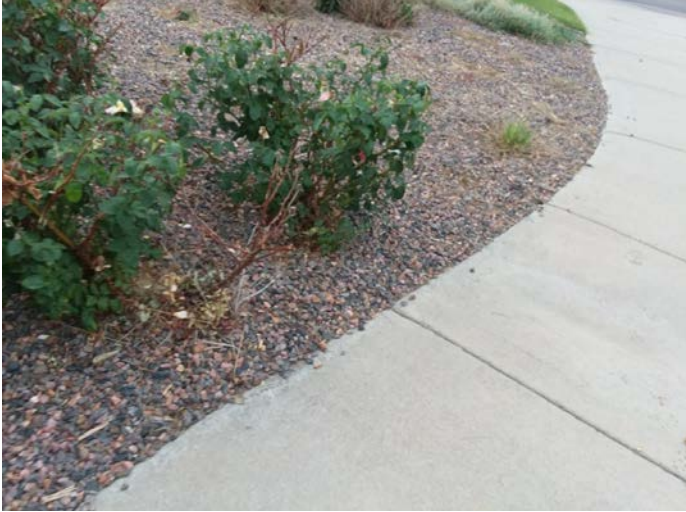
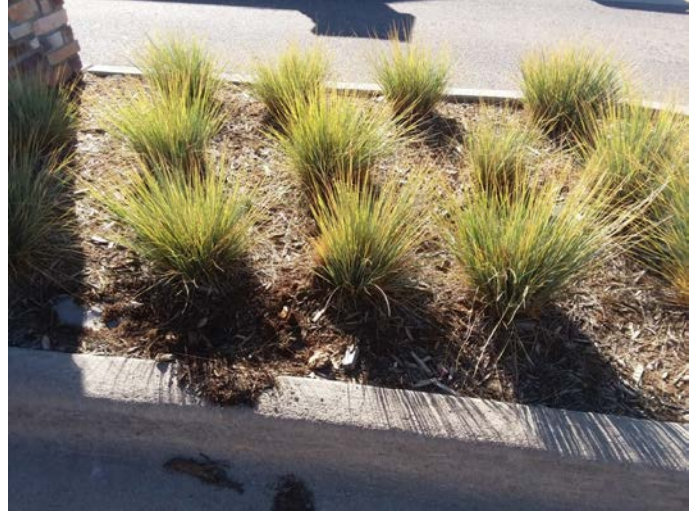
Comp #: 1801 Groundcover - Replenish

- Typically, associations will establish a line item in the operating budget to handle annual replacement of shrubs, plants, grass areas, etc.
- Therefore, separate Reserve funding is not necessary as long as funding has been established in a separate budget.
- If the association prefers to include a funding allowance for groundcover replenishment then we would need to know how much and how often the current board of directors would prefer to set aside since this would be considered a discretionary expense.

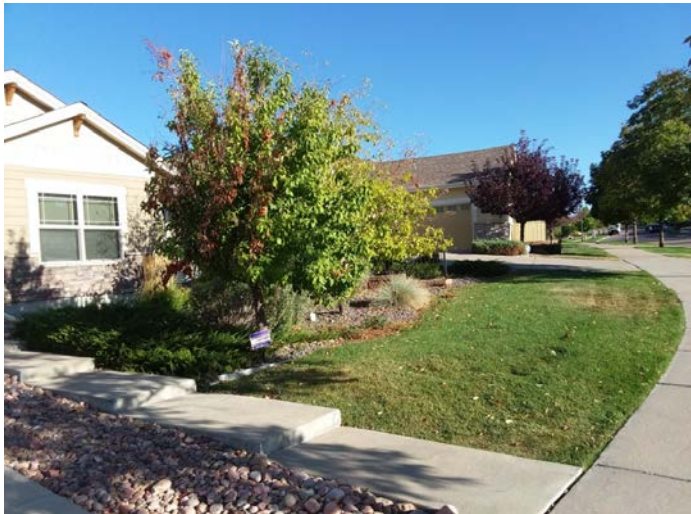
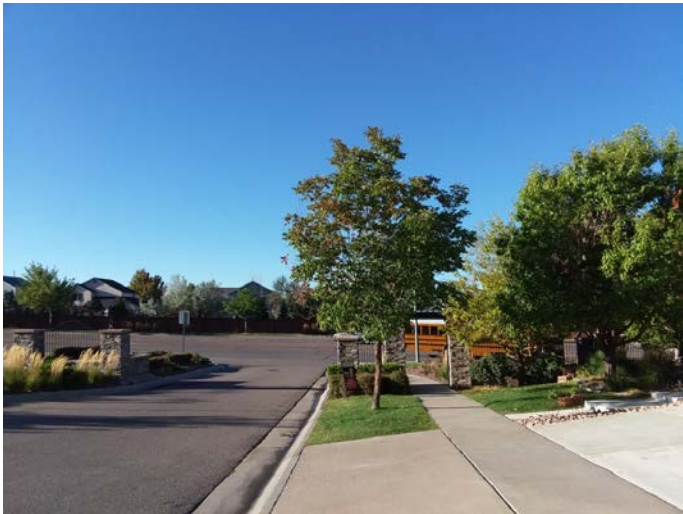
Comp #: 1804 Tree - Replacement/Major Maintenance

- It is very difficult to predict a replacement cycle for trees as there are several factors such as disease, infestation of insects, heavy snow storms, etc. can all attribute to eventual tree replacement.
- Since it is difficult to predict when the replacement will be necessary, Reserve funding is typically not a factor.
- Therefore, unless requested by the association, Reserve funding will not be included as part of the study for this component.
